SERVICE BULLETIN

SERVICE BULLETIN		No.: MSB-98E00-503		
		Date: 1998-12-15		
Subject:	CORRECTION TO DIAGNOSIS CODE READING PROCEDURE FOLLOWED WHEN USING WARNING LAMP		<Model>	<M/Y>
			(EC,EXP)COLT	96-10
			(CA0A,CC0A)	97-10
			(EC,EXP)	97-10
Group:	GENERAL	Draft No.: 98AL051414		
CORRECTION	OVERSEAS SERVICE DEPT	  T.NITTA - VICE GENERAL MANAGER QUALITY INFORMATION ANALYSIS	GALANTE (E50-80)	96-10
			(EC,EXP)L200(K00)	
			(EC,EXP)LANCER	
			(CB0A,CD0A)

This Service Bulletin informs you of correction to the diagnosis code reading procedure to be followed when using the warning lamp.

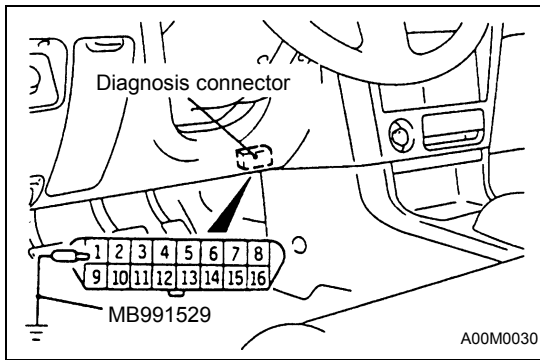
<Incorrect>

3. Turn off the ignition switch.
4. Read out a diagnosis code by observing how the warning lamp flashes.

ON <Correct>

1. Use the special tool to earth No.1 terminal (diagnosis control terminal) of the diagnosis connector.
2. To check ABS system, remove the valve relay.

That is because the valve relay is off and the warning lamp remains illuminated if there is a fault in the ABS system.
