# SERVICE BULLETIN

<b>SERVICE BULLETIN</b>		No.: ESB-99E11-504	
		Date: 1999-07-15	<Model> <M/Y>
<b>Subject:</b> CORRECTION IN CYLINDER HEAD BOLTS INSTALLING PROCEDURE		(EC) SPACE STAR (DG0A)	99-10
<b>Group:</b> ENGINE			
<b>INFORMATION</b>

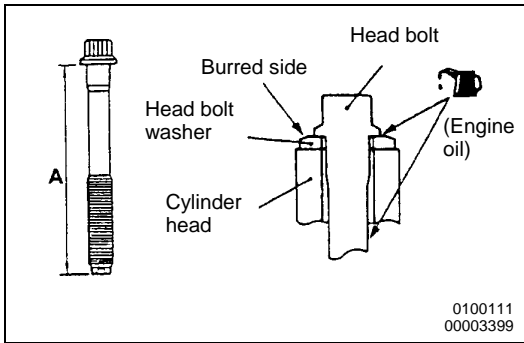
CYLINDER HEAD BOLT INSTALLATION

1. When installing the cylinder head bolts, the length below the head of the bolts should be within the limit. If it is outside the limit, replace the bolts.

**Limit (A): 96.4 mm**

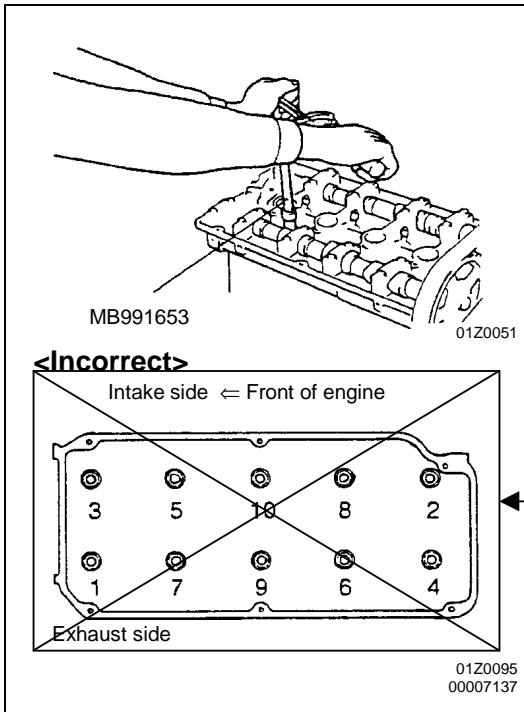
2. The head bolt washer should be installed with the burred side caused by tapping out facing upwards.
3. Apply a small amount of engine oil to the thread section and the washer of the cylinder head bolt.
4. Tighten the bolts by the following procedure.

Step	Operation	Remarks
1	Tighten to 74 Nm.	Carry out in the order shown in the illustration
2	Fully loosen	Carry out in the reverse order of that shown in the illustration
3	Tighten to 20 Nm.	Carry out in the order shown in the illustration
4	Tighten 90° of a turn.	In the order shown in the illustration. Mark the head of the cylinder head bolt and cylinder head by paint.
5	Tighten 90° of a turn.	In the order shown in the illustration. Check that the painted mark of the head bolt is lined up with that of the cylinder head.

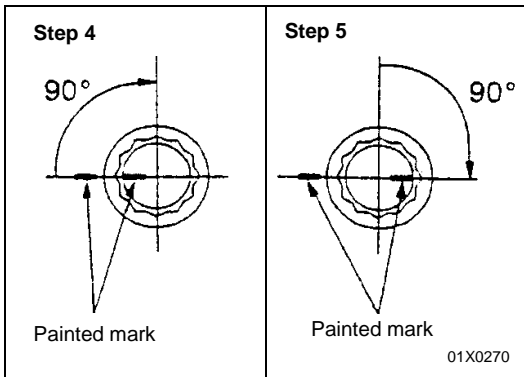
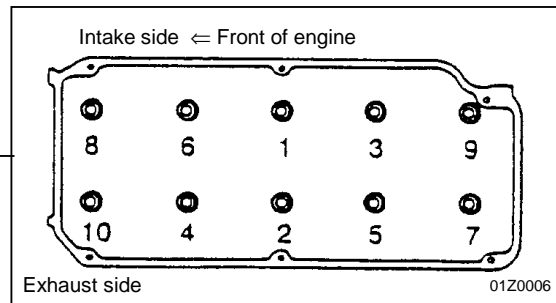
**<Correct>**

- (1) Always make a tightening angle just 90°. If it is less than 90°, the head bolt will be loosened.
- (2) If it is more than 90°, remove the head bolt and repeat the procedure from step 1.
