SERVICE BULLETIN

SERVICE BULLETIN		No.: ESB-99E33-502	
		Date: 1999-12-31	<Model> <M/Y>
Subject:	CORRECTION TO CAMBER VALUE FOR FRONT SUSPENSION	(EC) SPACE STAR (DG1A, DG5A)	99-10
Group:	FRONT SUSPENSION		
CORRECTION

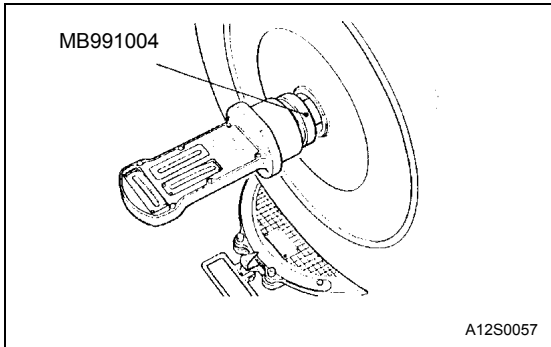
STEERING ANGLE

Standard value:

Inner wheel 41°30'

Outer wheel 34°00'
