SERVICE BULLETIN

SERVICE BULLETIN		Nr.: ESB-99E52-900	
		Date: 2000-09-15	<Model> <M/Y>
Subject:	CORRECTION OF CONNECTOR NUMBERS IN SRS-DIAGNOSTIC PROCEDURE.	(EC) SPACE STAR	99-10
Group:	INTERIOR		
INFORMATION/CORRECTION

O. Kai - E.V.P. & G.M. After Sales Service Dept.	
1. Description:			
Connector numbers of the SRS-system in diagnostic procedures have been corrected.			
2. Applicable Manuals:			
Manual	Pub. No.	Language	Page(s)
	CMXE99E1	(English)	52B-10
	CMXS99E1	(Spanish)	52B-10 – 52B-18
	CMXF99E1	(French)	
	CMXG99E1	(German)	
	CMXD99E1	(Dutch)	
	CMXW99E1	(Swedish)	
	CMXI99E1	(Italian)	
3. Details:

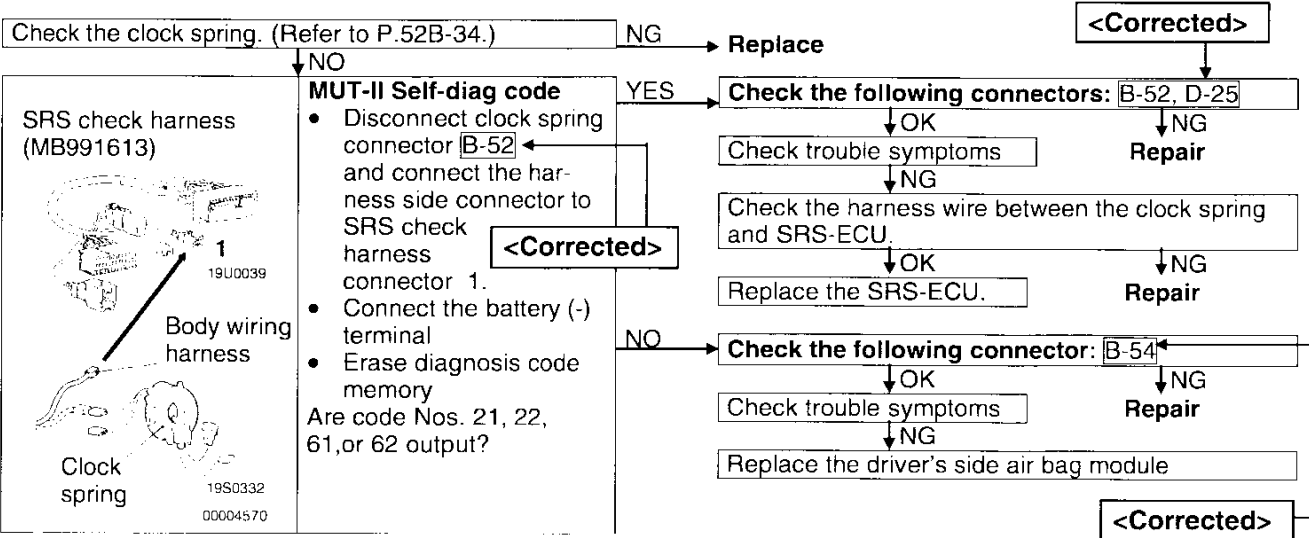
Code No.21, 22, 61 or 62 Driver's side air bag module (squib) system

These diagnosis codes are output if there is abnormal resistance between the input terminals of the driver's side air bag module (squib).
The trouble causes for each diagnosis code No. are as follows.

- Malfunction of clock spring
- Partial disconnection due to incorrect clock spring neutral position
- Malfunction of wiring harnesses or connectors
- Malfunction of driver's side air bag module (squib)
- Malfunction of SRS-ECU

Code No.	Trouble causes
21	<ul style="list-style-type: none"> • Short in driver's side air bag module (squib) or harness short • Short in clock spring
22	<ul style="list-style-type: none"> • Open circuit in driver's side air bag module (squib) or open harness • Open circuit in clock spring • Disconnected driver's side air bag module (squib) connector • Partial disconnection due to incorrect clock spring neutral position • Malfunction of connector contact
61	<ul style="list-style-type: none"> • Short in driver's side air bag module (squib) harness leading to the power supply
62	<ul style="list-style-type: none"> • Short in driver's side air bag module (squib) harness leading to the earth

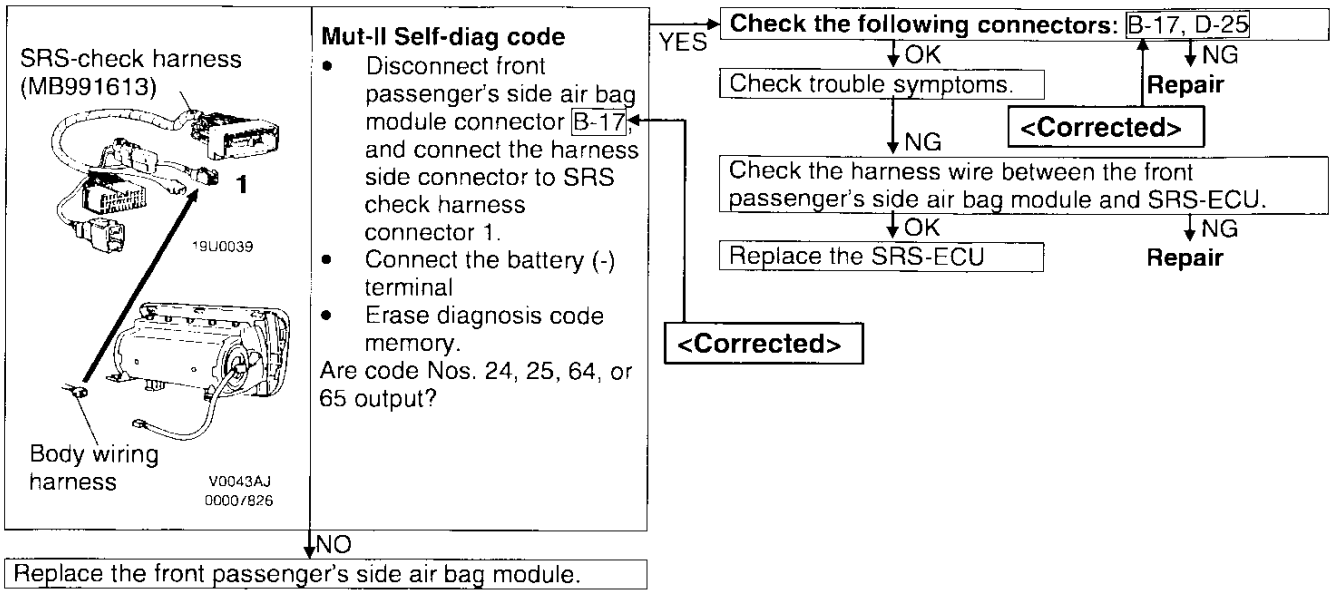
Code No.24, 25, 64 or 65 Front passenger's side air bag module (squib) system

These diagnosis codes are output if there is abnormal resistance between the input terminals of the front passenger's side air bag module (squib).
The trouble causes for each diagnosis code No. are as follows.

- Malfunction of wiring harnesses or connectors
- Malfunction of front passenger's side air bag module (squib)
- Malfunction of SRS-ECU

Code No.	Trouble causes
24	<ul style="list-style-type: none"> • Short in front passenger's side air bag module (squib) or harness short
25	<ul style="list-style-type: none"> • Open circuit in front passenger's side air bag module (squib) or open harness • Malfunction of connector contact
64	<ul style="list-style-type: none"> • Short in front passenger's side air bag module (squib) harness leading to the power supply
65	<ul style="list-style-type: none"> • Short in front passenger's side air bag module (squib) harness leading to the earth

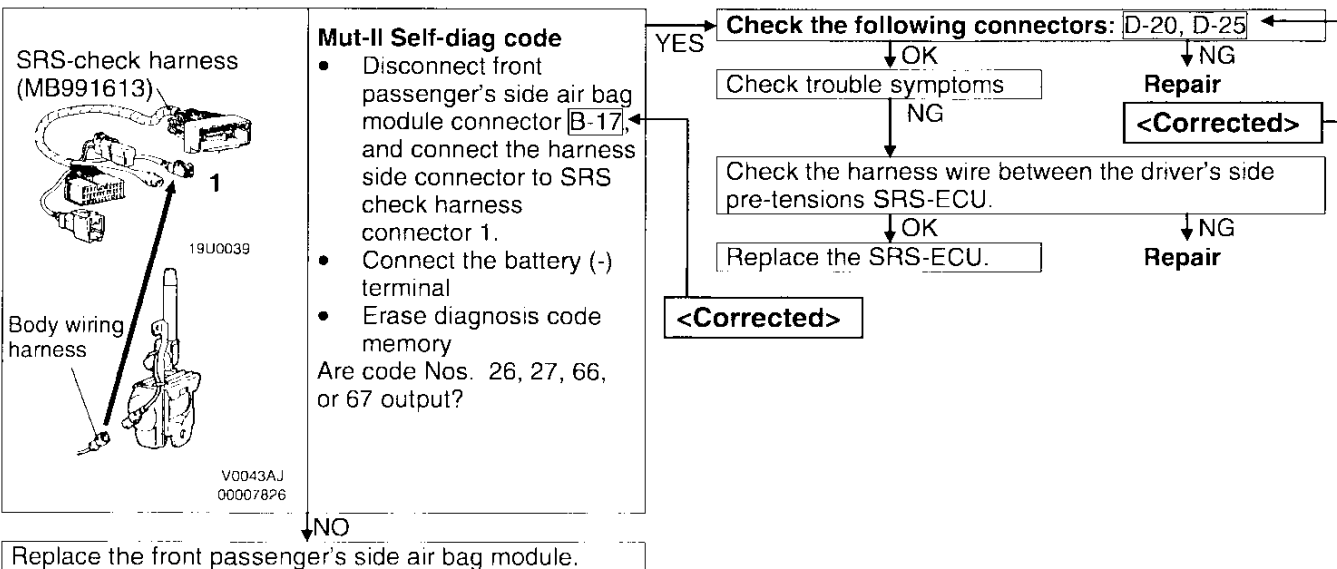
Code No.26, 27, 66 or 67 Driver's side pre-tensioner (squib) system

These diagnosis codes are output if there is abnormal resistance between the input terminals of the driver's side pre-tensioner (squib).
The trouble causes for each diagnosis code No. are as follows.

- Malfunction of wiring harnesses or connectors
- Malfunction of driver's side pre-tensioner (squib)
- Malfunction of SRS-ECU

Code No.	Trouble causes
26	• Short in driver's side pre-tensioner (squib) or harness short
27	• Open circuit in driver's side pre-tensioner (squib) or open harness • Malfunction of connector contact
66	• Short in driver's side pre-tensioner (squib) harness leading to the power supply
67	• Short in driver's side pre-tensioner (squib) harness leading to the earth

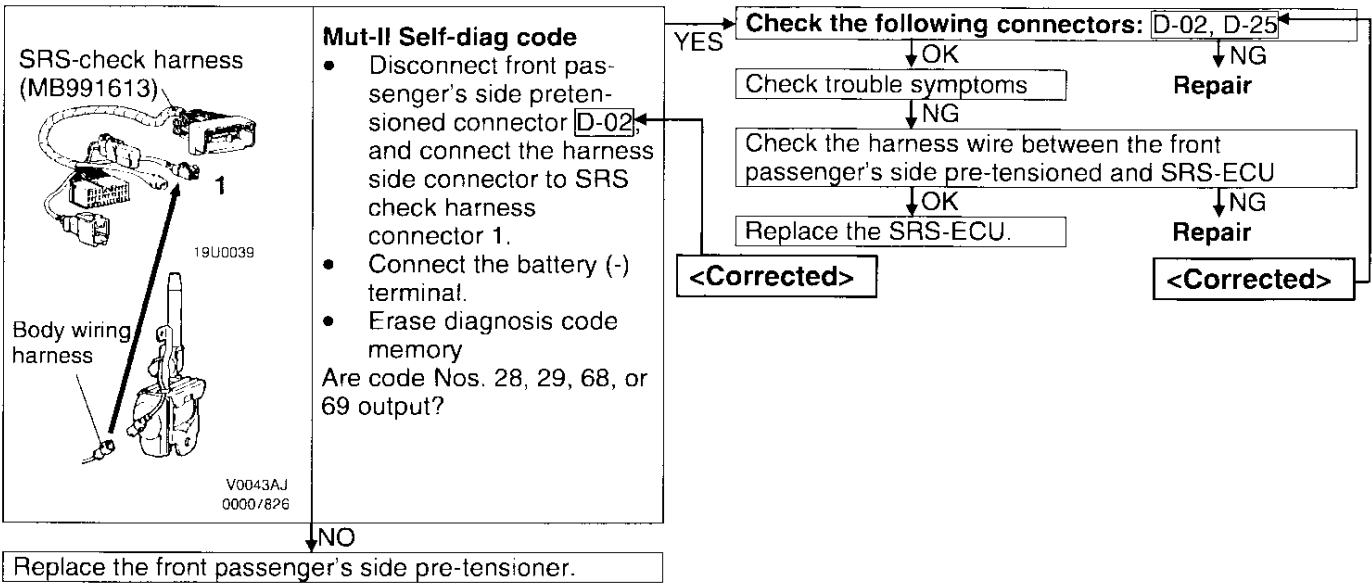
Code No.28, 29, 68 or 69 Front passenger's side pre-tensioner (squib) system

These diagnosis codes are output if there is abnormal resistance between the input terminals of the front passenger's side pre-tensioner (squib).
The trouble causes for each diagnosis code No. are as follows.

- Malfunction of wiring harnesses or connectors
- Malfunction of front passenger's side pre-tensioner (squib)
- Malfunction of SRS-ECU

Code No.	Trouble causes
28	<ul style="list-style-type: none"> • Short in front passenger's side pre-tensioner (squib) or harness short
29	<ul style="list-style-type: none"> • Open circuit in front passenger's side pre-tensioner (squib) or open harness • Malfunction of connector contact
68	<ul style="list-style-type: none"> • Short in front passenger's side pre-tensioner (squib) harness leading to the power supply
69	<ul style="list-style-type: none"> • Short in front passenger's side pre-tensioner (squib) harness leading to the earth

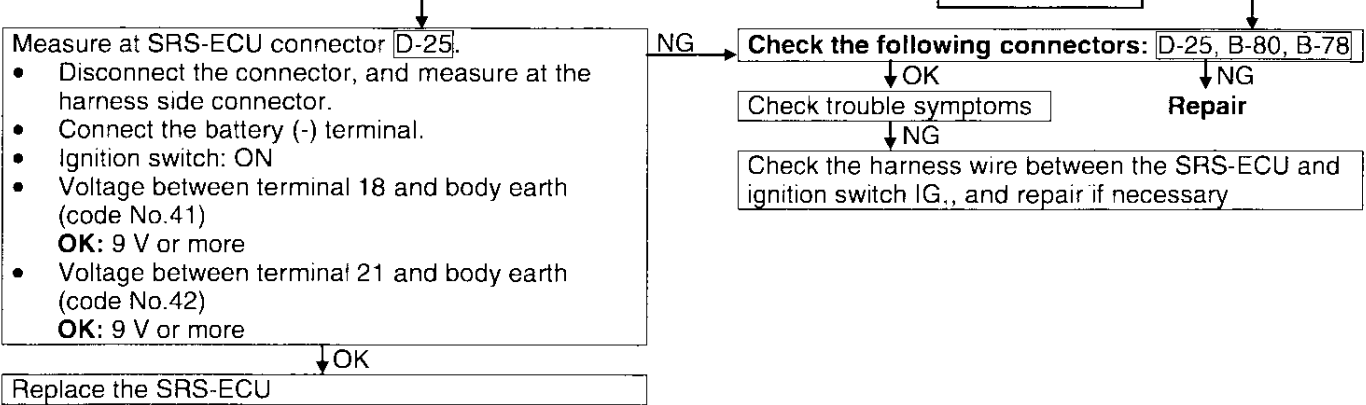
Code No.41 Power circuit system (fuse No.4 circuit)	Probable cause
<p>Code No.42 Power circuit system (fuse No.11 circuit)</p> <p>Code No.41 is output if the voltage between the IG, terminal (SRS-ECU, terminal 18) and the earth is lower than the specified value for a continuous period of 5 seconds or more. Code No.42 is output if the voltage between the IG, terminal (SRS-ECU, terminal 21) and the earth is lower than the specified value for a continuous period of 5 seconds or more. Automatically erased, and the SRS warning lamp will switch off. If the vehicle has a discharged battery it will store the fault codes 41 and 42. When these diagnosis codes are displayed, check the battery.</p>	<ul style="list-style-type: none"> Malfunction of wiring harnesses or connectors Malfunction of SRS-ECU

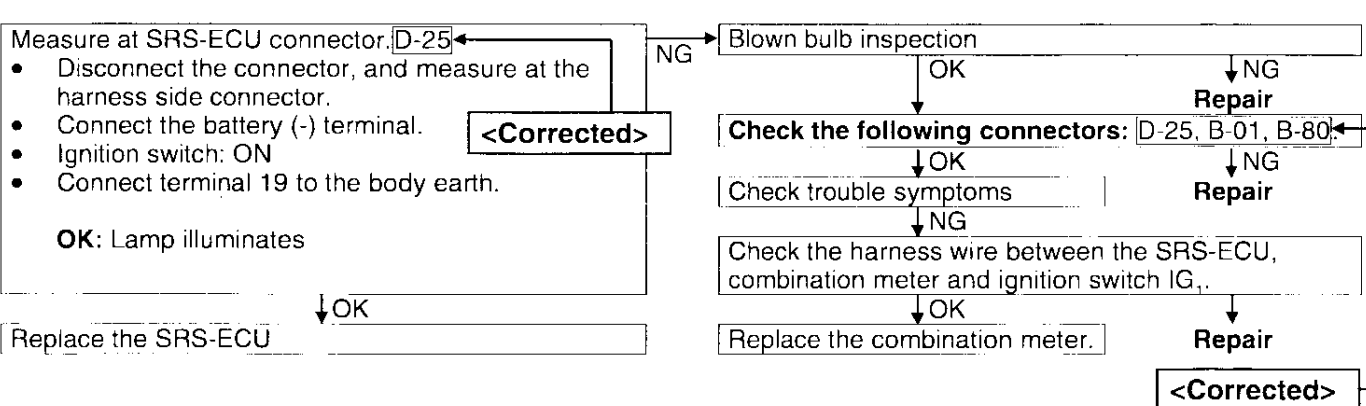
Code No.43 SRS warning lamp drive circuit system (Lamp does not illuminate.)	Probable cause
<p>This diagnosis code is output when an open circuit occurs for a continuous period of 5 seconds while the SRS-ECU in monitoring the SRS warning lamp and the lamp is OFF (transistor OFF). However, if this code is output due to an open circuit, if the vehicle condition returns to normal, this diagnosis code No.43 will be automatically erased, and the SRS warning lamp will return to normal.</p>	<ul style="list-style-type: none"> Malfunction of wiring harnesses or connectors Blown bulb Malfunction of SRS-ECU Malfunction of combination meter

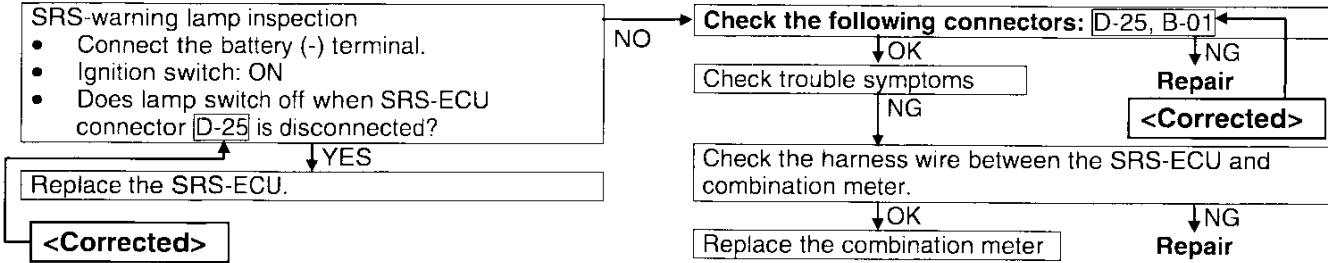
<p>Code No.43 SRS warning lamp drive circuit system (Lamp does not switch off.)</p>	<p>Probable cause</p>
<p>This diagnosis code is output when a short to earth occurs in the harness between the lamp and the SRS-ECU while SRS-ECU is monitoring the SRS warning lamp and the lamp is ON.</p>	<ul style="list-style-type: none"> • Malfunction of wiring harnesses or connectors • Malfunction of SRS-ECU • Malfunction of combination meter

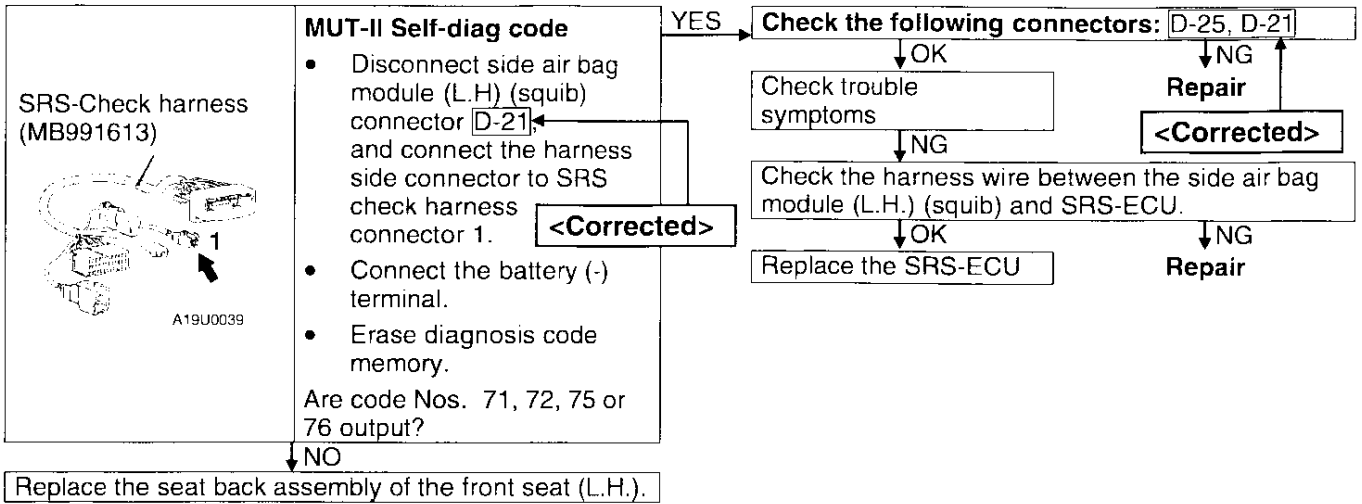
<p>Code No.71, 72, 75 or 76 Side air bag module (L.H.) (squib) system</p>	<p>Probable cause</p>
<p>These diagnosis codes are output if the resistance value between the side air bag module (L.H.) (squib) input terminals of the SRS-ECU is abnormal. The problems, which cause these codes to be output, are as follows.</p>	<ul style="list-style-type: none"> • Malfunction of wiring harnesses or connectors • Malfunction of side air bag module (L.H.) (squib) • Malfunction of SRS-ECU

Code No.	Trouble causes
71	<ul style="list-style-type: none"> • Short in side air bag module (L.H.) (squib) or harness short
72	<ul style="list-style-type: none"> • Open circuit in side air bag module (L.H.) (squib) or open harness • Malfunction of connector contact
75	<ul style="list-style-type: none"> • Short in side air bag module (L.H.) (squib) harness leading to the power supply
76	<ul style="list-style-type: none"> • Short in side air bag module (L.H.) (squib) harness leading to the earth

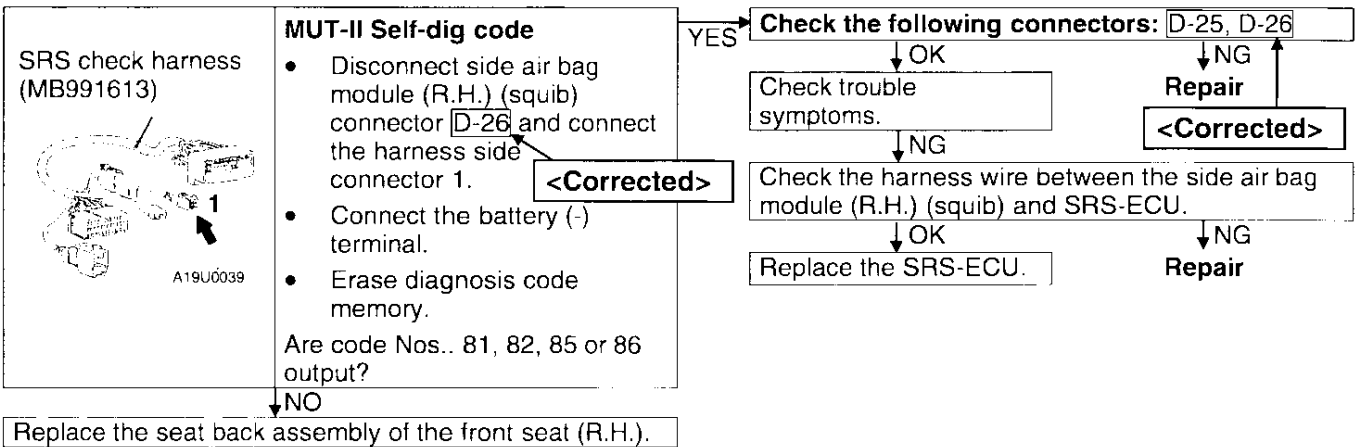
Code No.81, 82, 85 or 86 Side air bag module (R.H.) (squib) system	Probable cause
These diagnosis codes are output if the resistance value between the side air bag module (R.H.) (squib) input terminals of the SRS-ECU is abnormal. The problems, which cause these codes to be output, are as follows.	<ul style="list-style-type: none"> Malfunction of wiring harnesses or connectors Malfunction of side air bag module (R.H.) (squib) Malfunction of SRS-ECU

Code No.	Trouble causes
81	<ul style="list-style-type: none"> Short in side air bag module (R.H.) (squib) or harness short
82	<ul style="list-style-type: none"> Open circuit in side air bag module (R.H.) (squib) or open harness Malfunction of connector contact
85	<ul style="list-style-type: none"> Short in side air bag module (R.H.) (squib) harness leading to the power supply
86	<ul style="list-style-type: none"> Short in side air bag module (R.H.) (squib) harness leading to the earth

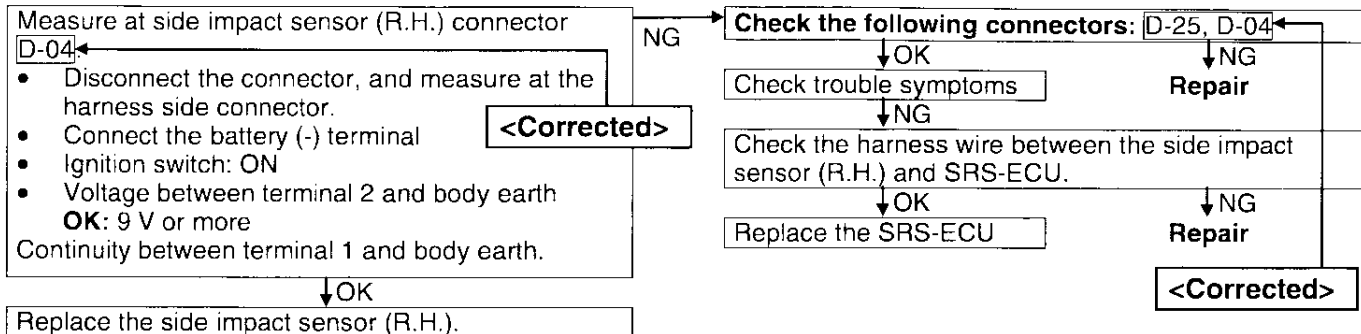
Code No.94 Side impact sensor (R.H.) power supply circuit system

This diagnosis code is output if the power supply voltage of the side impact sensor (R.H.) drops below the rated value for a continuous period of 5 seconds or more. However, code No.94 will be automatically cleared and the SRS warning lamp will switch off if the condition returns normal.

- Malfunction of wiring harnesses or connectors
- Malfunction of side impact sensor (R.H.)
- Malfunction of SRS-ECU

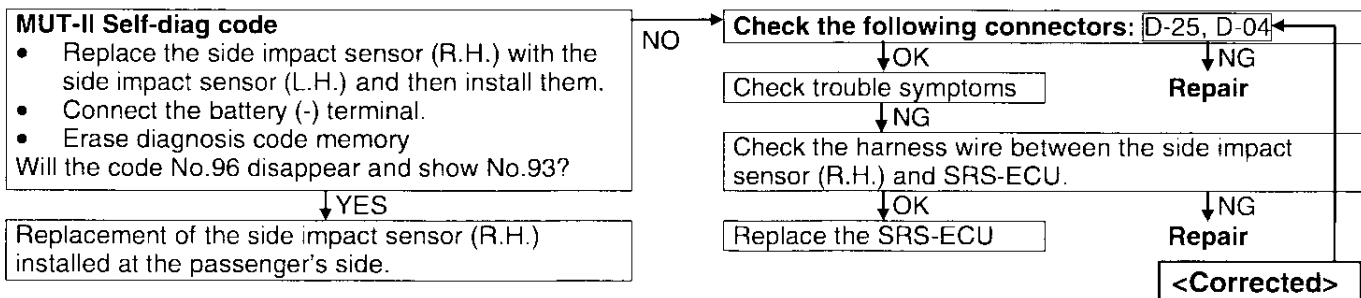
Code No.96 Side impact sensor (R.H.) communication system

This diagnosis code is output if communication between the side impact sensor (R.H.) and the SRS-ECU is abnormal

- Malfunction of wiring harnesses or connectors
- Malfunction of side impact sensor (R.H.)
- Malfunction of SRS-ECU

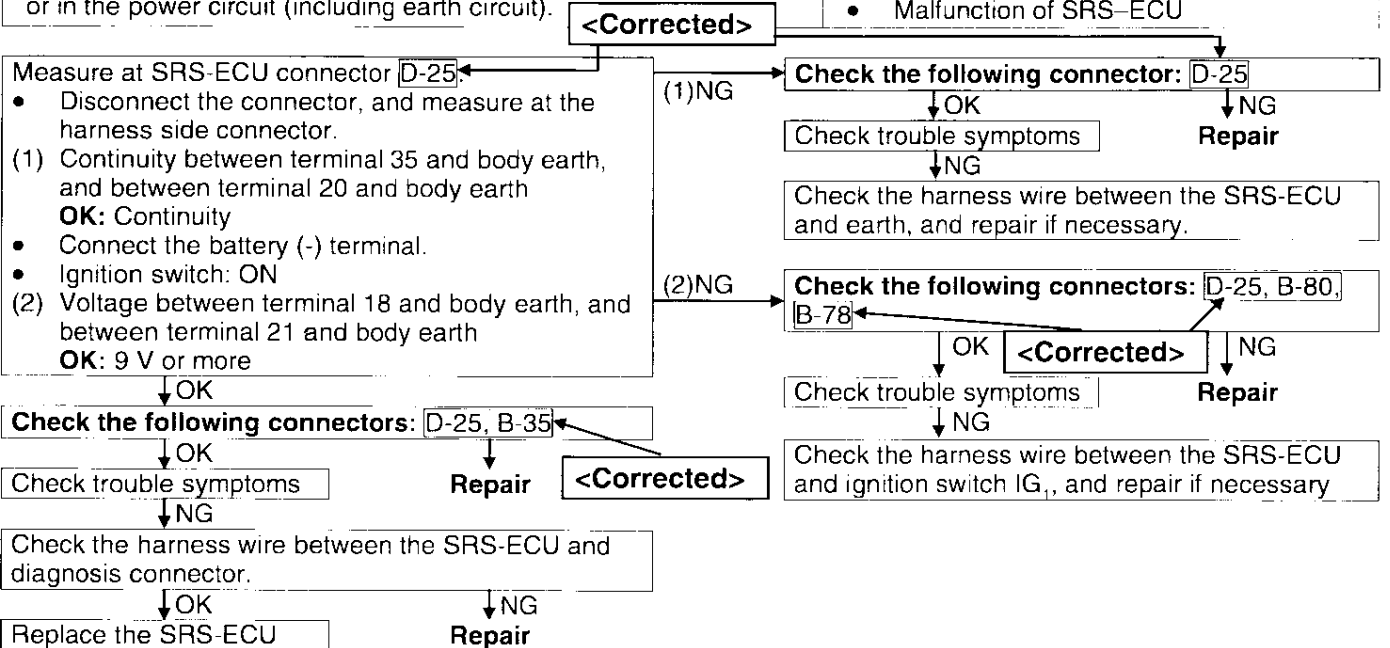
Inspection Procedure 2

Communication with MUT-II is not possible. (Communication is not possible with SRS only.)	Probable cause
If communication is not possible with the SRS only, the cause is probably an open circuit in the diagnosis output circuit of the SRS or in the power circuit (including earth circuit).	<ul style="list-style-type: none"> Malfunction of wiring harnesses or connectors Malfunction of SRS-ECU
