# insider info.

## Clutch Pedal Sticking

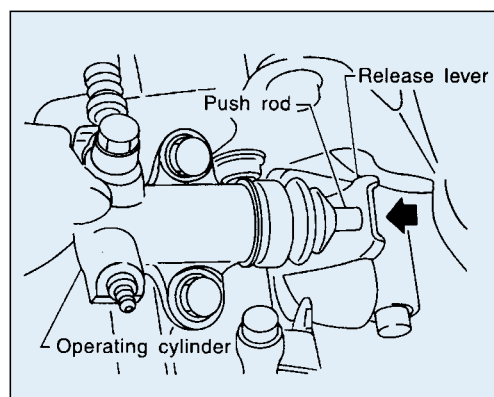
Clutch Operating Cylinder

If you encounter a customer complaint of the clutch pedal not returning completely after being engaged, or if there is a spongy or light pedal feel while shifting, the following repair method should be followed. This condition may affect certain manual transmission vehicles with a hydraulic clutch system under certain weather conditions. The affected manual transmission Subaru models are as follows:

- Remove the intercooler.
- Remove the clutch operating cylinder hose. In this procedure, the clutch master cylinder, clutch pipe and bracket are unnecessary to be removed.
- Replace the clutch hose that was removed with the new one listed below. Note that two pieces of gasket

(P/N 114130151) used on the connector of the operating cylinder must be replaced with new ones when replacing the clutch hose. Tightening torque of the bolt is:  $37 \pm 3$  Nm ( $27 \pm 2$  ft. lbs).

- Add brake fluid.
- Bleed the air from the system.
- Install the intercooler.
- Insure there is no leakage from the line, check whether fluid leakage occurs after the clutch pedal has been fully depressed.
- Check whether the clutch performs normally.

Clutch Operating Cylinder: 30620AA042  
Clutch Hose: 37251AC001  
Gaskets for Hose: 114130151 X 2

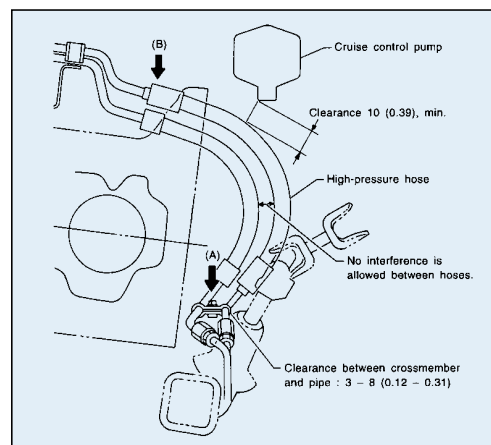
Power Steering Hoses

When turning the steering wheel, even slightly, on rough roads, or especially when entering a driveway over a curb, the tires will input a reactive force through the rack, caused by the impact. This causes the hydraulic pressure in the input lines to force back against the residual pressure in the free side lines. When the higher pressure hits the lower pressure, knocking noise is generated.

If you should encounter the condition on a 2000 Subaru vehicle, it will be necessary to install a set of modified power steering lines.

Modified Power Steering Lines:  
P/N 34190AE120

Always check the part number suppression for any changes. After installing the Modified Power Steering Lines using the procedures in the appropriate service manual, drive the vehicle to confirm the correction.

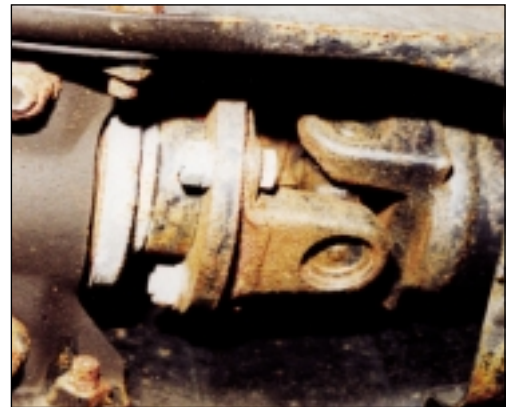
*Driveshaft Removal*

There is a paint mark located on the end of the universal joint that fastens to the rear differential. It is necessary to unbolt the propeller shaft from the rear differential to locate the paint mark.

Sedan & Wagon 5MT	
	Paint Color: Blue
	P/N 27031AC080
Outback 5MT	
	Paint Color: White
	P/N 27031AC060
Outback 4EAT	
	Paint Color: Pink
	P/N 27031AC070
Sedan & Wagon 4EAT	
	No Paint
	P/N 27031AC010
