SERVICE BULLETIN

ALL LEGACY MODELS EQUIPPED WITH
ANTI-LOCK BRAKES

SECONDARY SIDE BLEEDING OF A.B.S. HYDRAULIC
CONTROL UNIT

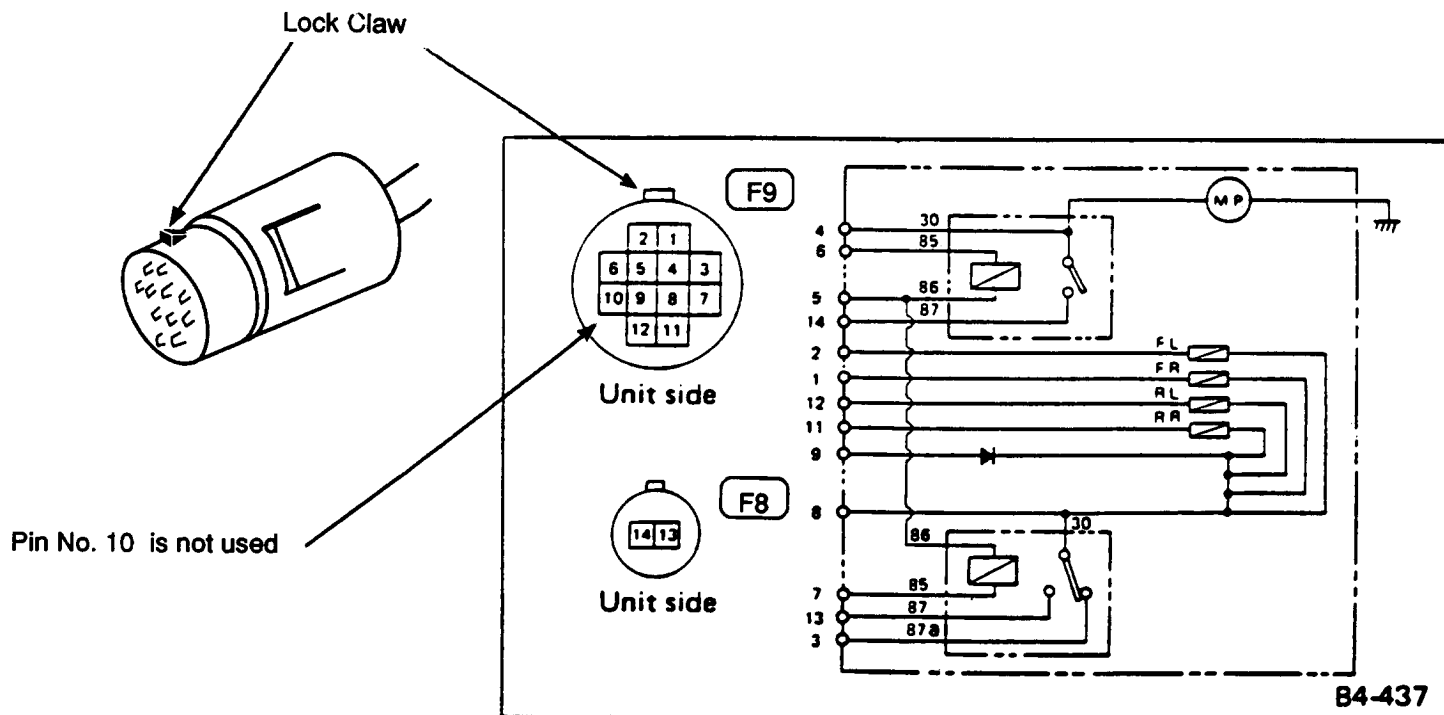
The locking claw at the forward part of the large connector should be at the top or 12 o'clock position. This will properly locate pins 1, 2, 11, and 12 which are used during the bleeding process. See diagram below. If connector F9 is not referenced correctly, pin 10, which is not used, may be mistaken for one of the pins used in the bleeding process.

When performing secondary side bleeding of the A.B.S. Hydraulic Control Unit, make certain you are referencing the connector (F9) at the control unit correctly.
