SERVICE BULLETIN

1991 LEGACY RIGHT-HAND DRIVE

SERVICE MANUAL CORRECTIONS

1991 SERVICE MANUAL CORRECTIONS

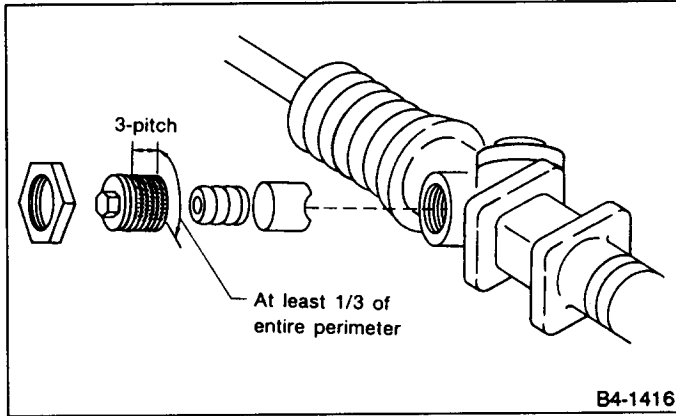
Fig. 30

- (1) Loosen adjusting screw.
- (2) Rotate input shaft so that rack is in the straight ahead direction. [Ensure that distance between rack end and stopper is 72.4 mm (2.850 in) .]
- (3) Apply liquid packing to at least 1/3 of entire perimeter of adjusting screw.

● While rotating input shaft to fully move rack shaft to the left and right, ensure that rack moves smoothly without binding, and that rotating torque is constant.

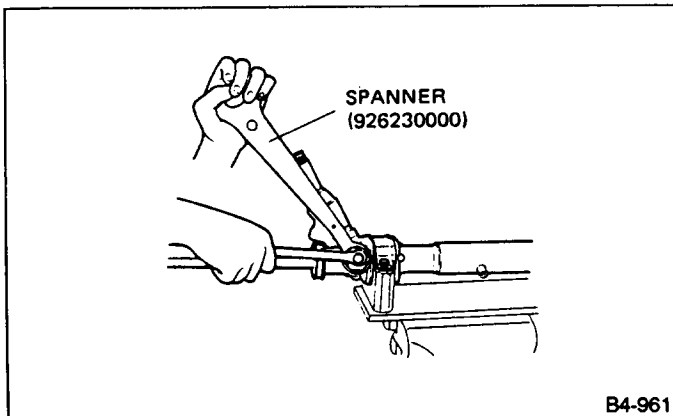
Fig. 31

- (6) Tighten adjusting screw to 5 N•m (0.5 kg-m, 3.6 ft-lb) and then loosen by 30°.

- (7) While holding adjusting screw using a closed wrench, tighten lock nut using SPANNER.

● Do not allow liquid packing to come in contact with sleeve.

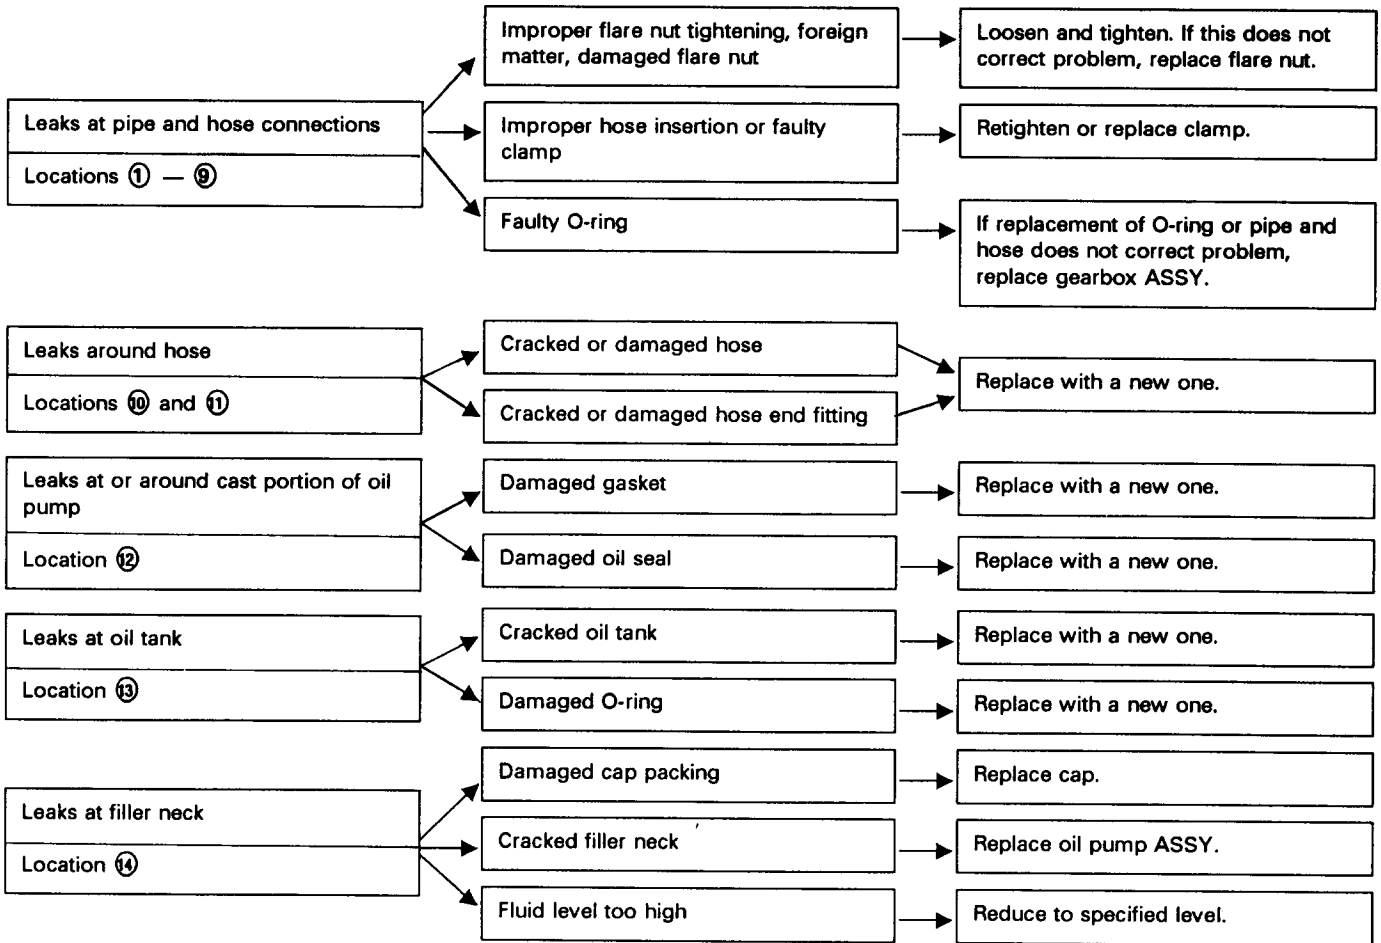
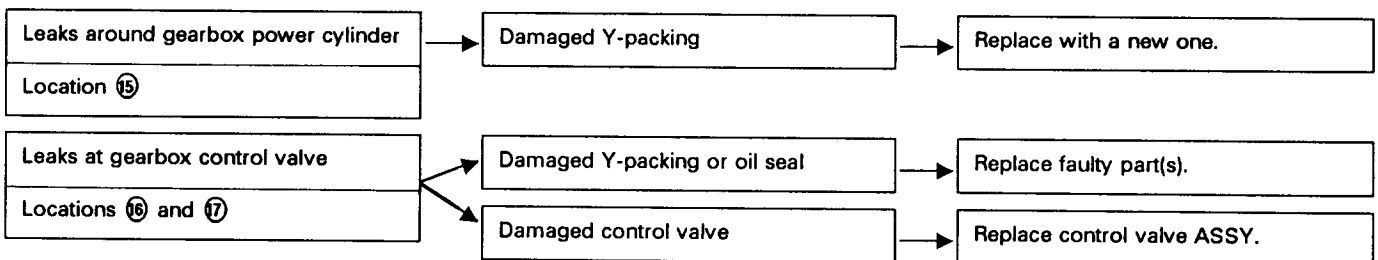
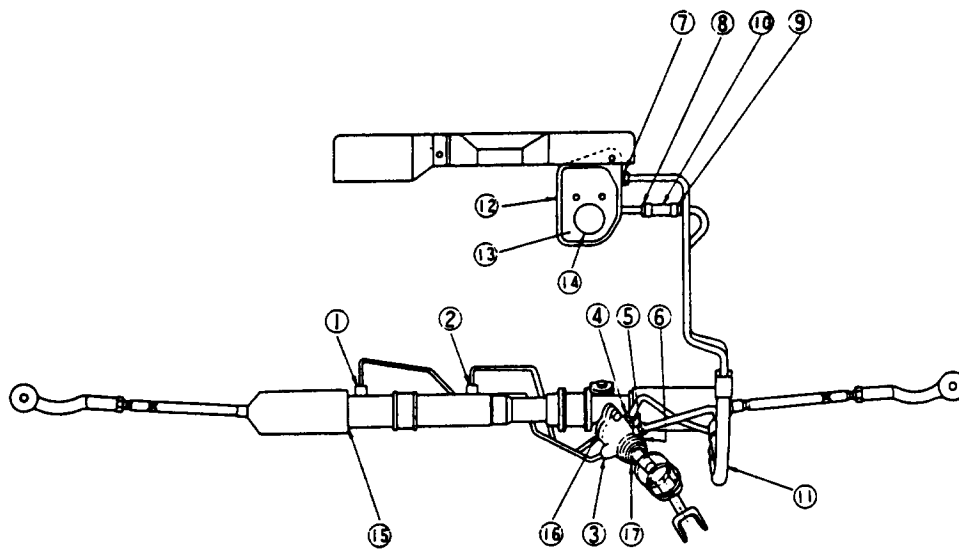
Fig. 79

It is likely that although one judges fluid leakage, there is actually no leakage. This is because the fluid spilt during the last maintenance was not completely wiped off. Be sure to wipe off spilt fluid thoroughly after maintenance.

Severe operation of vehicle may cause fluid to ooze out at air vent in cap. However, this is not a problem.

Wipe clean spilled fluid after servicing.

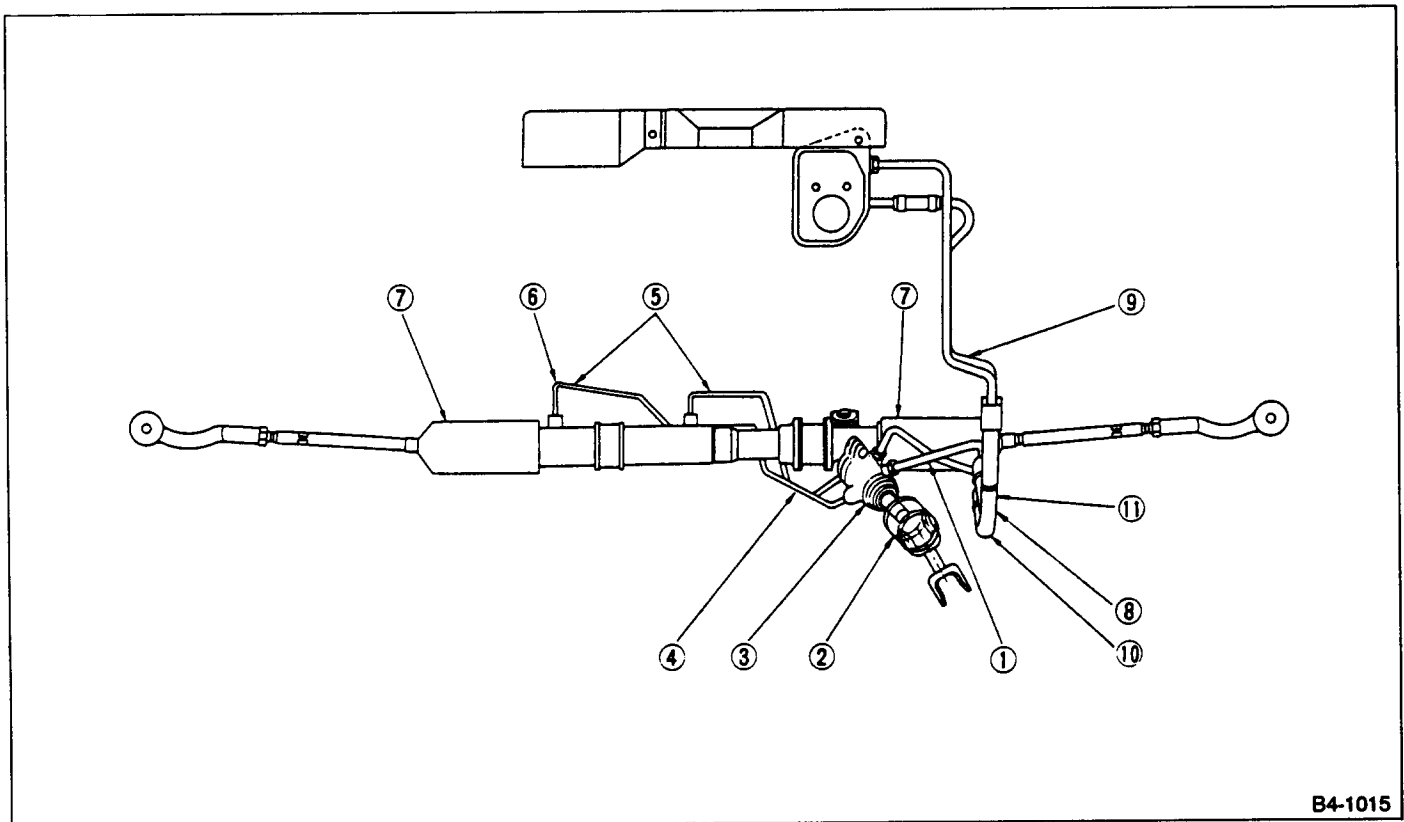
Fig. 80

This table lists various clearances that must be correctly adjusted to ensure normal vehicle driving without interfering noise, or any other faults.

No.	Location	Minimum clearance mm (in)	No.	Location	Minimum clearance mm (in)
①	Pipe-to-pipe clearance of crossmember and hose ASSY and pipe-to-pipe clearance of hose ASSY	5 (0.20)	⑦	Exhaust pipe-to-gearbox boot clearance	18 (0.71)
②	DOJ-to-shaft and DOJ-to-joint clearances	14 (0.55)	⑧	Side frame-to-hose clearance	15 (0.59)
③	DOJ-to-valve housing clearance	11 (0.43)	⑨	Blow-by hose-to-hose clearance	5 (0.20)
④	Pipe-to-pipe and pipe-to-crossmember clearance	2 (0.08)	⑩	Master cylinder-to-hose clearance	20 (0.79)
⑤	Stabilizer-to-power steering feed pipe clearance	5 (0.20)	⑪	Cruise control pump-to-hose clearance	12 (0.47)
⑥	Exhaust pipe-to-power steering feed pipe clearance	15 (0.59)
