## SERVICE BULLETIN

APPLICABILITY ALL SUBARU MODELS

DATE 09-08-92

SUBJECT: BRAKE VIBRATION DIAGNOSIS AND REPAIR

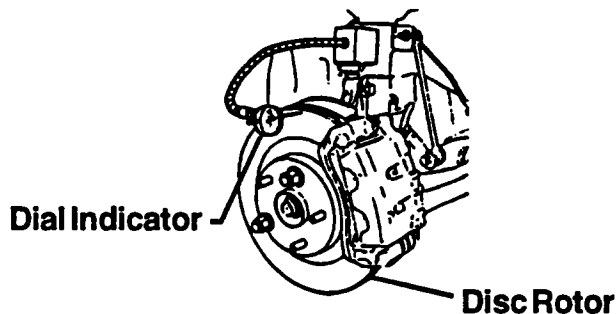
**Figure 2**

**Make sure that dial indicator is set 5mm (0.20in) inward of rotor outer perimeter.**

1. Measure free play of bearing by pushing and pulling hub in an axial direction.
  - a. Confirm free play of bearing in an axial direction is 0.05mm or less.
  - b. Front wheel bearing free play on all models except Legacy, SVX, and XT6 is not required to be measured due to the ball bearing design.
2. Mount rotor to the hub securely with all lugs, flat side in and tighten slightly, using a socket or wrench.
3. Clean pad contact surfaces of rotor (especially where measurement will be taken).
4. Attach dial indicator gauge on caliper mount or strut and measure maximum run out of rotor on both sides at a point of 5mm inside from the circumference of rotor by rotating rotor gradually. See Figure 2. Run out is best checked when the rotor is cool. (See specifications on Page 4.)

5. In case the run out of a new or resurfaced rotor is out of specification when re-checking, relocate the rotor to another position on the hub and re-check run out. Repeat the process of relocating the rotor to compensate for minor run out variations between the rotor and hub.
6. If relocating the rotor does not correct run out, check the hub run out for inaccuracy and repair as necessary.
