SERVICE BULLETIN

ALL 1992 LEGACY A/T AND 1992 SVX

02-87-92

EFFECTS OF LOW RVP FUEL ON COLD STARTABILITY/DRIVEABILITY

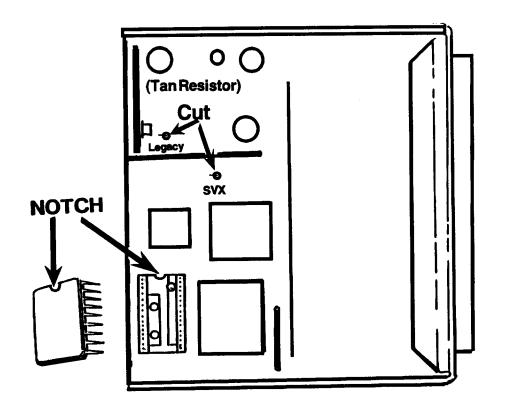
- 4. Remove ECU and its top cover by removing 6 Phillips head screws.
- 5. Locate the ROM socket and remove the protective tape.
- 6. Align the notch in the new ROM with the notch in the ROM socket. See illustration. It is very important that the notches are located on the same side to prevent permanent damage to the control unit. Insert the ROM pins into the socket receptacles as follows:

- c) Press down on the ROM to fully seat it into the socket.
- 7. Locate the tan resistor. See illustration. Remove the resistor by carefully cutting the two leads near the circuit board. This resistor must be removed to activate the ROM. Do not remove the resistor using a solder iron. This will damage the board.
