SERVICE BULLETIN

ALL LEGACY MODELS

04-06-92

WIND NOISE FROM FRONT DOOR GLASS/ MIRROR GUSSET AREA

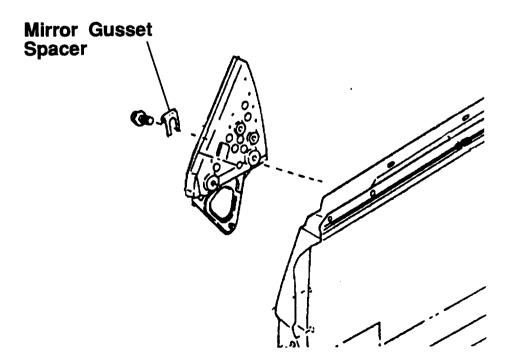
If you encounter a customer complaint of wind noise at speeds above 35 mph, which sounds like it is coming from the area surrounding the driver's side mirror gusset, use the following glass adjustment information to correct the noise. While driving, place your fingers near the mirror gusset inside the vehicle and carefully push outward. If the noise diminishes, the installation of a mirror gusset spacer may correct the noise.

STEP 2: Install a spacer, P/N 62175AA000. It fits between the mirror gusset and the door inner structure, using one of the gusset mounting bolts to retain the spacer. See illustration below.

Road test the vehicle. If the wind noise is still present, further window adjustments may be necessary. Verify the window adjustment procedure outlined in Step 1 and Section 5-2 of the Legacy Service Manual.
