SERVICE BULLETIN

92MY SIA BUILT LEGACY STATION WAGON
WITH MANUAL TRANSMISSION

SUBJECT: COMBINATION METER WIRING

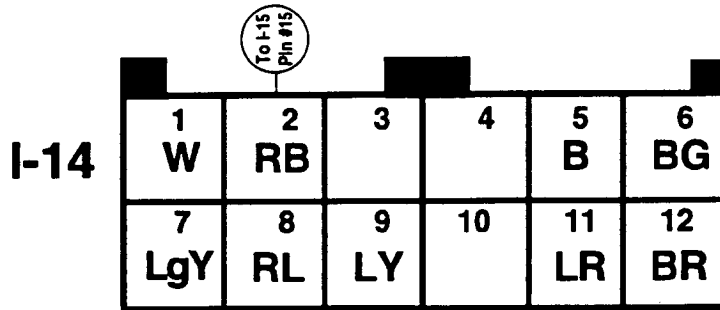
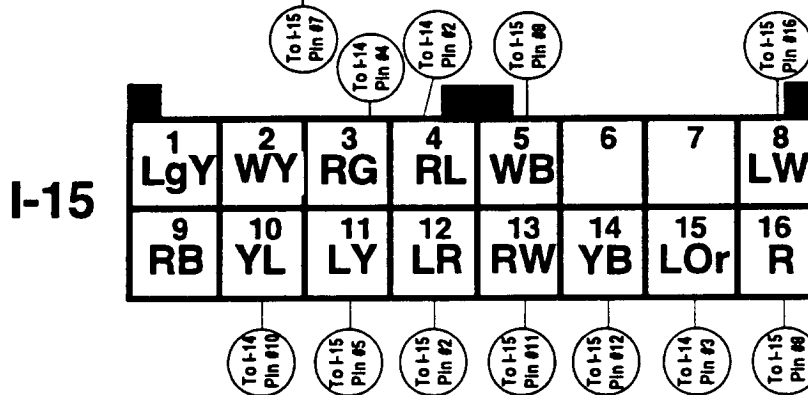
Before
Pin
Location

The connectors may be incorrectly wired for an automatic transmission. Use the schematic in Figure 1 to relocate the pins in connectors I-14 and I-15 to convert the harness to a manual transmission configuration.

Relocate the pins in connectors I-14 and I-15 as shown

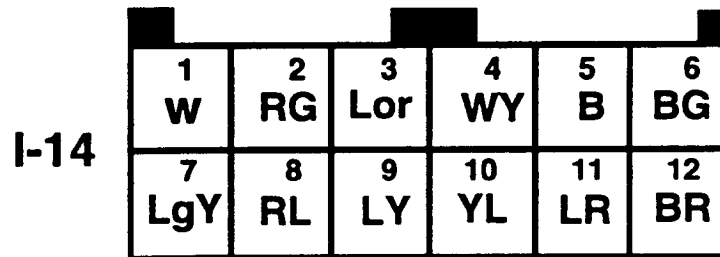
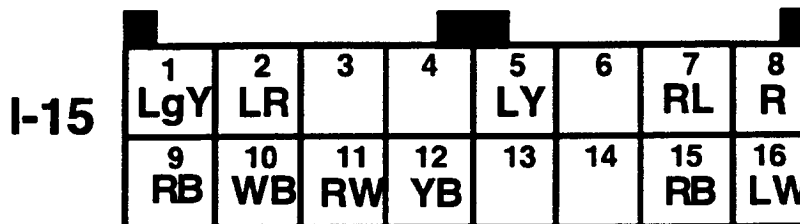
After
Pin
Location

Note: I-14 is not used on manual transmission Models
