SERVICE BULLETIN

ALL LEGACY MODELS, INCLUDING TURBO

EXHAUST PIPE "EPR" WHISTLING NOISE

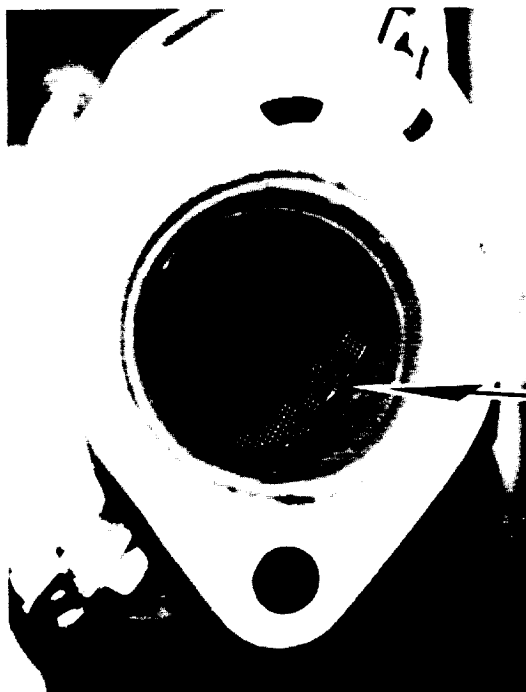
Figure 1

Visually examine the rear catalytic converter inlet shield ring for a bend in the ring in the shape of a "VEE". See Figure 1, below.

**Bent
Shield
Ring**

Using compressed air and an air blow gun, with a tip 6 to 8 inches long, blow air around the shield ring. If the shield ring begins to whistle the "EPR" or rear pipe needs to be replaced. EPR pipes, produced on and after October 1, 1992, will have a modified shield ring to prevent the whistling sound. See Figure 2 for production code identification.

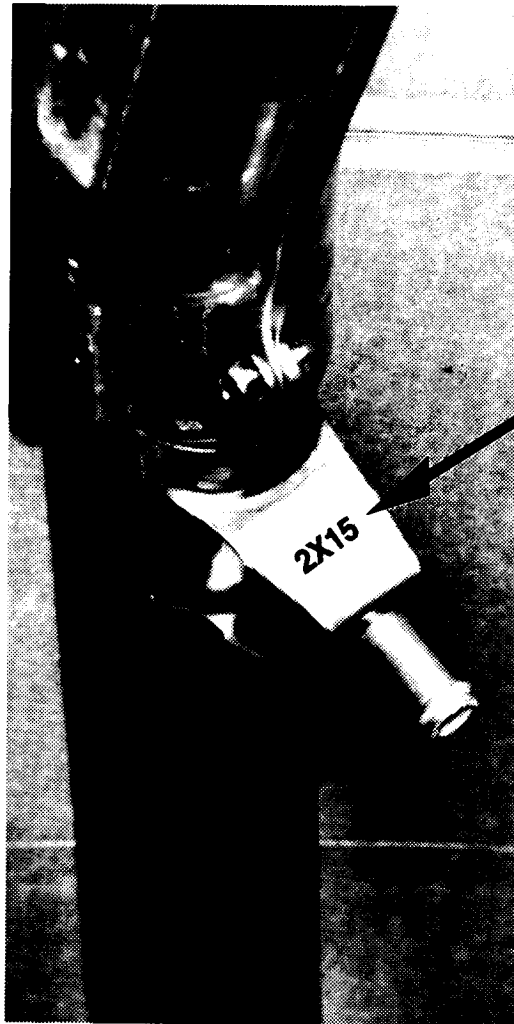
Figure 2

2 X 15

YEAR MONTH DAY

**Lot
Number**

If you are replacing the EPR pipe with a pipe before the production change you will need to perform the shield ring test as described in the opening paragraph.
