SERVICE BULLETIN

ALL LEGACY MODELS

01-12-93

FRONT END "POP" NOISE

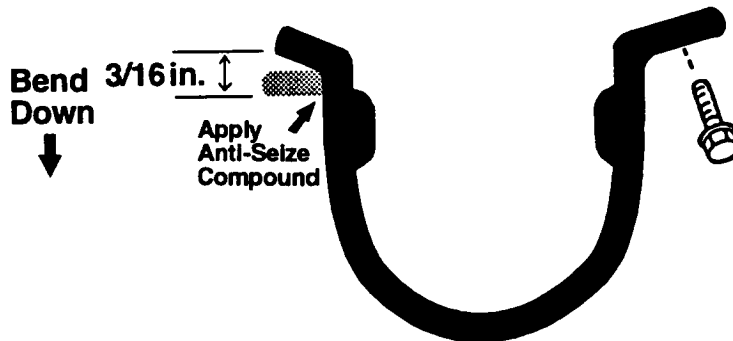
Figure 1

If you encounter a customer complaint of a noise coming from the front end when turning, (similar to a small stone hitting the floor pan), pivoting front stabilizer bar bushing clamps may be the cause. Use the following information to adjust the clamps:

- o Remove both right and left bushing clamps. Use Section 4-1 of the applicable Legacy Service Manual.
- o Bend the tab hook approximately 3/16". See Figure 1.
- o Coat the underside of the hook with anti-seize compound.
- o Re-install in reverse order of disassembly.
