SERVICE BULLETIN

ALL VEHICLES EXCEPT JUSTY

02-16-93

FRONT SEAT TRACKS

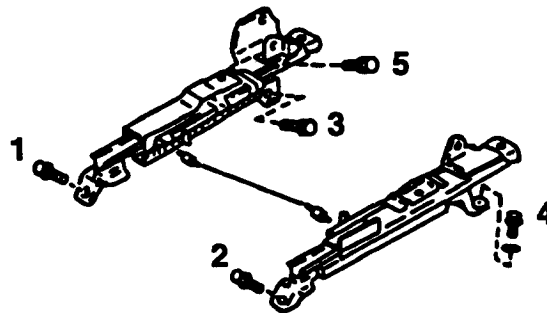
Figure 1
Driver's Seat

If you encounter a customer complaint of a front seat bottom which when adjusted does not readily re-lock into the left and right tracks simultaneously, the following procedure should remedy the condition.

1. Loosen, but do not remove, all five (5) mounting bolts for the seat tracks. (Refer to Figure 1.)
2. Slide the seat all the way to the rear. Make sure the lock plate pawls are completely and equally inserted into the corresponding holes in both the inboard and outboard seat rails.
3. Tighten bolts 1 and 2, in that order, to the required torque. (Refer to Figure 1.)

4. Slide the seat all the way to the front. Make sure the lock plate pawls are completely and equally inserted into the corresponding holes in the inboard and outboard seat rails.
5. Tighten bolts 3, 4 and 5, in that order, to the required torque. (Refer to Figure 1.)
6. Make sure the seat now works properly. If it does not, then proceed onto the next procedure.

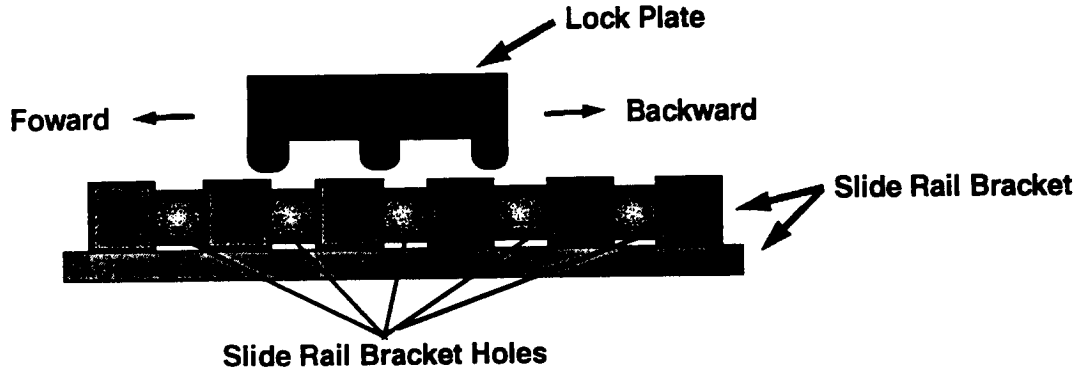
Figure 2

1. Slide the seat forward and back until one rail does not engage properly. Determine which rail's lock plate pawls have not engaged. In most cases, this will be the outboard rail.
2. Look closely at the lock plate pawls and the slide rail to determine whether the slide rail is misaligned by being too far forward or by being too far towards the rear of the vehicle. (Refer to Figure 2.)

This drawing shows a slide rail that is misaligned towards the rear of the vehicle.

3. If the outboard slide rail is too far to the rear of the vehicle, adjust forward as follows:
 - 1) Loosen bolt 4. (See Figure 1.)
 - 2) Remove bolt 2. (See Figure 1.)
 - 3) Insert a washer between the slide rail bracket and the floor as shown in drawing. (Refer to Figure 3.)
