SERVICE BULLETIN

ALL LEGACY, SVX AND IMPREZA MODELS
EQUIPPED WITH 4EAT TRANSMISSION

03-08-94

SUBJECT: 4EAT MODIFICATIONS

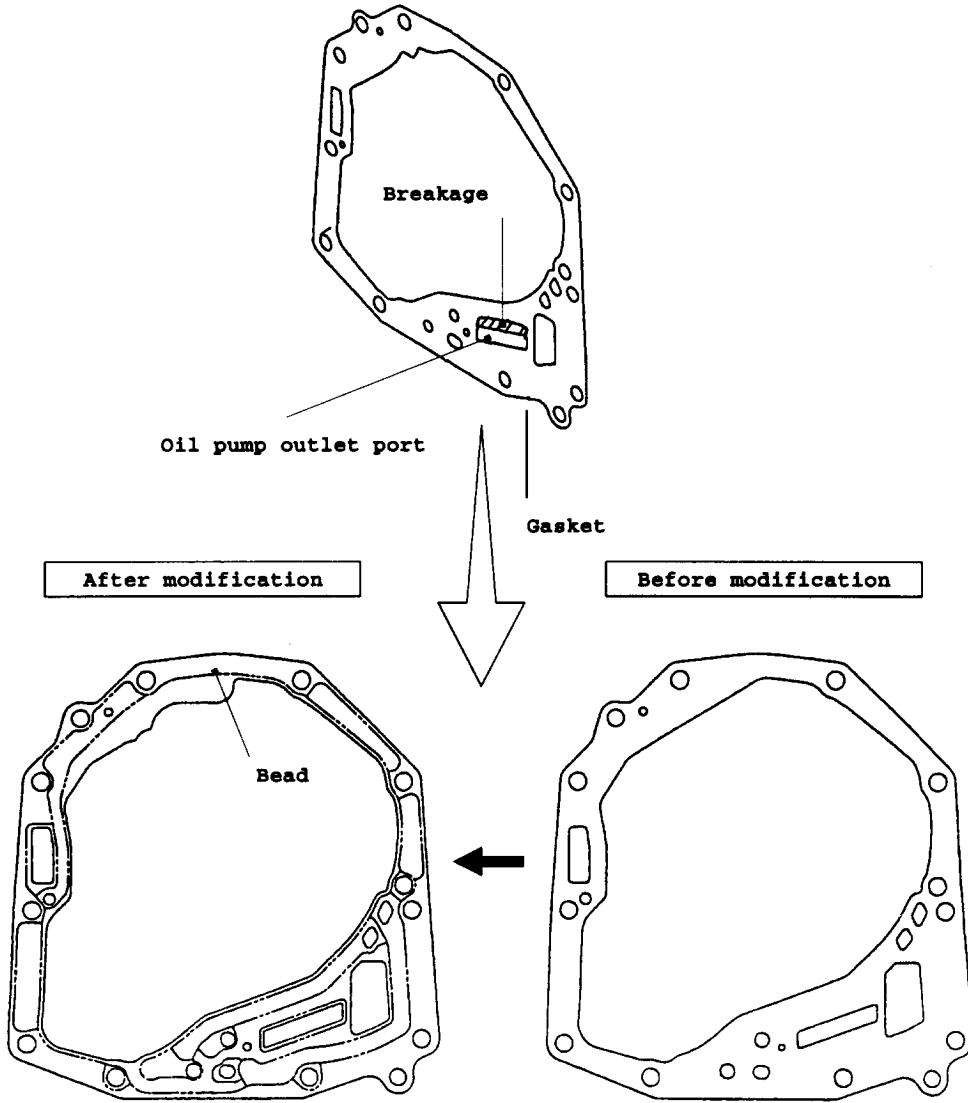
1.) OIL PUMP GASKET

The transmission Oil Pump Gasket (P/N 31339AA121) was changed to a metal type gasket to lessen the possibility of gasket deterioration. This gasket was installed in production starting with transmission number 513102/SVX, 527022/Legacy, and since the beginning of production on all Imprezas. This gasket must always be used when gasket replacement is necessary. When using this gasket, the small metal deflector mounted to one of the oil pump cover bolts must be removed (Reference Parts Bulletin PT-26-03-93).

Symptoms of a deteriorated gasket are approximately 1/2 line pressure at idle and full line pressure at stall speed. It may also be accompanied by a delay going into reverse on SVX and Turbo vehicles.

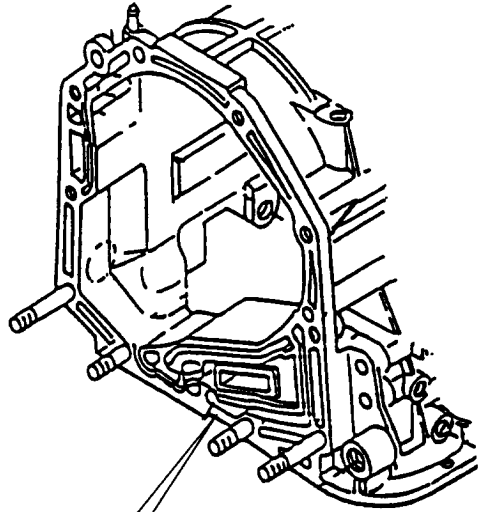
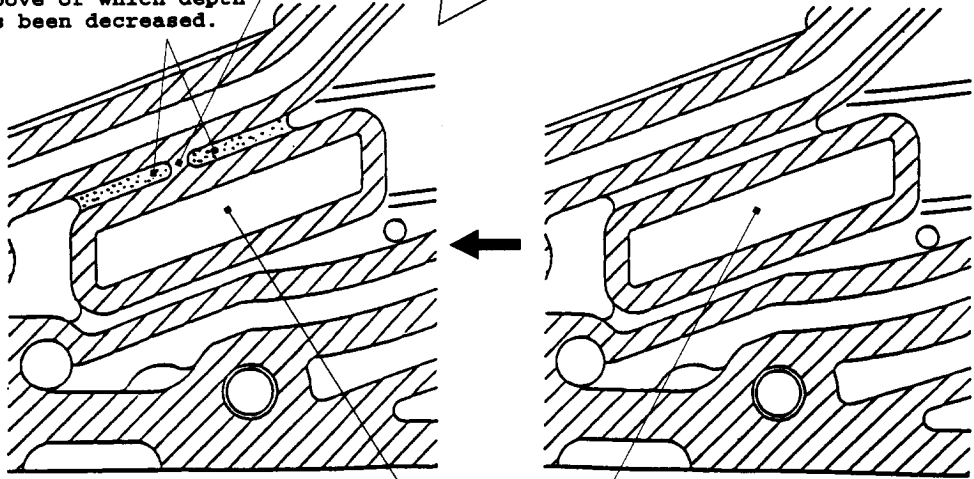
2.) TRANSMISSION CASE

The transmission case was slightly modified starting with transmission number 426208. Modification was made to prevent oil pump gasket deterioration. Installation of the updated oil pump gasket is all that is necessary to prevent gasket deterioration on these earlier transmission.

Symptoms are the same as with oil pump gasket deterioration in Number 1 above since it will result in a gasket sealing problem. In both cases, oil pressure will be degraded. Other related symptoms may be a delay in starting when the select lever is placed into 'D' and/or 'R' from neutral or park.

Rib
Groove of which depth
has been decreased.

*****TRANSMISSION CASE REPLACEMENT IS NOT NECESSARY AND IS NOT RECOMMENDED*****

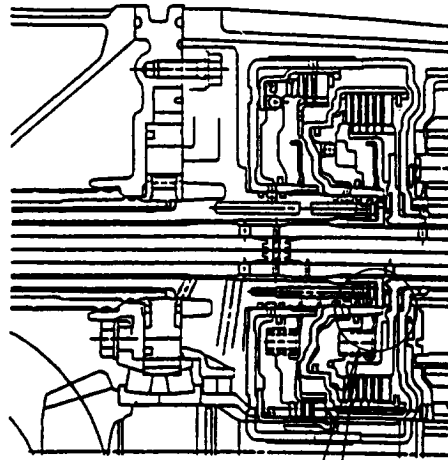
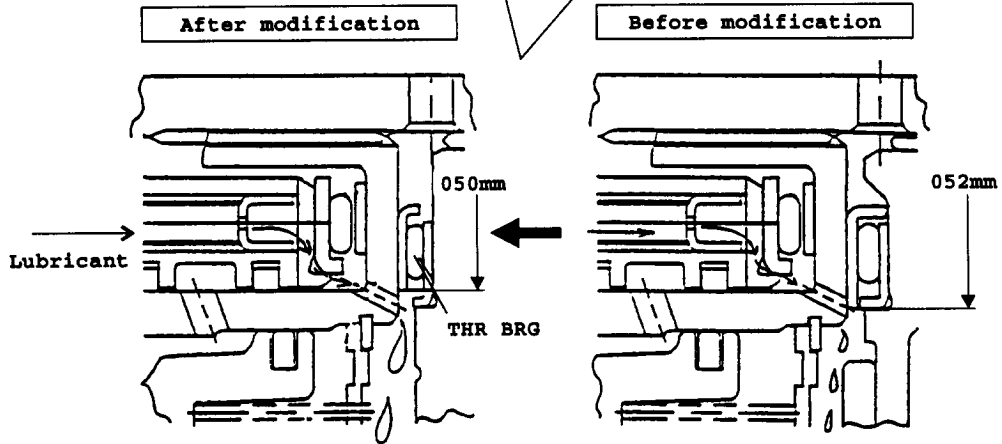
3.) HIGH CLUTCH BEARING

Legacy N.A. - Install Thrust Bearing (P/N 80653620) **only** up to transmission number 351299. The diameter of this bearing has been reduced from 52mm to 50mm to ensure adequate lubrication to the high clutch assembly.

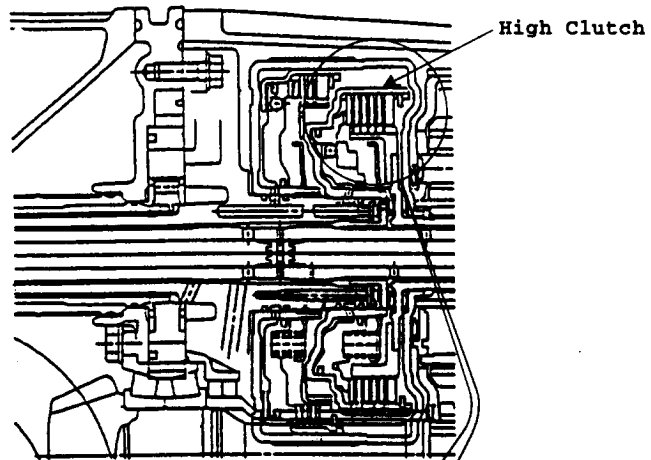
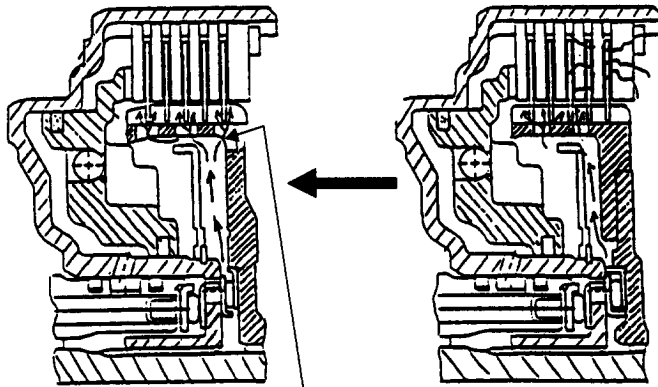
3.) HIGH CLUTCH HUB

The modified high clutch hub has additional lubrication holes in it to provide required lubrication to the fifth clutch plate of the high clutch assembly. Recommended repair for a failed high clutch is replacement with the modified part(s) as applicable above.

Symptoms of a failed high clutch might be no shifting or an increase in engine rpm when shifting into 3rd gear (trans. neutrals out).

A lubricant hole has been newly adopted to high clutch hub.

Install High Clutch Hub (P/N 31550AA020) and Thrust Bearing (P/N 806537010) **only** on SVX and Legacy Turbo models up to transmission number 633657 for SVX and transmission number 615173 for Legacy Turbo models.

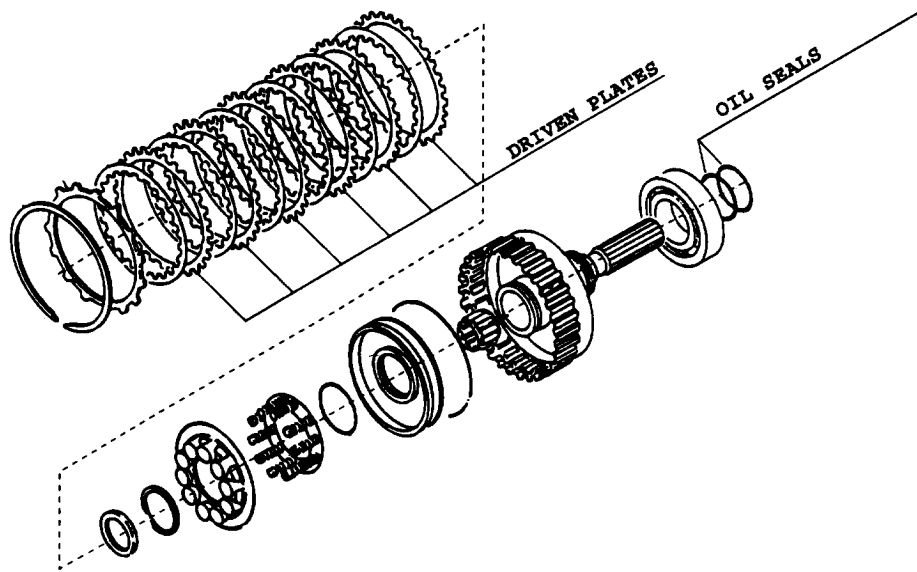
4.) TRANSFER CLUTCH DRIVEN PLATES AND OIL SEALS

Modified Clutch Driven Plates (P/N 31589AA041) were installed to reduce rear axle binding starting with transmission number 389607. Additionally, new style Oil Seals (P/N 31377AA131) have been installed on the transfer clutch output shaft. These updated seals are black in color with a "notched" design on their inner diameter and are cut diagonally on the ends. The purpose for the change was to reduce the chance of these seals rotating in their grooves and cutting into the rear extension housing.

If you experience a case of rear axle binding on turns, with a transmission that has the updated transfer clutch driven plates, it is recommended that you install another set of the updated driven plates. After installing these new driven plates, it will be necessary to drive the vehicle in several figure 8's to break them in. As always, the first thing to check when diagnosing an AWD binding complaint is tire size. All tires must be of the same size and brand name.
