SERVICE BULLETIN

ALL MODELS WITH 4EAT TRANSMISSIONS

PREVENTION OF REPEAT PLANETARY GEAR FAILURE

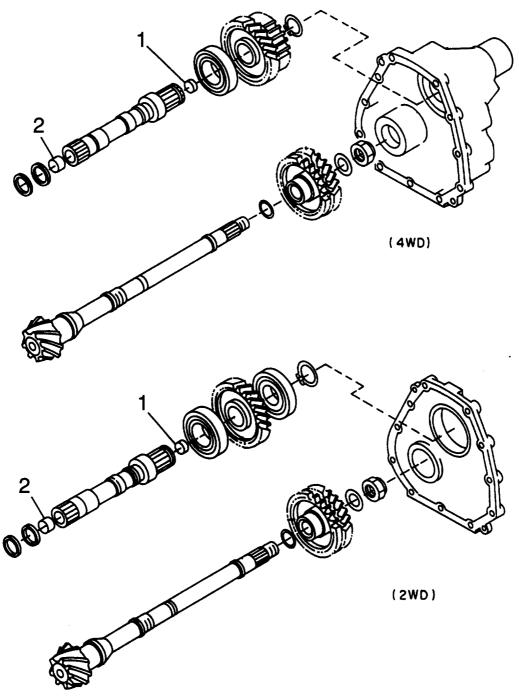
FIGURE 1

- o Restricted flow through the radiator cooler.
- o Kinked or obstructed radiator cooler lines.
- o Improper ATK-50 filter kit installation or hose routing.
- o Debris restricting ATF flow through the input shaft or its oil feed holes.
- o Reuse of a heat damaged input shaft (where the internal seal has become deformed).
- o Orifice plug missing from the rear of the reduction shaft (see Item 1 in Figure 1 on the back page).
- o Bushing missing from the front of the reduction shaft (see Item 2 in Figure 1 on the back page).

By ensuring that the above items are checked on the vehicle and on the parts being reinstalled into the transmission case (both new and used), you are ensuring a quality finished product.
