## SERVICE BULLETIN

**APPLICABILITY** 1990 THROUGH 1995 LEGACY 2.2L  
1992 THROUGH 1995 SVX 3.3L  
1995 IMPREZA 2.2L

**DATE** 10/11/95

**SUBJECT** KNOCK SENSOR

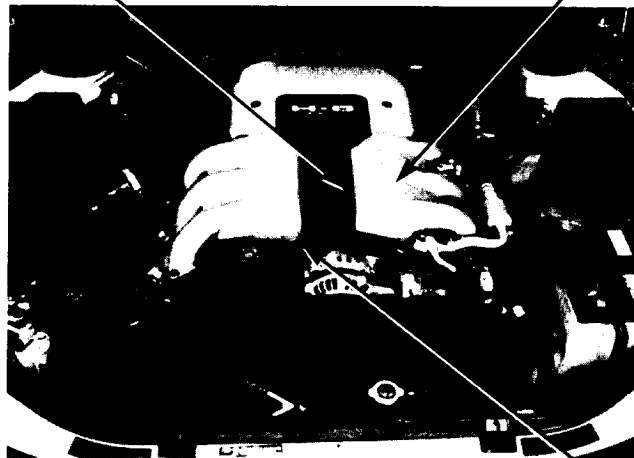
Access area for extension and socket assembly

Location of left knock sensor number 2

Location of right knock sensor number 1

1. Disconnect the knock sensor wire connector.
2. Note the orientation of the knock sensor on the engine block and install the new sensor in the same position.
3. Use a 3/8 drive ratchet, 12 inch extension and a 12mm flex socket to access the knock sensor mounting bolt.
4. Insert the extension and socket assembly through the left side of the hole in the center of the intake manifold, refer to the illustration below.

**Note:** When removing the knock sensor, the wire connector is tight but will pass between the coolant crossover manifold and the engine block.

1. Disconnect the knock sensor wire connector.
2. Note the orientation of the knock sensor on the engine block and install the new sensor in the same position.
3. Use a 12mm boxed end wrench to access the knock sensor mounting bolt from the front of the engine.
