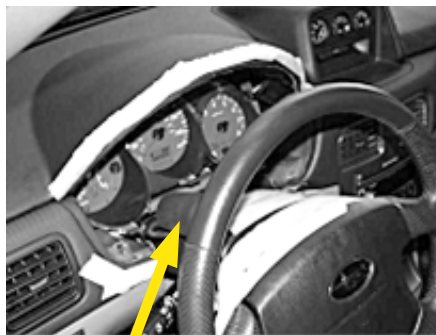
Turbo Gauge Pod

- 3) When reinstalling the meter visor (combination meter cover), you will need to carefully depress the rubber gauge pod down to clear the meter visor over the upper steering column cover. Therefore, do not install the turbo gauge into the rubber pod until the meter visor is properly installed. Damage to the gauge or the interior panels could occur if the meter visor is installed with the gauge inside the rubber pod.

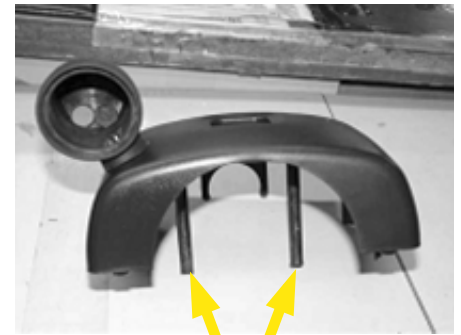
Plastic Case Bosses

- 1) Due to the small area you will be working in, take caution when removing the upper column cover. Pay special attention to the plastic case bosses (see arrows in pictures below). They are permanently attached to upper cover and will break if pried too far from their original form.

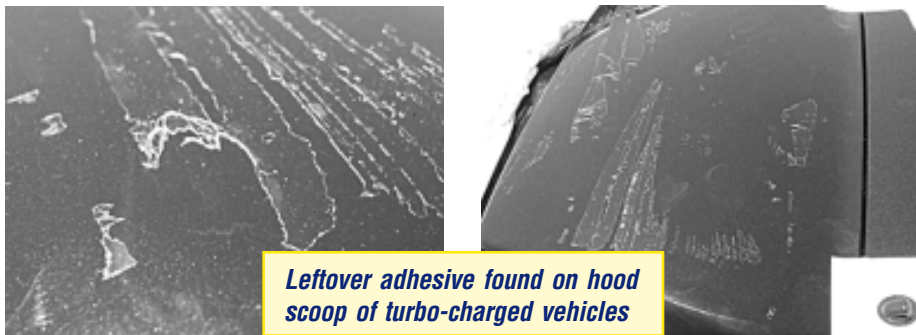
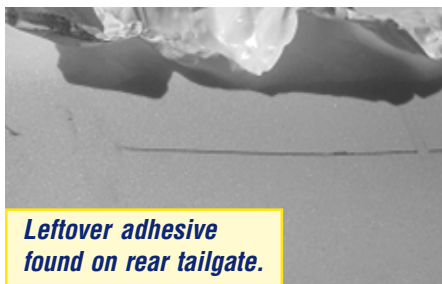
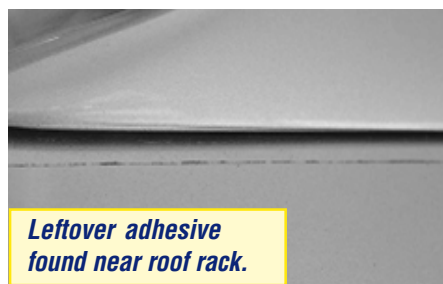
When performing a PDI, if you encounter a light film of residue on the painted surface, especially at the edges of the plastic wrap, it may be caused by leftover adhesive from the protective plastic wrap.

The concern could appear anywhere plastic wrap covers the vehicle, but the symptom may appear more prevalent on vehicles equipped with a hood scoop on turbo-charged vehicles. To ensure that the adhesive does not remain on the vehicle, the plastic wrap should be removed with slow and steady pressure. Removing the plastic wrap too quickly could result in adhesive remaining on the vehicle.

Special care must be taken when removing the adhesive from all painted surfaces. As a rule for leftover adhesive, use R-M Pre Kleano or equivalent product for adhesive removal. It is paint safe and it must be applied with a clean cloth. Use light pressure and let the remover do the work. Be sure to change cloth sections frequently so that any adhesive and dirt built up on the cloth won't scratch the paint. It was used on the vehicle in the photos and it removed the residue easily. You may want to follow it up with 99% isopropyl alcohol on a clean rag to remove any hazing left by residual adhesive. Isopropyl alcohol is available through any body shop supply store or local pharmacy.

Regardless of the removal technique and the chemicals used, it is critical to wash the vehicle following wrap removal to reduce the chances of paint damage from either the adhesive or chemicals being left on the painted surfaces.

- 1) Extended exposure of paint to alcohol may cause the painted surface to lose its gloss. This can be restored by the use of a clear coat safe polish or wax.
- 2) In addition, please be sure to remove any and all traces of adhesive before performing any buffing process. Any residue remaining may get ground or burnt into the finish causing clear coat or paint damage.

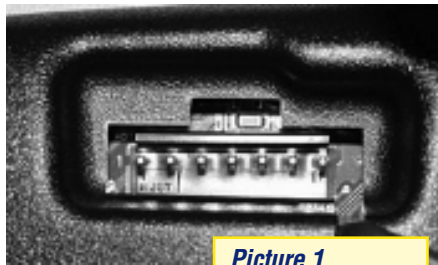
Picture 1

- 1) The internal components and circuitry have been revised on all models. The updated mirror is less susceptible to outside influences.
- 2) The 7-pin connector to the mirror is now recessed on all models (see picture 1 below).

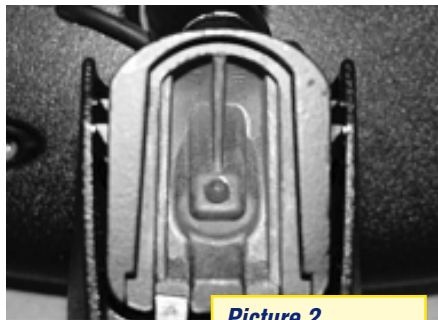
Picture 2

- 3) The mounting for the 2004 Legacy, Outback, and Baja has changed. It now uses a mounting plate and setscrew (see picture 2 below) instead of a camlock (see picture 3).
