16 PHASE II 4EAT STUD LEAK REPAIR (REVISED)

This is revised information concerning the article published in the **November 2003 TechTIPS Newsletter**.

Articles in This Issue

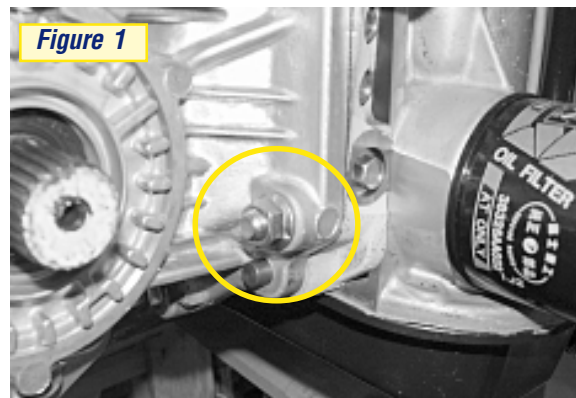
While diagnosing a transmission leak on a Phase II 4EAT, it is advisable to inspect the left-side transmission stud area (see figure 1 for illustration). If the transmission leak originates from this stud, please perform the following repair.

- 1) Remove the left-front tire.
- 2) Separate the left-hand stabilizer link from the lower control arm (also referred to as transverse link).
- 3) Separate the left-front balljoint from the lower control arm.
- 4) Remove the axle shaft pin.
- 5) Remove the axle shaft from stub shaft and place out of the way.
- 6) Remove the transmission stud nut from the stud (see *Figure 1* for stud location).
- 7) Remove the transmission stud.

NOTE: Regardless of the method used to retract the stud from the main case, be sure to inspect the stud for damage and replace if necessary.

- 8) Wrap the stud (whether it is old or new) with Teflon tape.
- 9) Reinstall the stud and tighten the stud to 13-ft. lbs.
- 10) Reinstall the stud nut and torque to 30-ft. lbs.
- 11) Reinstall the axle shaft, pin, swaybar link, balljoint, and tire in reverse order.

NOTE: Axle shaft pins are not re-useable. Please install a new axle shaft pin during re-assembly.

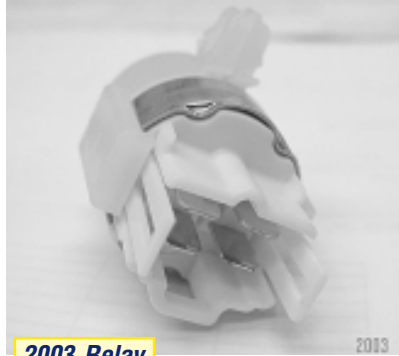
2003 Relay

With the start of production of the 2004 Baja the relay location for the Sport Activity Lights has changed. See below for details:
