**15 BUMPER BEAM PLUG FOR BAJA TRAILER HITCH**

**15 STI SECURITY MODULE TORQUE SPECIFICATIONS**

**Articles in This Issue**

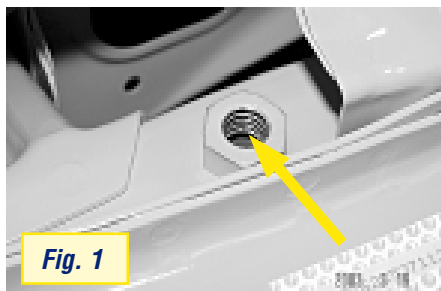
Fig. 1

Before installing the trailer hitch on the Baja, please ensure that the silicone plugs are taken out of the weld nut on the bumper beam (see Fig. 1).

If the bumper plugs are not removed, this may cause difficulty in properly installing the trailer hitch bolt. It may be a good idea, when initially threading the bolt into the bumper beam weld nut, to start it by hand. This will avoid cross-threading the bolt. For proper installation instructions, please download the information from <http://www.subarunet.com>

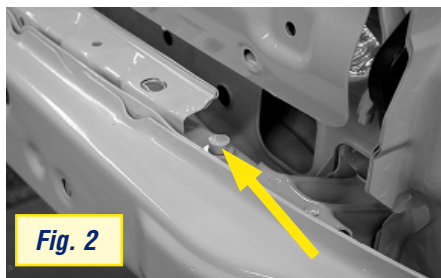
The bumper beam plugs are installed at the factory to prevent the inside on the threads from being painted (see Fig. 2 and 3).

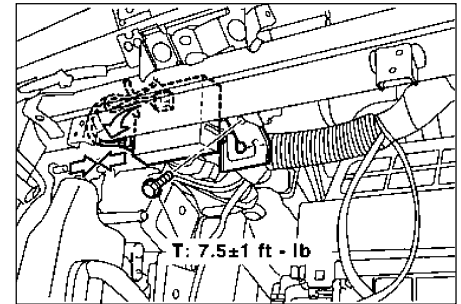
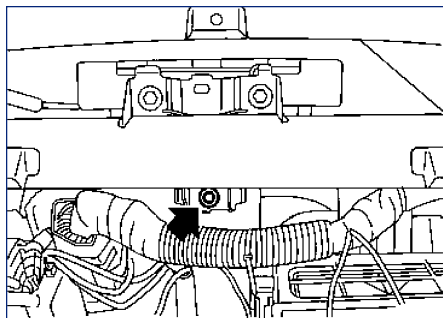
This article is to reinforce the importance of the specific torque specifications for the 2004 STi security system module. The security module is mounted behind the glove box and servicing it requires the removal and reinstallation of one passenger side air bag bolt (see pictures).

Please ensure that the air bag/security

system module bolt is torqued to 7.5 ± 1 ft. lbs (torque specification of the bolt is normally 5.4 ft. lbs.). For detailed installation guidelines, please refer to the installation guide supplied in kit # H7110SS200 or download the information from: <http://www.subarunet.com/fixe d operations/accessories>.

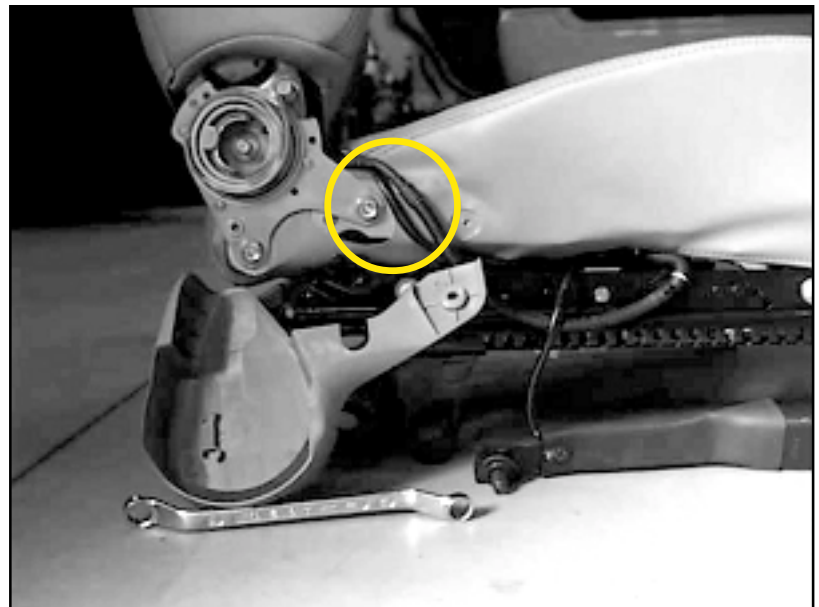
If you encounter a 2003MY Forester with any of the above codes, please inspect the area shown below in the accompanying photo.

The Technical Support Line has received a few calls where the wiring harness has been pinched/cut when the seat trim cover has been installed.

The area to inspect is on the outboard side of the seat on either the driver's side (code 42) or passenger's side (code 41).

If no damage is seen in this area of the harness, please inspect the total length of the harness to ensure that it isn't damaged where it runs under the seat near the seat track.
