02 COOLANT SEEPAGE FROM WATER PUMP

Articles in This Issue

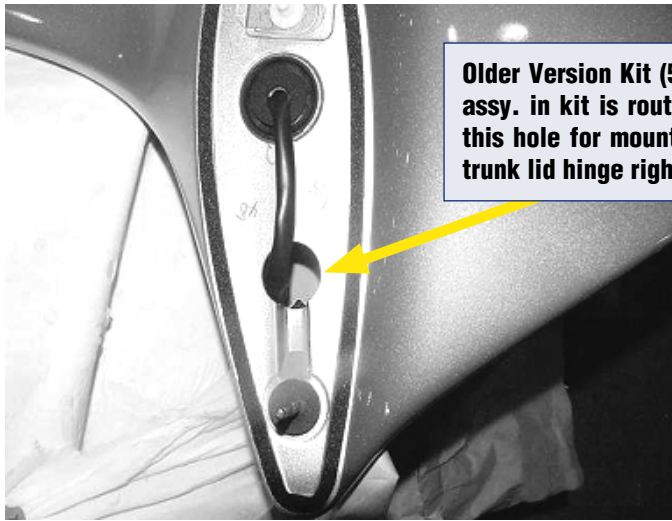
Older Version Kit (501): Cable assy. in kit is routed through this hole for mounting on the trunk lid hinge right and left.

2) If a vehicle had a spoiler previously installed (kit #501) and only kit #502 is available, the installer will need to ensure that the sheet metal foam piece is reinstalled to provide a tight seal around the hole previously drilled for the cable. A new sheet metal foam piece (part # E7210FE520) is available if the original foam piece is not reusable.

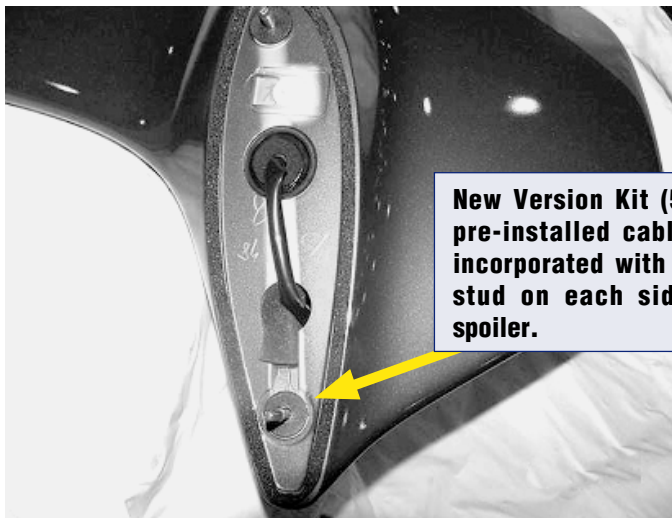
New Version Kit (502): Has pre-installed cable that is incorporated with the front stud on each side of the spoiler.

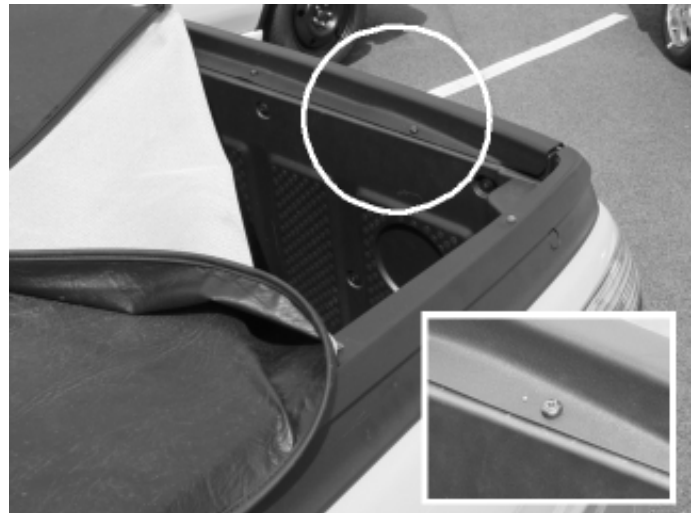
Old Style

L0010LS030 -- Soft cover replacement part includes two latches

L0010LS080 -- Support bow. If the customer wants a bow, you will need to order it separately.

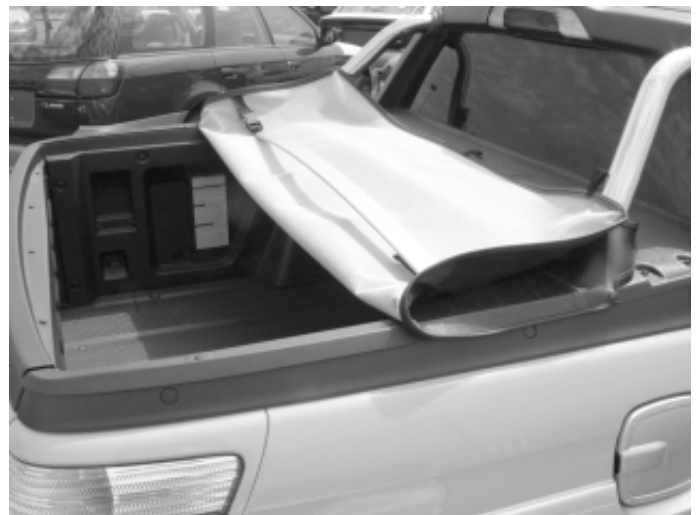
New Style

L0010LS031 -- Soft cover replacement part (the support bow is included in the original kit).
