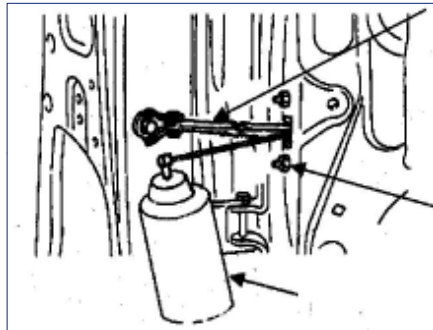
**CREAKING NOISE FROM DOOR CHECKER**

There is a reported "creaking noise" when opening or closing some vehicle doors. This noise has been attributed to the door checker. Applicable models for this customer issue are 2003-04MY Legacy, Forester, and Impreza vehicles.

1. Open the door fully, and loosen the two (2) nuts 1/3 to 1/2 turn where the door checker attaches to the door.
  2. Push the door open as far as it will go.
  3. Retighten the 2 nuts. Tightening torque is 5.5 Ft Lbs.
- If creaking noise is still audible, please proceed to the next step.*
4. Apply spray grease (White Lithium Grease) to the door checker as shown in the drawing.
  5. Open and close the door several times, working the grease into the effected area.

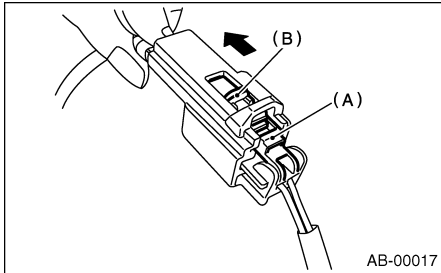
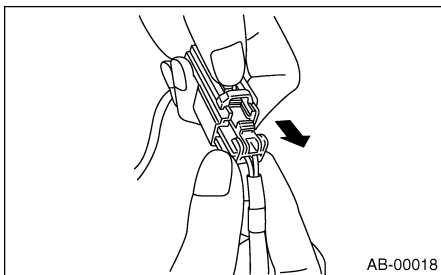
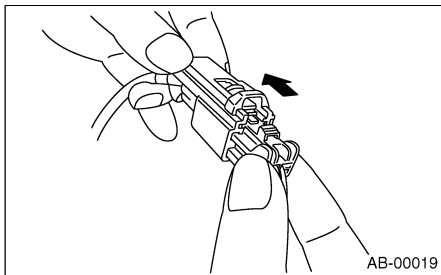
## 17 AIRBAG CONNECTORS

Recently, here at the Tech Line, we have been receiving calls where technicians have mentioned the difficulty they are having getting air bag connectors apart for the side airbag on some vehicles. In particular, this information applies to 2003-04MY Forester left-side airbag (steering wheel), roll connector, side-airbag and pre-tensioner.

- (1) Press tab (A) and hold.
- (2) While holding (A) depressed, pull back green slide lock (B) FULLY.
- (3) While still holding green slide lock (B), release tab (A)

- (4) Now (grasping the connector body - **not** the wire) separate the connector.
- (5) If the connector does not come apart easily, most likely the green slide lock (B) is not pulled back fully. Do not force the connectors apart! Start over at step (1).

- (1) Carefully push the connector together till a distinct “click” is heard.
- (2) Gently pull on connector body to insure it is locked.

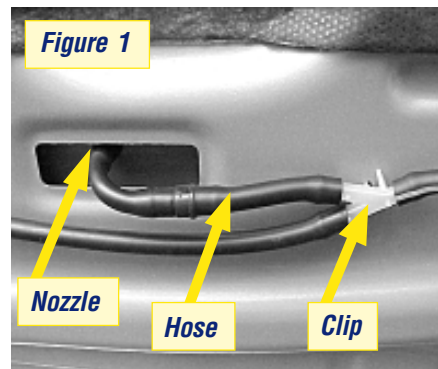
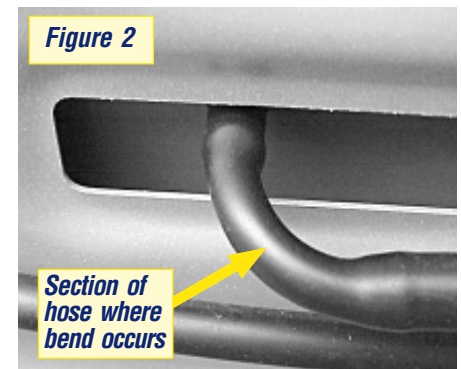
In the event that you encounter poor discharge from the Left Front Windshield Washer, replacement of the washer hose between the nozzle and clip may be necessary (See Figure 1). The hose could be bent near the nozzle. See Figure 2 for the suspect area. Prior to replacing this part, be sure to inspect the LF washer nozzle for obstruction and all other related components for proper operation.

- 1) Replace "Hose LH" between nozzle and clip with new one (part # 86659SA010)
- 2) Please pay special attention not to twist the hose when installing it. A ribbed hose is provided to prevent twisting the hose
- 3) Test the system for proper operation of windshield washer components.

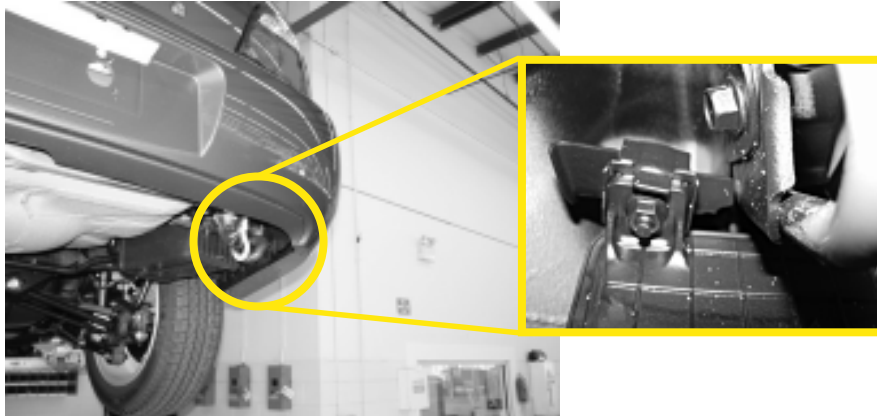
If you encounter a rattle noise while driving or when closing the rear doors of a 2004 Impreza, check that the Evaporative Canister Bracket is not rubbing on the right rear Tie Down Hook.

If you do encounter this condition, push or bend the Canister Bracket slightly to the left allowing enough clearance for the two parts not to rub together. This can be done by hand in most cases.
