TECHNICAL SERVICE BULLETINS

APPLICABILITY: STi Vehicles, All Model Years
SUBJECT: Towing Recommendations

NUMBER: 01-162-05
DATE: 06/28/05

APPLICABILITY: All Models
SUBJECT: Cylinder Head Gasket (residual carbon deposits and rubber coating removal)
NUMBER: 02-100-06R
DATE: 10/31/06

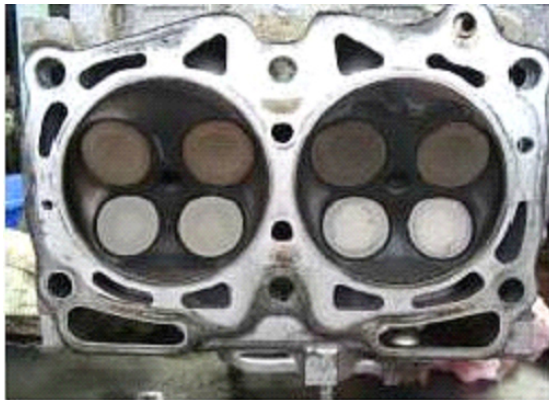
Removed Cylinder Head

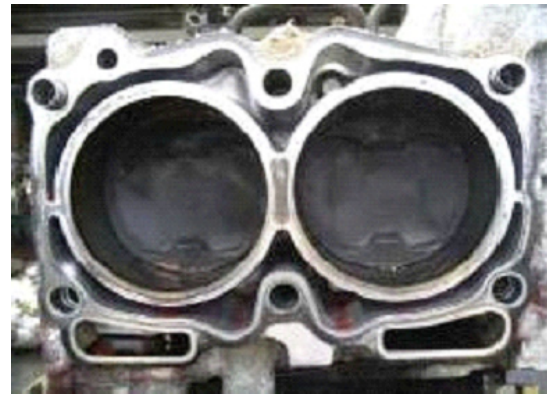
Cylinder Block after Head Removal

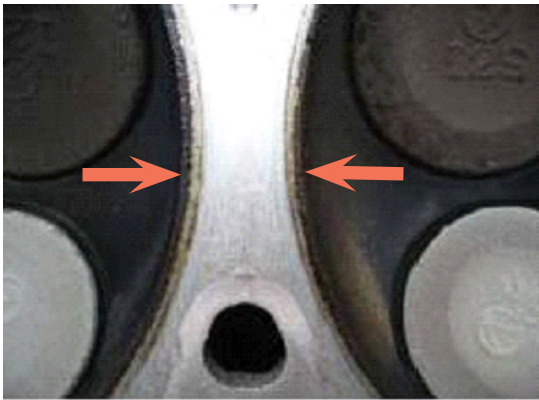
Accumulated carbon deposit on bore sealing portion

Using a gasket scraper, carefully clean any carbon deposits and rubber coating found on the surface of cylinder block and cylinder head.

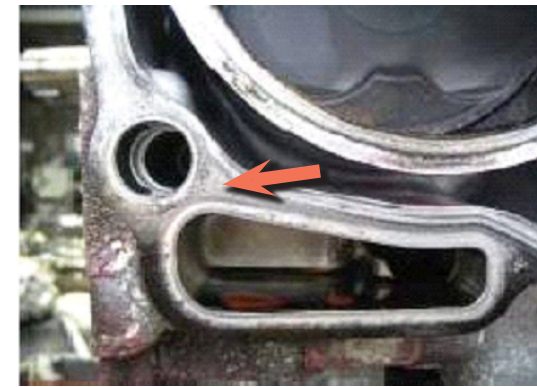
Rubber coating residue on oil sealing portion

CAUTION: Keep the scraper as flush as possible to the surface to avoid damage to the mating surface of cylinder block and cylinder head.

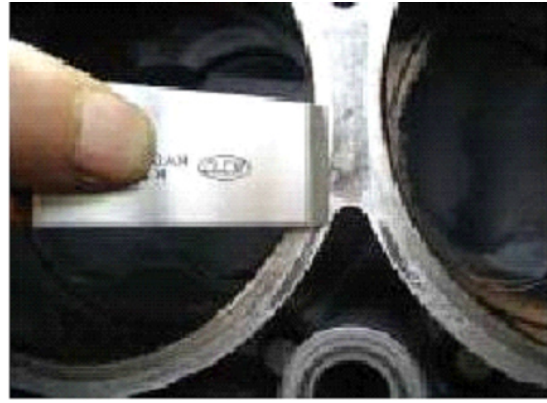
Carbon deposits being removed

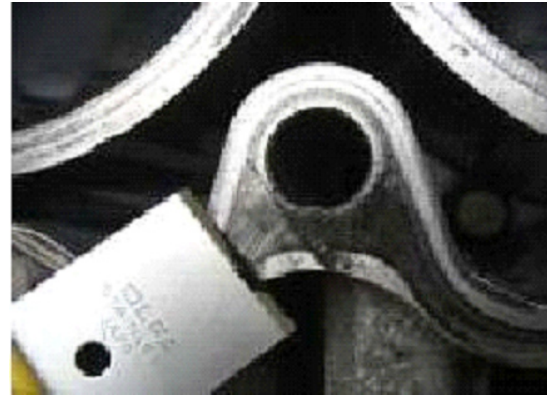
Rubber coating being removed

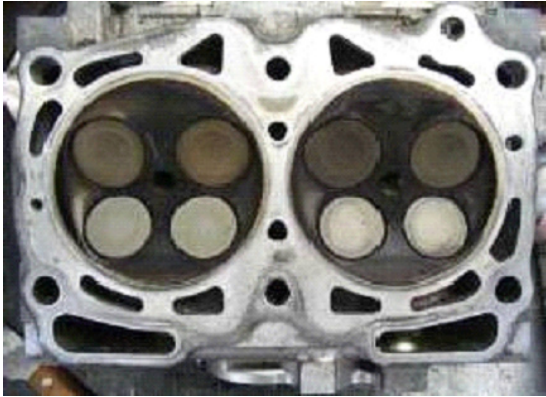
Finished cleaning (head)

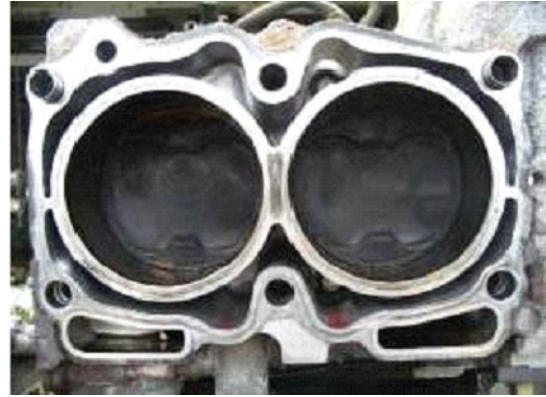
Finished cleaning (block)

NOTE: After removing carbon deposit and rubber coating, clean the surfaces using a rag and cleaning solvent.

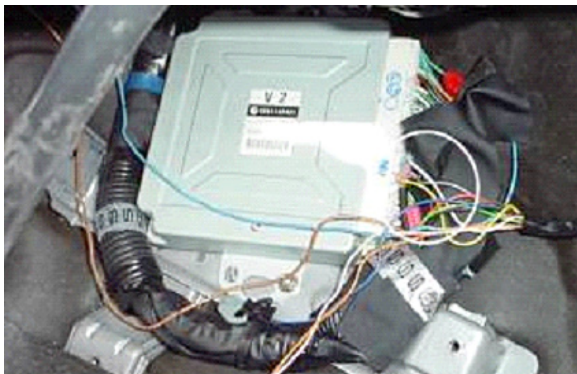
Modifying the engine tuning of a Subaru to increase horse power by Engine Control Unit (ECU) replacement or reprogramming can lead to engine failures. Other external engine modifications, such as intake or exhaust systems, can also lead to failures. Any modifications can reduce engine durability and cause reliability deterioration.

Aftermarket Air Fuel Controller wired to ECM

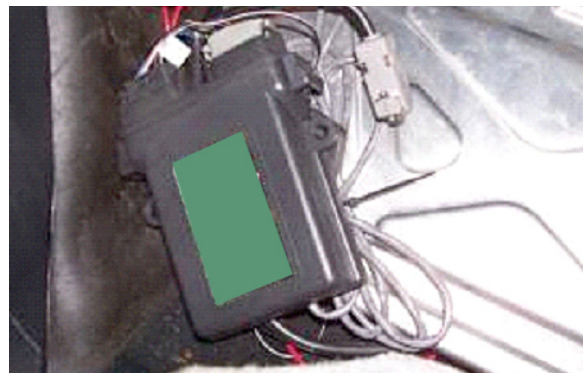
Aftermarket Chip Processor

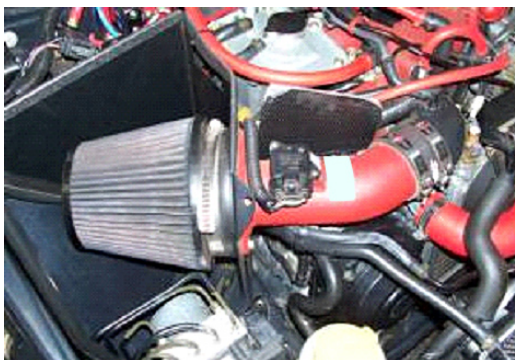
- Allow foreign objects to enter the engine.
- Change the Air/Fuel mixture ratio, due to the change of intake air amount.
- System malfunctions due to a contaminated air flow sensor.
- Reduced engine durability due to higher horse power that exceeds engine design specifications.
- Turbo charger internal damage from excessive turbine speed.

Aftermarket Cold Air Intake

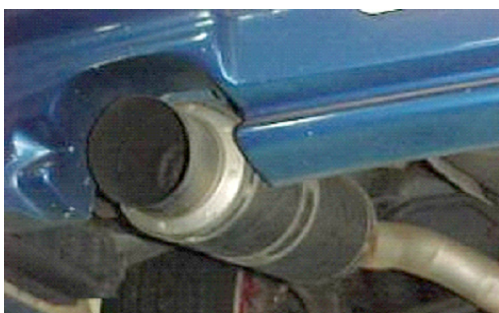
Modifications to the Exhaust System may create a reduction of exhaust resistance. This can lead to similar problems as found in Intake System modifications.

Aftermarket Exhaust System

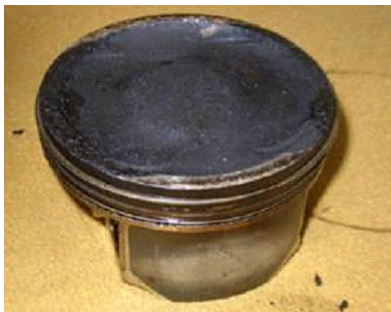
Modifications to the Engine Ignition System, such as “plugs”, can cause abnormal ignition, and result in engine damage.

Ring Land Damage from Detonation

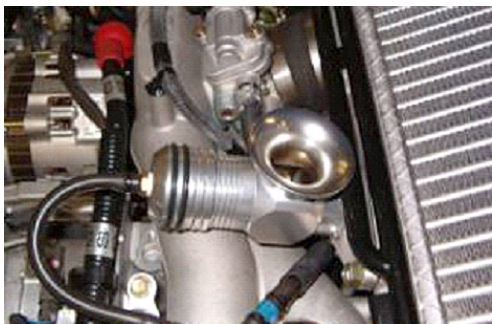
Aftermarket Blow Off Valve

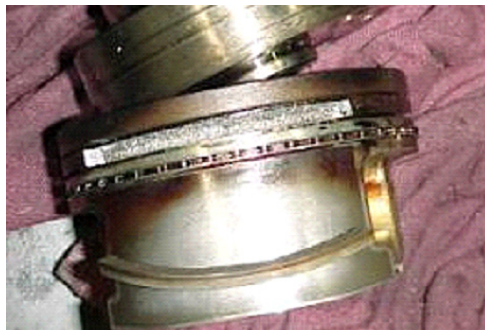
Ring Land Broken from Over Boosting

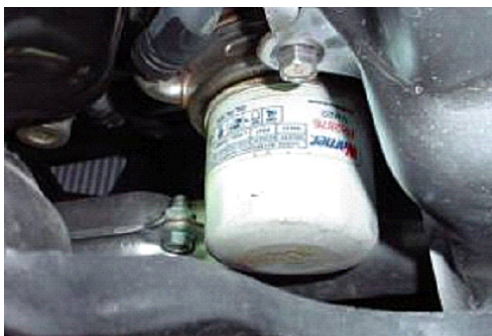
- The use of a Genuine Subaru oil filter is strongly recommended. Many aftermarket oil filters have different filtration capacity and relief valve opening pressure. Those filters may not meet Subaru's requirements and may cause engine problems.

Aftermarket Oil Filter

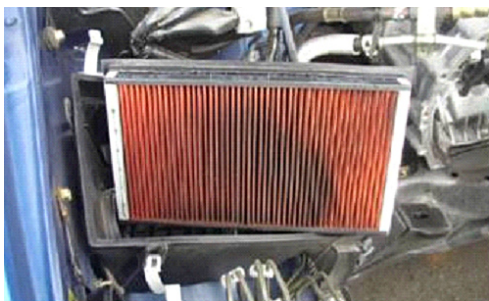
If the air cleaner element is contaminated, intake air flow is reduced. This condition will create an increase in engine vacuum causing an extra load on the turbo charger.

Contaminated Air Cleaner Element

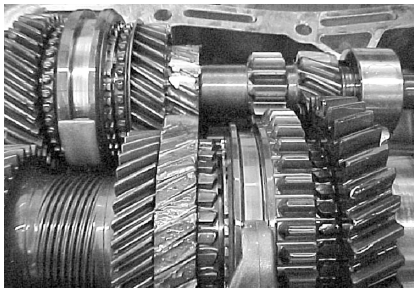
Second Gear Teeth Missing

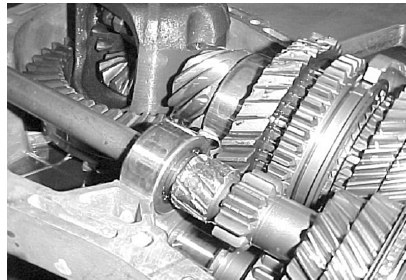
First Gear Teeth Stripped from Mainshaft

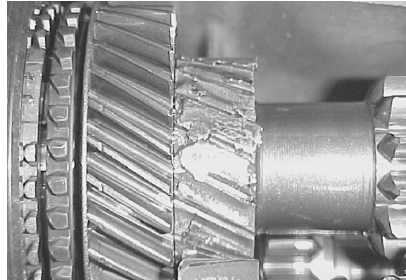
Second Gear Teeth Missing

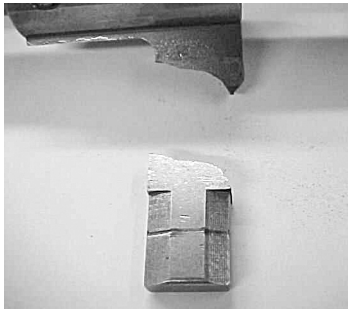
6-Speed 1-2 Shift Interlock
Arm Broken

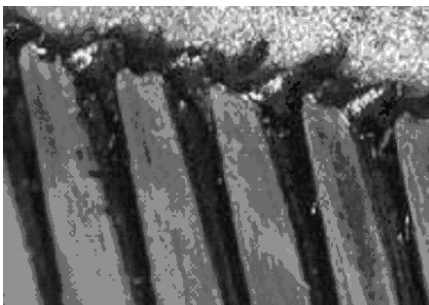
Damaged Land of Baulk Ring

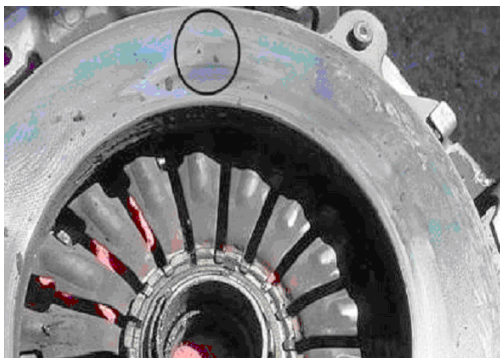
Over Heated Pressure Plate

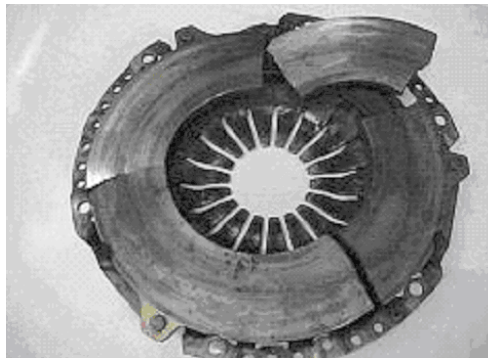
Broken Pressure Plate

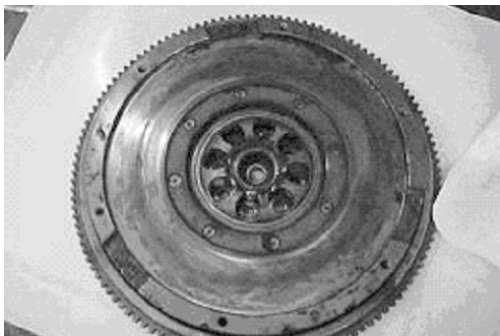
Over Heated Flywheel

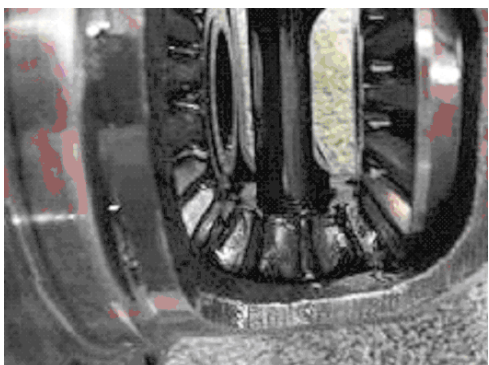
Rear Differential Gear Damage

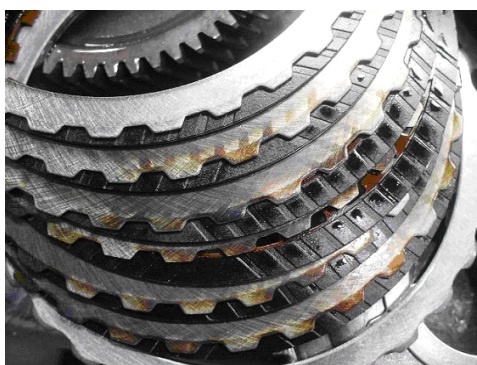
Burnt automatic transmission clutches

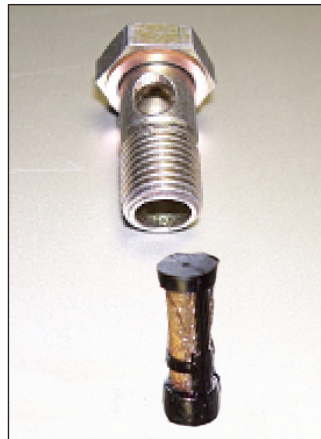
**Banjo bolt and Mesh Screen
(note direction of screen)**

- Make sure the mesh screen is installed in the proper direction; incorrect installation will cut off oil supply to the turbo.

In addition, the mesh screen which is located inside the banjo bolt that secures the turbocharger oil supply pipe to the back of the right side cylinder head should be checked to make sure it is not clogged or restricted especially if the condition of the oil is questionable or as to when the last oil change was performed. If clogged or restricted, it will reduce or cut off the oil supply to the turbo resulting in failure. The oil supply pipe should also be checked to make sure that there are no obstructions. *Note: The mesh screen is only available with a replacement banjo bolt.*

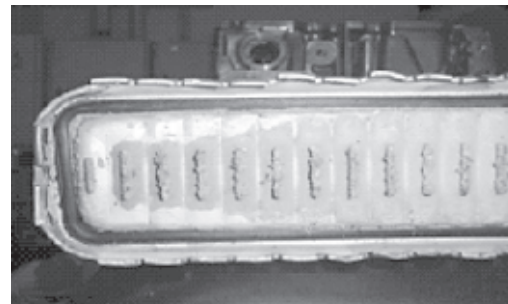
This photo shows the condition of a clogged radiator that has been filled with non-genuine coolant. The residue is corroded aluminum.

Whenever the coolant is changed, you must add Genuine Subaru Cooling System Conditioner. Genuine Subaru Cooling System Conditioner has been tested and approved for aluminum engines and radiators.

Do not use after-market coolant reinforcement agents, sealers and/or flushing agents as those chemicals could corrode aluminum parts.

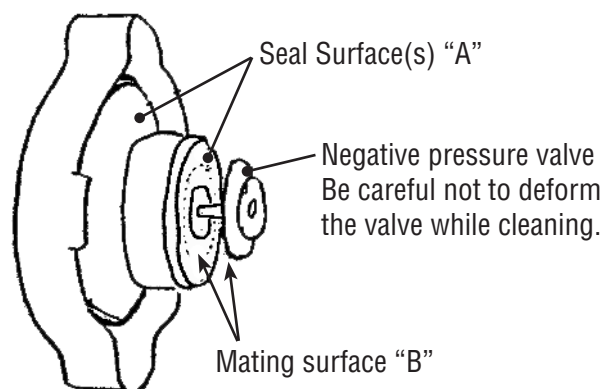
If foreign material is left in the filler neck sealing area, it will become embedded in the rubber seal and will prevent the cap from sealing properly. Before making the determination that the radiator cap is faulty, perform the following repair procedure.

- 1) Wash and clean the rubber seal surface(s) "A" using clean water and a soft bristle brush.
- 2) Carefully open the negative pressure valve. Using clean water and a soft bristle brush wash and clean the mating surface "B" between the valve and the rubber seal.

Note: Clean thoroughly. Failure to do so will prevent the cap from holding pressure.
