## Specific Problems

The AirCare Repair Newsletter is a quarterly publication of the Insurance Corporation of B.C. AirCare Program  
102-4705 Wayburne Drive  
Burnaby, B.C. V5G 3L1

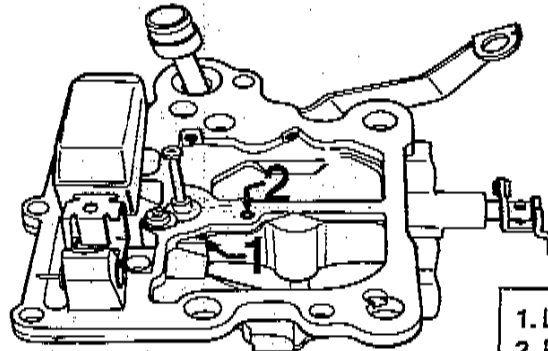
1. Labyrinth hole
2. Power cushion jet

Take a look at Fig # 1 (above) of the Suzuki power valve circuit from a 1987 Samurai. You will note that the vacuum supply from the intake manifold passes through a restriction orifice which Suzuki calls a "cushion jet". This feature is common to a number of Asian manufactured carburetors and is intended to slow power valve operation. The other design feature which Suzuki uses on this carburetor is a labyrinth hole which bleeds off some of the vacuum signal from above the power valve piston. The combination of these features allows the valve to open quickly but close slowly.

Now lets look at what happens as the power valve piston and bore wear. As the clearance between the piston and the bore increase so does the amount of vacuum which leaks around the piston. As we noted in the previous paragraph this vacuum is supplied through the "cushion jet" so the volume that can be supplied is limited by the size of the jet. To make matters worse we are already bleeding off some of the available volume through the labyrinth hole. As wear increases the power valve opens at higher manifold vacuum levels and loaded mode AirCare failures are the result. As the wear gets worse the problem will show up during high idle operation as well.

There are several ways to correct this problem other than replacement with a "new" (not rebuilt) carburetor. I prefer to do all three at once so the repair lasts. Step one, drill out the cushion jet to  $\frac{7}{64}$ " to increase the flow volume. Step two, plug the labyrinth hole to remove this bleed point. Step three, replace the power valve piston, if it is available, to minimize piston to bore clearance and bleed off. With these modifications the power valve resumes normal operation even as the carburetor body continues to wear over time, since the power valve spring rate becomes the only major control factor.
