SERVICE BULLETIN

No.: MSB-00E35-001

Subject: CHANGE TO ERASING OF ABS DIAGNOSTIC CODES

<Model>
(EC)COLT/LANCER

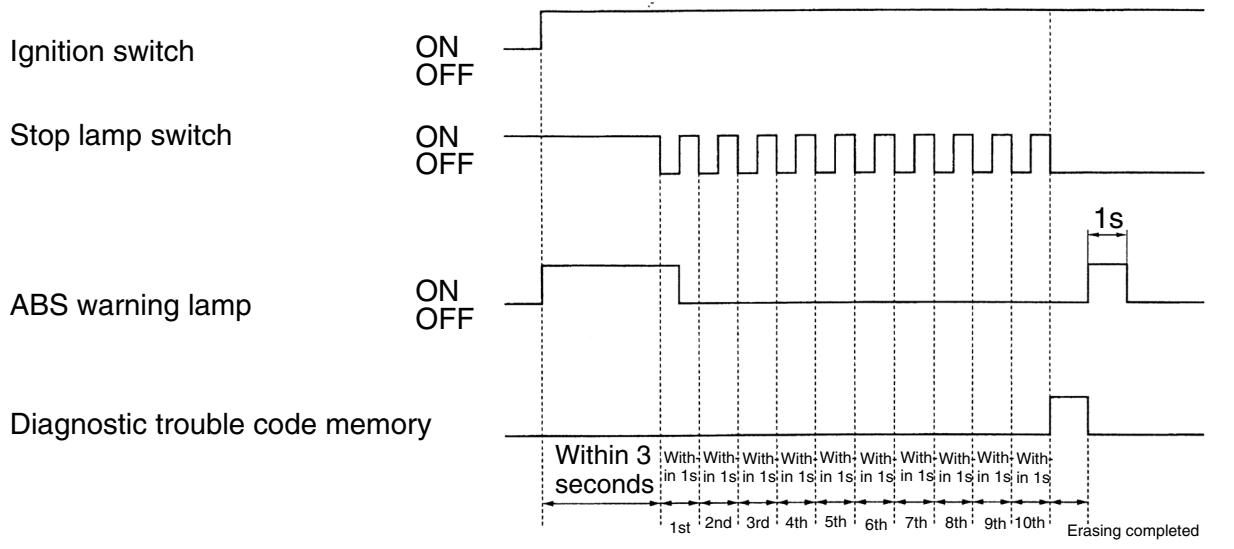
When ABS-ECU stops functioning through the fail-safe mechanism, erasing of the diagnostic trouble codes cannot be performed.

1. Stop the car.
2. Place the stop lamp switch to ON (with brake pedal depressed).
3. Under the condition of 1 and 2 above, turn the ignition switch ON. After that, place the stop lamp switch to OFF (with brake pedal released) within 3 seconds, and cycle the stop lamp switch ON and OFF ten times consecutively.

4. Ensure that the diagnostic trouble codes have been erased. When diagnostic trouble codes (Nos. 21 to 24) (for vehicle wheel speed sensor system failures) occur, the above procedures may not erase those codes. In that case, turn the ignition switch OFF, then repeat steps 1 to 3 above.
