# SERVICE BULLETIN

| <b>SERVICE BULLETIN</b> | | No.: MSB-99E13-501 | |
| <b>Subject:</b> CORRECTION OF CONNECTOR NOS. | | <b>&lt;M/Y&gt;</b><br>99-10 | |

| <b>Subject:</b> CORRECTION TO SHAPE OF LSPV AND TO<br>SPRING SUPPORT INSTALLATION | | <b>&lt;M/Y&gt;</b><br>99-10 | |

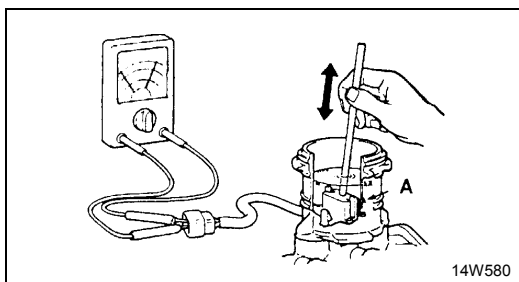
**BRAKE FLUID LEVEL SENSOR CHECK**

The brake fluid level sensor is in good condition if there is no continuity when the float surface is above "A" and if there is continuity when the float surface is below "A".

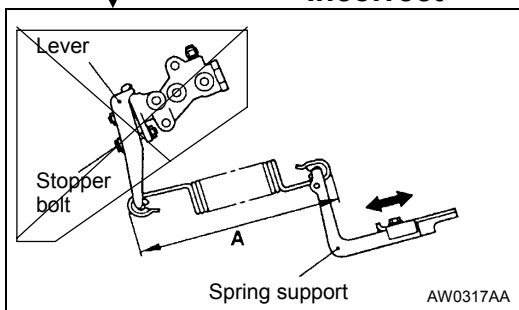
2. While the lever of the load sensing proportioning valve is touching the stopper bolt, install the spring support so that the distance (A) is at the standard value.

**Standard value (A): 164 - 168 mm**

3. If the spring length is not within the standard value, loosen the bolt attaching the spring support and adjust the distance by moving the spring support.

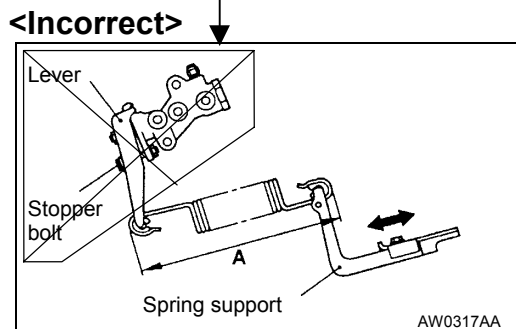
Vehicle is on the ground in an unladen condition,

While the lever of the load sensing proportioning valve is touching the stopper bolt, install the spring support so that the distance (A) is at the standard value.

Standard value (A): 164 - 168 mm
