# SERVICE BULLETIN

FA00-001

April 12, 2000

## STEERING PULL DIAGNOSIS AND REPAIR

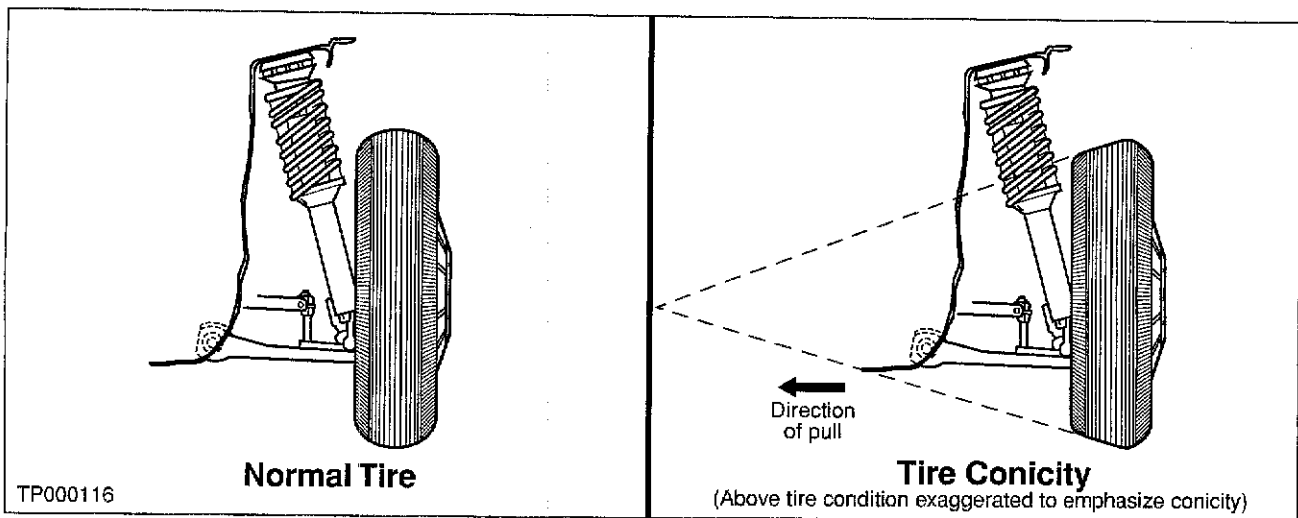
Figure 1

Pull can occur as a result of incorrect wheel alignment, tire condition or steering rack sliding force. It can also occur as a result of excessive tire "conicity". This refers to a condition when the tire tread surface is not parallel to the axle centerline (see Figure 1). Conicity occurs during the manufacturing process and the tire may not show noticeable tread wear. When it occurs, it has the affect of the tire taking the shape of a cone. As a result, the tire has a tendency to roll towards the point of the cone.

The vehicle will pull in the direction of the tire with the greatest conicity. If the tire conicity is equal on both sides of the vehicle, there is no effect on vehicle pull.

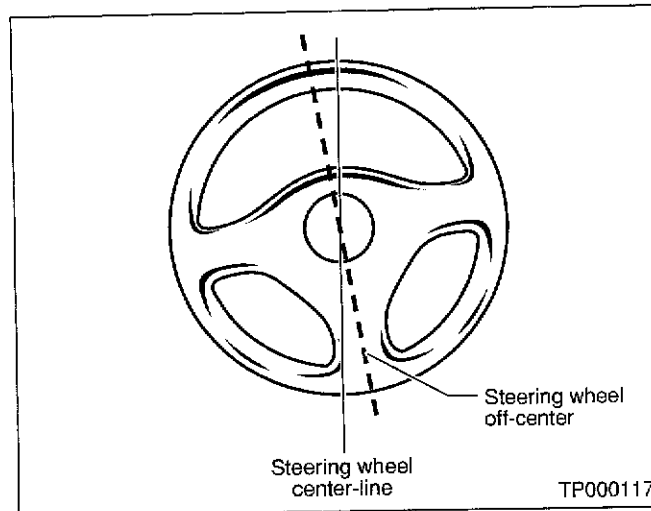
Figure 2

The steering wheel spokes are tilted to the left or right (see Figure 2) when driving straight ahead on a straight flat road. Although the vehicle does not pull in either direction, the customer may perceive that the vehicle pulls because it will respond if he or she tries to bring the steering wheel back to center. This condition will occur if the toe-in is out of adjustment causing the tie rod length to be uneven from side to side.

1. Position the vehicle on an alignment rack.
2. Set the road wheels in the straight ahead position.
3. Loosen the tie-rod lock nuts and rotate the left and right tie-rods an equal amount in opposite directions. This will center the steering wheel. If the steering wheel off-center increases, reverse the direction you are turning the tie rods.
4. Use the alignment equipment to verify and adjust the toe-in.
5. Verify the steering wheel is centered.
  - If the steering wheel is centered and the toe-in is correct, the procedure is complete.
  - If the steering wheel is still off-center or the toe-in is incorrect, repeat steps 2, 3, 4, 5.

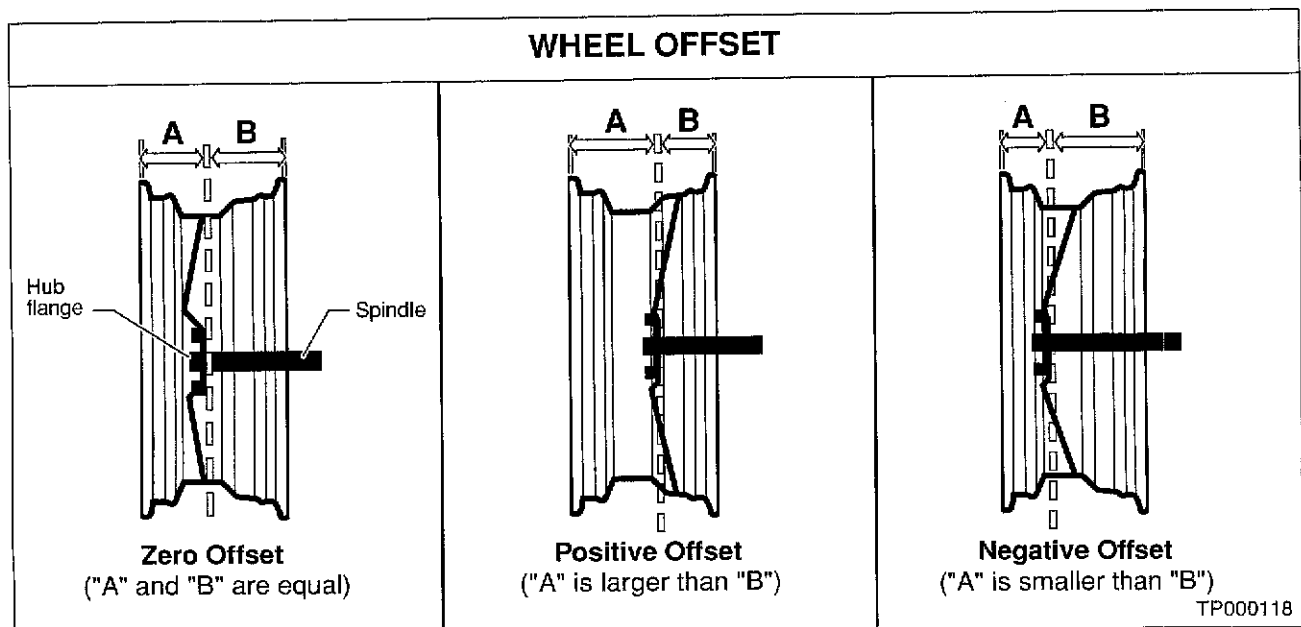
Figure 3

The vehicle has a tendency to drift to the right or left depending on road surface conditions. Wander can occur as a result of too little caster (incorrect wheel alignment), steering rack Sliding Force setting or incorrect road wheel offset. See figure 3
