# SERVICE BULLETIN

| Classification:<br>EF&EC93-016 | Section:<br>Engine Fuel | Models:<br>All models |

## GREEN OR BLUE (TYPE 1M) RELAY CAUTION

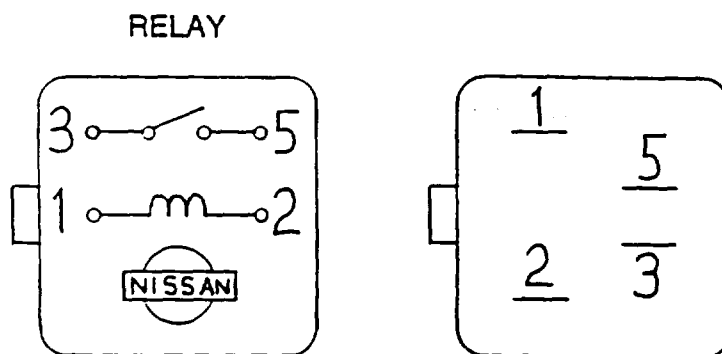
1. Note that the schematic on the fuel pump relay is rotated 90 degrees from the orientation of the relay terminals in the relay connector (see diagram below):

**NOTE:** If terminals 2 or 3 (battery voltage) are connected to terminal 1, the ECM will become damaged if the circuit being tested has terminal 1 connected to the ECM.

2. Exercise caution to ensure that the correct terminals are being probed at the relay connector during diagnosing / checking.
