# SERVICE BULLETIN

| Classification: | BR94-002 | Section: | Brake | Models: | All models |
| Reference: | TECHNICAL BULLETIN NTB94-012 | | | Date: | February 3, 1994 |

## BRAKE JUDDER/STEERING WHEEL SHIMMY

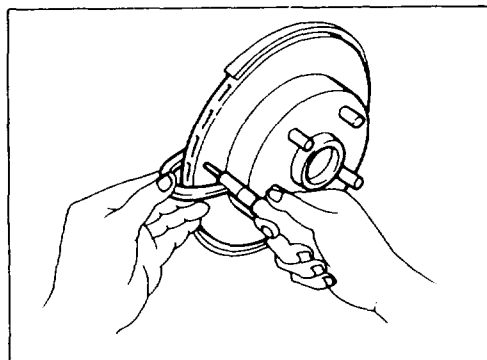
*Rotor Thickness Variation (RTV)* is the variation in thickness around the rotor. The *RTV* can be determined by measuring the rotor thickness with a micrometer at several locations around the circumference of the rotor. The RTV is the difference in thickness between the thickest and thinnest points on the rotor.

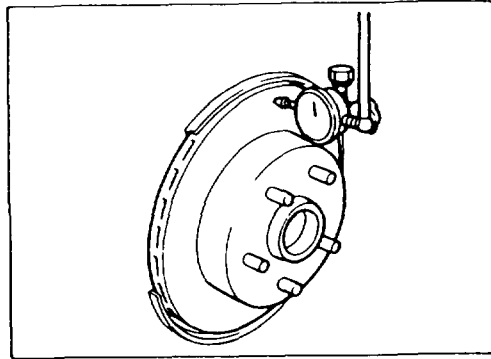
**Rotor Run-Out** is the distance that the rotor surface travels in and out, in relation to the vertical plane of the hub, as the rotor turns with the hub. The distance is measured with a dial indicator.

**NOTE:** *Rotor Run-Out* does not cause brake judder or steering wheel shimmy. However, excessive *Rotor Run-Out* does lead to rotor thickness variation as the rotor wears. It is the excessive rotor thickness variation that causes judder and/or steering wheel shimmy. This is described in more detail below.

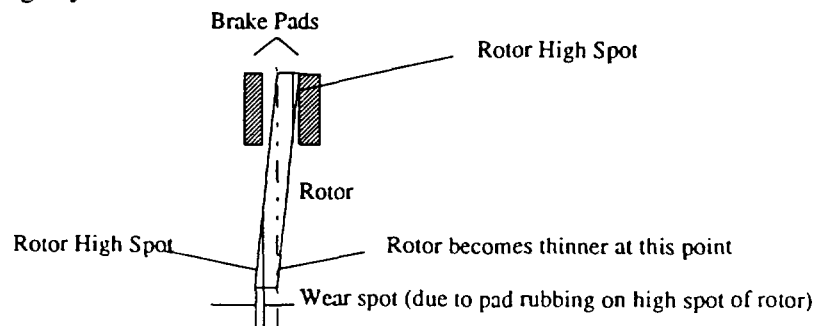
- \* The brake rotor *run-out* exceeds specification limits.
- \* As the brake pad rubs against the rotor while driving, the high spots on the brake rotor wear slightly.

- \* Rotor *thickness variation* may develop as the high spots on the brake rotor wear. If this *thickness variation* becomes large enough, brake judder/shimmy may occur.
