# SERVICE BULLETIN

| Classification: | EM94-002 | Section: | Engine Mechanical | Models: | See Below |

## BROKEN EXHAUST MANIFOLD STUD

**APPLIED MODELS:**      **Only Those Equipped w/VG30E Engine**  
Pathfinder (WD21)  
Maxima (J30 and U11)  
Truck (D21)  
300ZX (Z31)  
200ZX (S12)

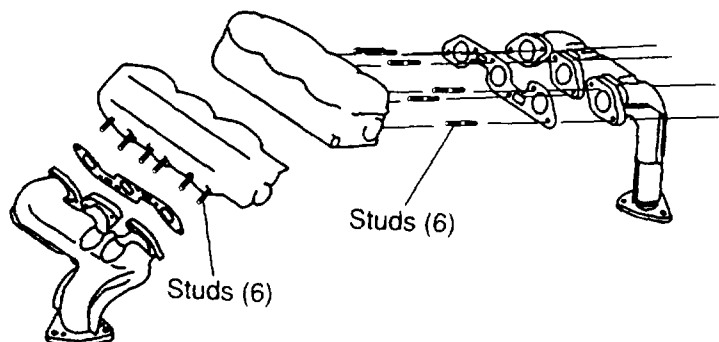
Index # 037907

The exhaust manifold stud has been changed for improved durability. Use the following procedure to repair vehicles which exhibit excessive exhaust noise due to exhaust manifold stud breakage.

1. Remove the exhaust manifold on the side of the engine with broken stud(s). (Figure 1) For additional information, refer to the **EM** Section of the appropriate Service Manual.

2. Replace the broken stud(s) and the front and rear studs **only** using the **improved part, P/N 14065-V5003**.
3. Replace the exhaust manifold gasket and the exhaust manifold with new parts. Refer to the EM Section of the appropriate Service Manual for proper torque values for the fasteners. Refer to the Parts Catalog/Microfiche for applicable P/N's.
