# SERVICE BULLETIN

BT98-027

## 1987-95 PATHFINDER DRIVER'S SIDE FLOOR PAN CORROSION/PERFORATION REPAIR PROCEDURE

**APPLIED VEHICLE:** V6 4WD Pathfinder (WD21)  
**APPLIED VIN(S):** ALL  
**APPLIED DATE(S):** 1987-95

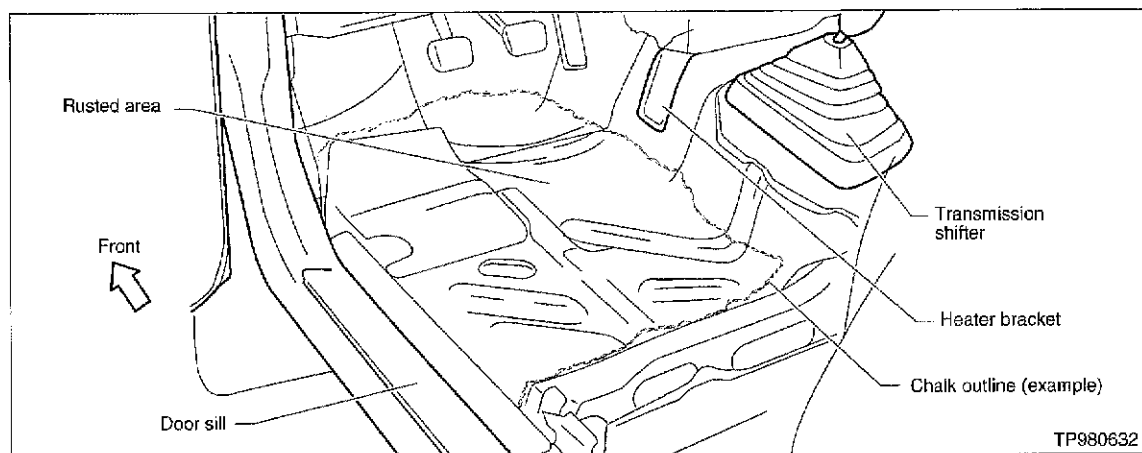
Figure 1

7. Inspect the area of corrosion. Clean all dirt, floor insulation and debris away from the area to be cut. This is necessary in order to see all the original spot welds holding the corroded section. Draw a chalk outline around the area to be removed (see Figure 1).
