SERVICE INFORMATION BULLETIN

APPLICABILITY: All Models

NUMBER: 02-174-18

SUBJECT: Engine Oil Pan Dent / Deformation at
Drain Plug Area

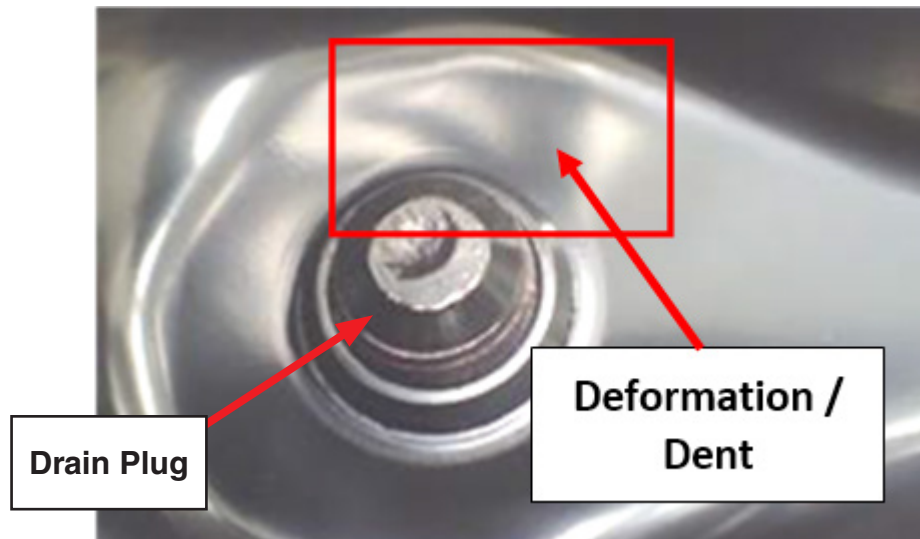
This Service Information bulletin serves as a reminder regarding standard procedures when removing and / or tightening / torquing the engine oil drain plug to avoid damaging the oil pan as shown below.

NOTE: This type of oil pan damage is caused by outside influence. It is **NOT** a defect and therefore, not a matter for warranty.

REMEMBER: Whenever reinstalling the drain plug, always use a **NEW** sealing washer and torque to the proper value as specified in the applicable Service Manual.

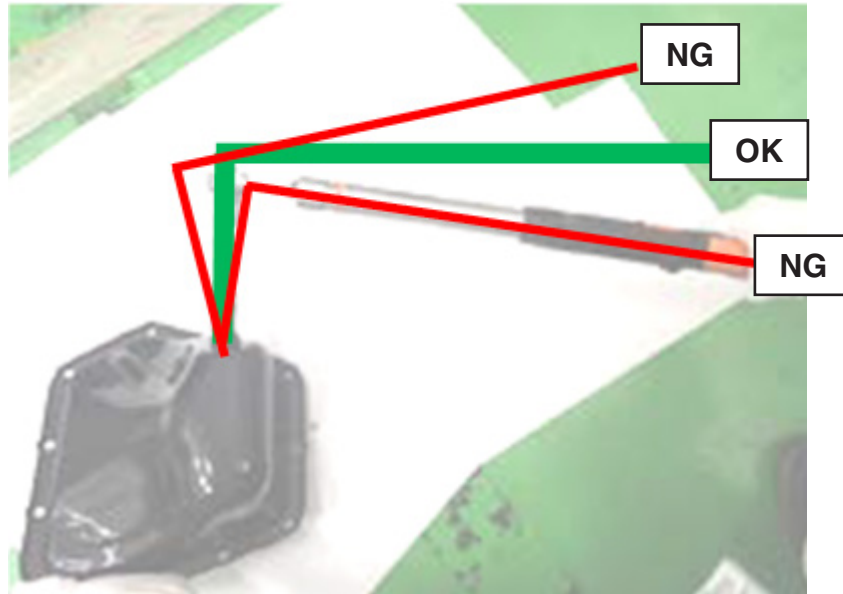
This type of damage can EASILY occur when the tool being used is at an angle not in alignment (out of square or not perpendicular) with the centerline of the drain plug when loosening or tightening it. See the illustration below for further explanation.

The red lines represent a tool out of alignment (NG) while the green shows a tool in the proper position (OK).
