## Specific Problems

The AirCare Repair Newsletter is a quarterly publication of the Insurance Corporation of B.C. AirCare Program  
102-4705 Wayburne Drive  
Burnaby, B.C. V5G 3L1

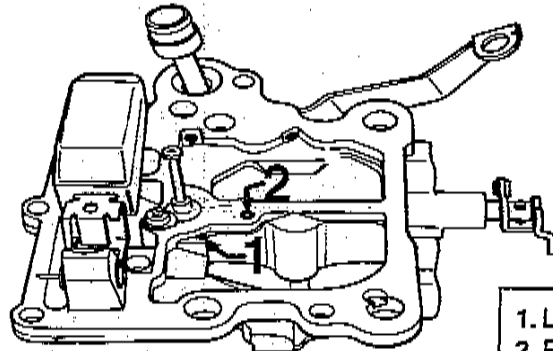
Take a look at Fig # 1 (above) of the Suzuki power valve circuit from a 1987 Samurai. You will note that the vacuum supply from the intake manifold passes through a restriction orifice which Suzuki calls a "cushion jet". This feature is common to a number of Asian manufactured carburetors and is intended to slow power valve operation. The other design feature which Suzuki uses on this carburetor is a labyrinth hole which bleeds off some of the vacuum signal from above the power valve piston. The combination of these features allows the valve to open quickly but close slowly.

Now lets look at what happens as the power valve piston and bore wear. As the clearance between the piston and the bore increase so does the amount of vacuum which leaks around the piston. As we noted in the previous paragraph this vacuum is supplied through the "cushion jet" so the volume that can be supplied is limited by the size of the jet. To make matters worse we are already bleeding off some of the available volume through the labyrinth hole. As wear increases the power valve opens at higher manifold vacuum levels and loaded mode AirCare failures are the result. As the wear gets worse the problem will show up during high idle operation as well.

There are several ways to correct this problem other than replacement with a "new" (not rebuilt) carburetor. I prefer to do all three at once so the repair lasts. Step one, drill out the cushion jet to  $\frac{7}{64}$ " to increase the flow volume. Step two, plug the labyrinth hole to remove this bleed point. Step three, replace the power valve piston, if it as available, to minimize piston to bore clearance and bleed off. With these modifications the power valve resumes normal operation even as the carburetor body continues to wear over time, since the powervale spring rate becomes the only major control factor.
