## Technical Service BULLETIN

### A/C COMPRESSOR MAINTENANCE FOR STORED VEHICLES

All Models

AC002-00

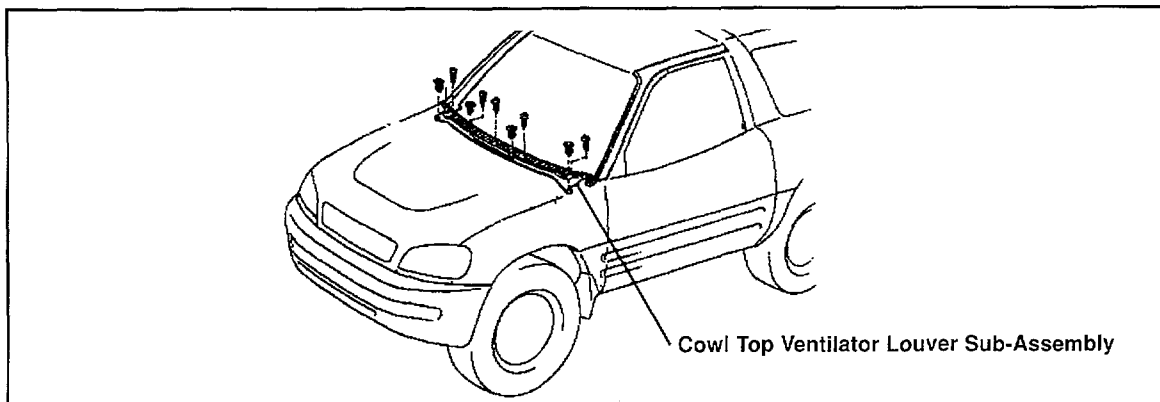
**Introduction** An improved Cowl Top Ventilator Louver Sub-Assembly is available as a field fix to help prevent snow from entering the Cowl Vent.

If during the process of diagnosing heater blower problems, the presence of water is noted in the Blower Assembly, replace both the Cowl Top Ventilator Louver Sub-Assembly and the Blower Assembly.

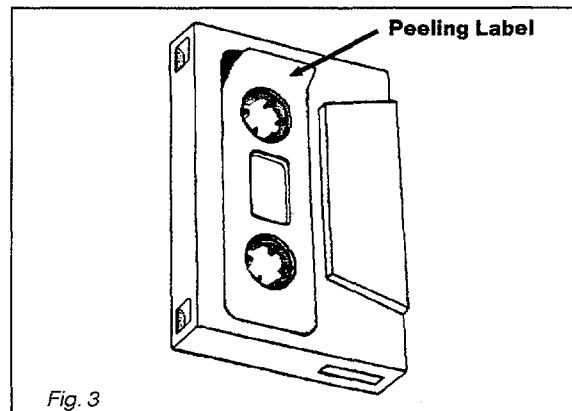
6. Avoid inserting a cassette into the player if the cassette label is loose or peeling as shown in figure 3. This can cause a cassette to become stuck in the player.

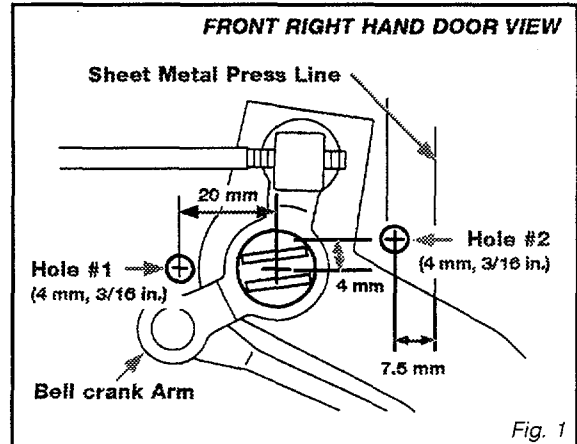
Fig. 1

**Introduction** Toyota recommends the use of a clamping band (P/N 69749-32020) to reduce free-play at the bell crank pivot.

6. Install clamping band.
  - a. Route clamping band through both holes and across the face of the bell crank pivot shaft.
  - b. Loosely engage tip of the clamping band into the locking portion of the band.
  - c. Route the clamping band into the groove on the front side of the bell crank pivot as shown.
  - d. Pull clamping band tightly enough that it prevents free play between the pivot shaft and the inner panel.

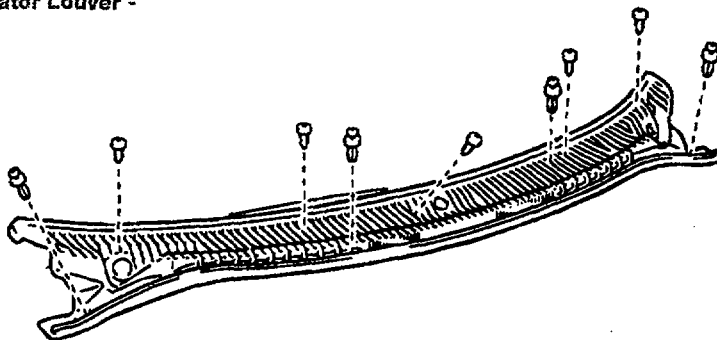
Cowl Top Ventilator Louver -

**Introduction** To prevent snow from entering the cowl vent on 1996 and 1997 RAV4s, stainless steel mesh nets have been added to the cowl top ventilator louver.

Replace the Cowl Top Ventilator Louver per the Repair Manual procedures.

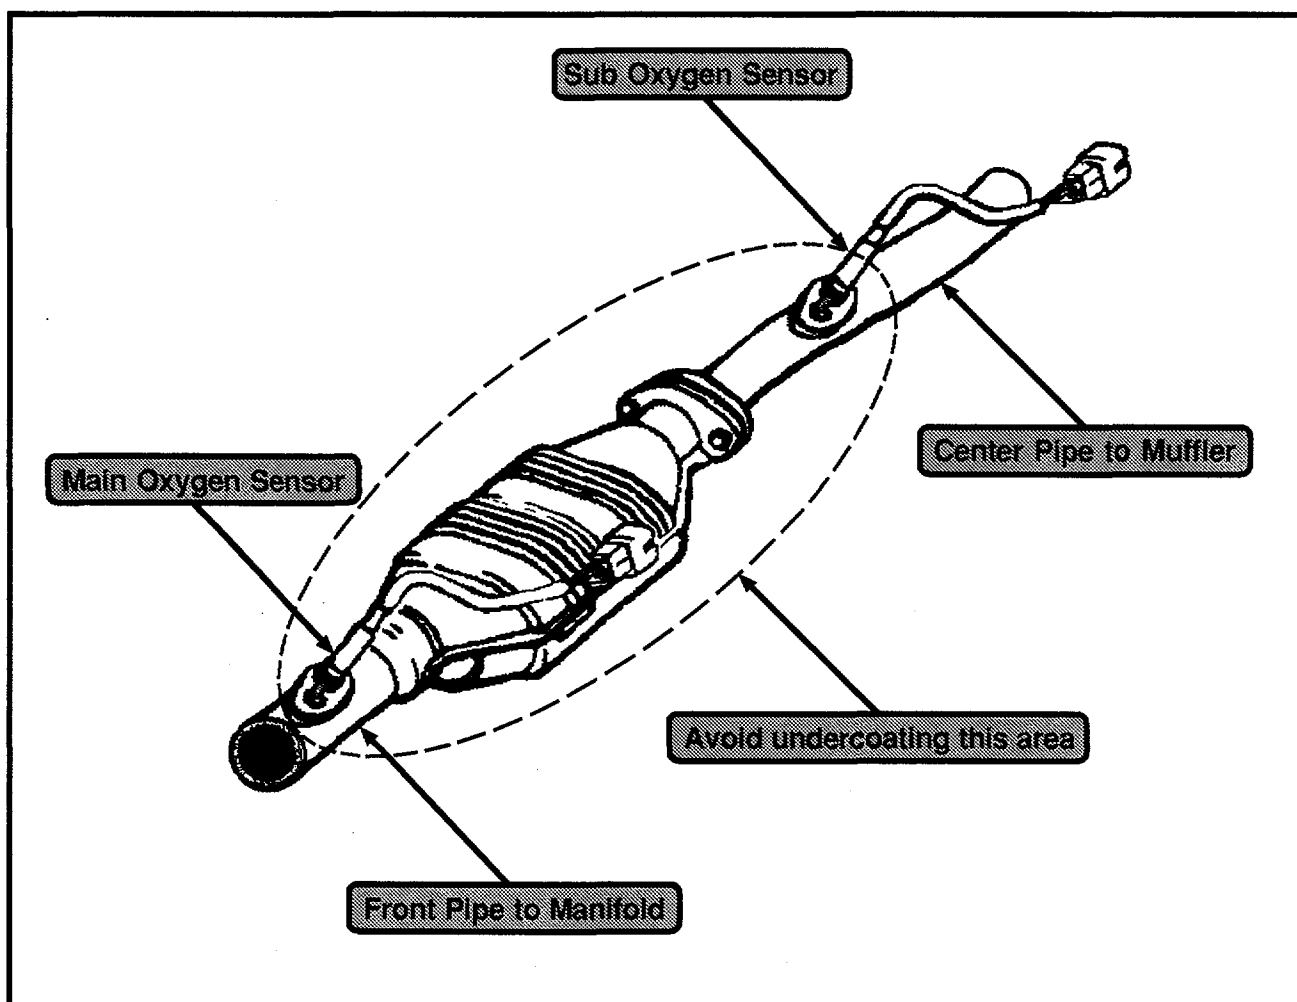
During vehicle processing by Dealers, care must be taken to avoid applying undercoating in the area surrounding the Oxygen Sensors. Application of undercoating on or near the Oxygen Sensors can cause insufficient air to flow around the sensor, and inaccurate information storage by the ECM. If this condition occurs, the Malfunction Indicator Light (MIL) may illuminate.

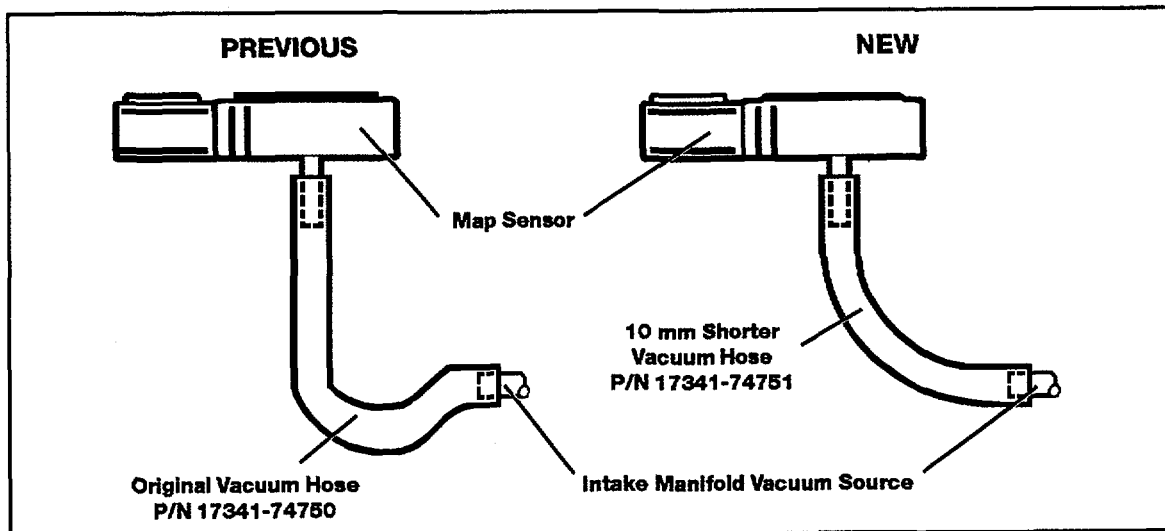
**Introduction** To minimize moisture retention and improve MAP Sensor operation, the length of the connecting vacuum line has been shortened 10 mm.
