The Subaru 2.5 liter twin cam engine is an interference engine. If its timing belt breaks or if it is incorrectly installed, intake and exhaust valves can collide with one another. The same circumstances can also cause the valves to collide with the tops of the pistons as the pistons rise in the cylinders. So this is one engine that requires your full attention during a timing belt replacement.

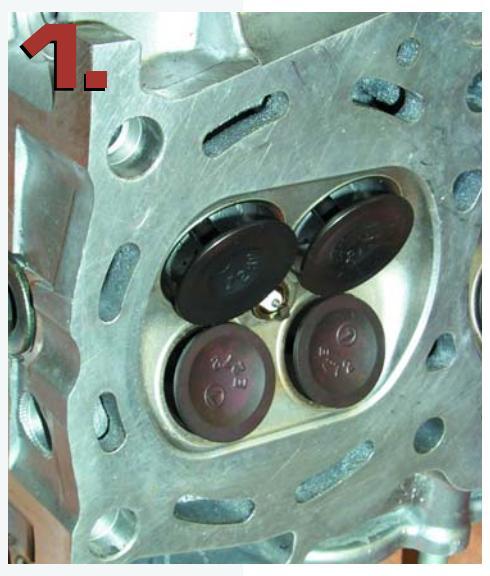
We've removed a 2.5 cylinder head to show just how crowded it is in the combustion chamber area. Each intake valve has its own cam lobe. The intake valve timing is slightly staggered, so one intake valve begins to open and close slightly ahead of its partner. If the intake and exhaust cams are allowed to get out of time in relation to one another, intake and exhaust valves will collide in the combustion chamber area. Intake valves in four-valve heads are necessarily small, and more easily damaged than similar components on two-valve engines. A collision between valves, even when the engine is not running (during a timing belt replacement for example), can cause valve damage. The object is to finish the job with the engine running at least as well as it was before you started, which is why it's so important to approach this job with the necessary caution and the proper tools.

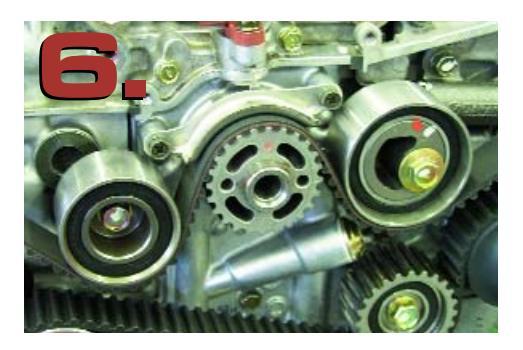
Beginning with the 1998 model year, 2.5 liter engines have this sheet metal belt guide mounted above the crankshaft sprocket.

The belt guide serves to maintain belt engagement mainly during the time the vehicle is being shipped. Manual transmission vehicles are shipped in gear, which transmits the rocking action of the shipment vehicle to the

cambelt tensioner, compressing the oil chamber. The tensioner begins to refill the oil chamber after the engine is started and in some cases the tension of the belt was not increased in a timely manner. This would cause the torque of the engine to slip the crankshaft sprocket ahead of the timing belt, creating a crankshaft to camshaft timing problem.

The belt guide prevents this condition from occurring by pushing the belt downward back into the crankshaft sprocket. This guide is not in constant contact with the belt. Contact only occurs if the belt begins to slip.

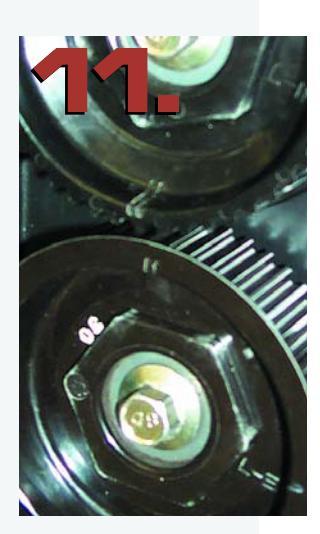
The camshaft pulleys must also be aligned *in relation to one another*. To accomplish this, each camshaft pulley also has a pair of side-by-side timing marks. When the engine is properly timed, these double notches will be directly facing each other. The notches on the intake (upper) camshaft sprockets should be at the 6 o'clock position, while the notches on the exhaust (lower) camshaft sprockets should be at the 12 o'clock position. Proper alignment of the left camshaft sprocket double timing marks is shown here.

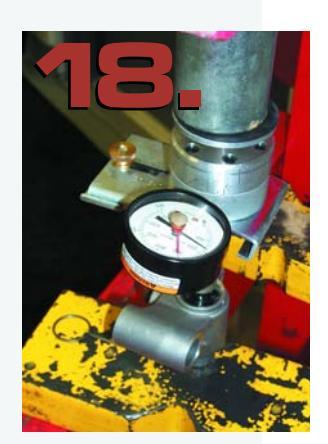
The tensioner rod must be compressed using a hydraulic press. The pressure exerted on the rod must not exceed 66 pounds. Exceeding this pressure may bend the tensioner rod. This will keep the rod from extending fully when it is reinstalled on the engine. If the rod cannot extend fully, excessive slack may develop in the timing belt, causing it to jump teeth. Jumped teeth can mean bent valves or damaged pistons, something you'll certainly want to avoid.

- Secure the tensioner in a press. This photo shows the recommended setup. An ABS brake pedal force gauge is inserted between the press road and the adjuster piston. A small pin fits between the force gauge and the adjuster rod, assuring that all press force is directed to the adjuster rod. Use press plates to make sure the tensioner assembly is square and that no press force is directed to the tensioner pulley assembly.
- Slowly press the adjuster rod down to the end surface of the tensioner surface. Repeat this motion two or three times.
- Allow the adjuster rod to extend fully, then apply a pressure of 66 psi to the rod. Check the tensioner for resistance.
- If no resistance is felt and the adjuster rod moves down freely, replace the tensioner with a new one.
- Release the press and allow the adjuster rod to move up.

- Measure the extension of the adjuster rod beyond the body. Replace the tensioner if it is beyond the specification of $6.0 \text{ mm} \pm 0.5 \text{ mm}$.
- Check the condition of the tensioner and pulley contact surface, bearing operation and grease leakage. Replace the tensioner if any abnormality is found.
- If the tensioner passes inspection to this point, slowly move the rod down with a force of 66 pounds. Up to 10 minutes of slow pumps on the press lever may be necessary to fully retract the adjuster rod. Pump the lever until the pressure reaches 66 psi, then allow the pressure to drop before giving it another slow pump.
- Stop when the adjuster rod is fully retracted (flush with the tensioner body). Pushing beyond this point will damage the tensioner. A 2 mm retaining pin should fit easily through the holes in the tensioner housing and adjuster rod.

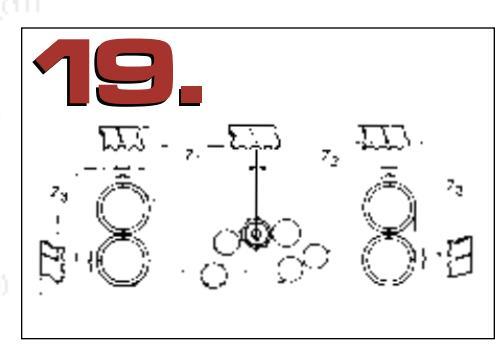
By far the most accurate method of determining proper belt alignment is to count the belt teeth. This diagram illustrates the tooth counts for all five timing marks. Tooth count Z1 is 54.5 teeth. This measures from the crankshaft pulley timing mark to the right (upper) intake camshaft sprocket timing mark. Tooth count Z2 is 51 teeth. This measures from the crankshaft pulley timing mark to the left (upper) intake camshaft sprocket timing mark. Tooth count Z3 is 28 teeth. This is the number of teeth between the (upper) intake and (lower) exhaust camshaft sprocket timing marks. The Z3 tooth count is the same for both the left and right sides of the engine because the same relationship must be maintained between the upper and lower cams on both sides of the engine.

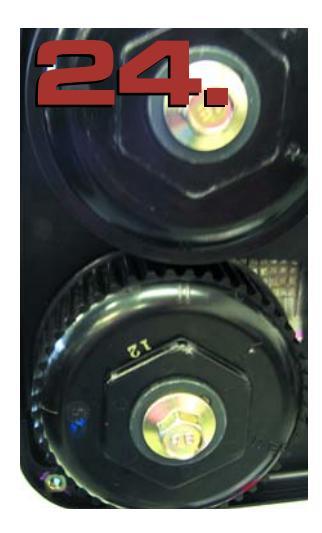
The timing marks on this engine lined up everywhere but here at the left cam sprocket match marks. After normalizing the belt by rotating it, the upper and lower pulley match marks didn't line up quite as precisely as we would have liked. The four marks didn't line up like four fingers pointing directly at each other. Rather, they lined up like four fingers pointing ever so slightly away from each other.

Subaru training instructor Joe Stoffa assured us that this was as close as we were going to get on this engine. Remember, four of the engine timing marks are simple notches in the inner timing cover plastic. Due to manufacturing tolerances and assembly variations, these notches may not end up in precisely the right spot. A slight variation here or there can add up to the slight misalignment we saw on our engine. Moving either of the pulleys a full tooth in either direction would not have corrected our perceived misalignment; it would only have made it worse.
