1. Door Glass

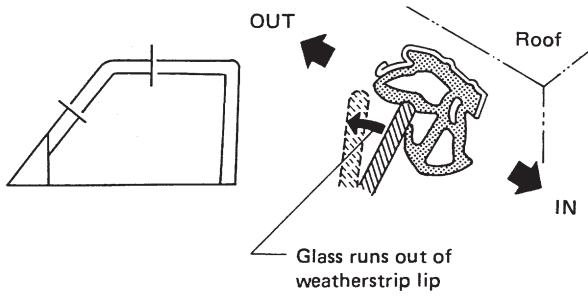
Condition	Apparent cause/Correction
<p>Glass in fully closed position</p>	<p>1) Glass runs out of weatherstrip lip when considerable hand pressure is applied to it from inside.</p>

<p style="text-align: right;">G5M0502</p> <p>(This condition may cause wind/booming noise during high-speed operation.)</p>	<ul style="list-style-type: none"> ● Insufficient upward travel of glass Increase upward travel of glass.
	<p>2) Clearance exists between glass and weatherstrip when light hand pressure is applied to it at center and rear pillar locations.</p>

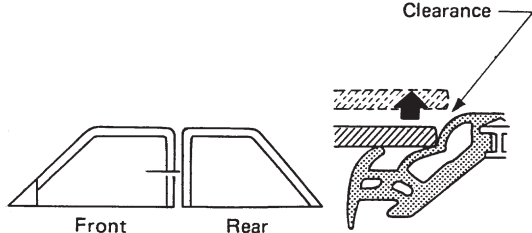
<p style="text-align: right;">G5M0503</p> <p>(This condition may cause wind noise and/or water leakage.)</p>	<ul style="list-style-type: none"> ● Insufficient glass-to-door weatherstrip contact Check stabilizer and glass for proper contact. Increase contact using upper sash adjustment bolt. ● Improper adjustment of striker in in-out direction Close door and check for alignment of striker with vehicle body.

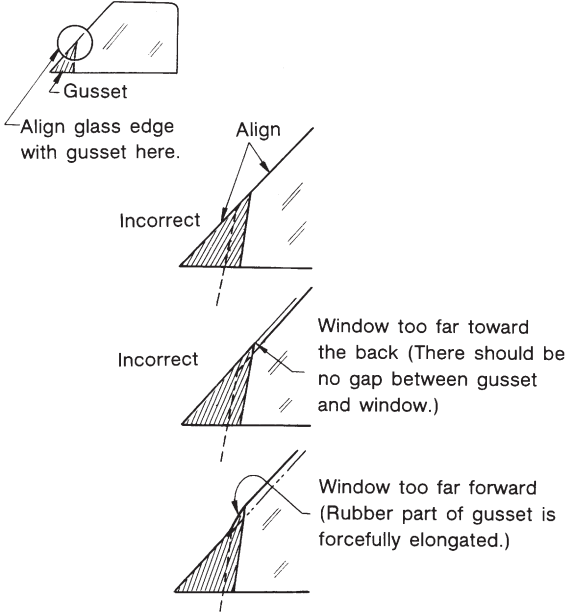
<p>3) Adjust door glass so that it is aligned with door rearview mirror gusset.</p>

<p style="text-align: right;">G5M0504</p>	<ul style="list-style-type: none"> ● Window is not properly adjusted in up-down/fore-aft direction. Adjust window. If necessary, move B channel regulator to eliminate window tilt. ● Gusset is not properly adjusted in fore-aft direction. Adjust gusset after loosing all bolts and nuts with tightening it.

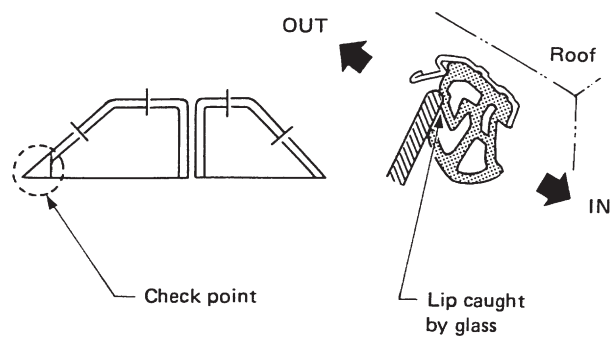
Condition	Apparent cause/Correction
<p>Door in fully closed/open position</p>	<p>1) Glass rides over weatherstrip lip when door is closed.</p>

<p style="text-align: right;">G5M0505</p> <p>(This condition increases wind/booming noise, leakage and/or effort required to close door.)</p>	<ul style="list-style-type: none"> ● Improper up-down and in-out glass alignments Adjust glass for up-down and in-out alignments (incl. rear sash, upper stopper adjustment, etc.). If necessary, correct glass tilt by moving B channel regulator.
	<p>2) Edge of glass contacts retainer when door is fully closed.</p>

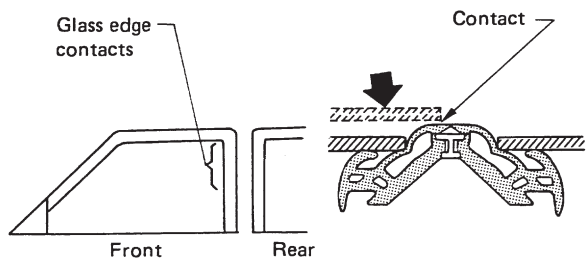
<p style="text-align: right;">G5M0506</p>	<ul style="list-style-type: none"> ● Improper glass-to-center pillar weatherstrip or excessive glass contact to weatherstrip ● Excessive adjusting in contact to weatherstrip Causes rear edge of glass to tilt inboard closer to center pillar. Adjust rear sash adjustment bolt to reduce glass contact to weatherstrip.

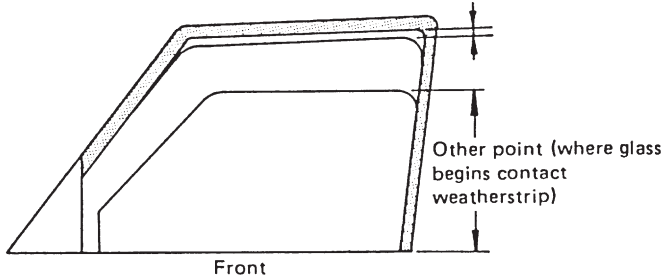
<p>Raise or lower window glass</p>	<p>1) Considerable effort or time is required to operate regulator. Standard operating effort:</p> <ul style="list-style-type: none"> ● Entire up-down travel except for point 5 mm (0.20 in) below fully closed position: 29.4 N (3.0 kg, 6.6 lb) ● Point 5 mm (0.20 in) below fully closed position: 44.1 N (4.5 kg, 9.9 lb) <p style="text-align: center;">Point 5 mm (0.20 in) below fully closed position</p>

<p style="text-align: right;">G5M0507</p>	<ul style="list-style-type: none"> ● Sliding resistance increased due to high stabilizer-to-glass contact pressure. Reduce contact by mounting inner stabilizer to inside of the vehicle. ● High glass-to-windshield contact pressure Reduce contact using upper sash adjustment bolt. ● Unequal contact adjustment stroke between front and rear sashes Set to equal stroke. ● Tilt of rear sash adjustment bolt mounting bracket Correct tilt of bracket so it is parallel to inner panel.

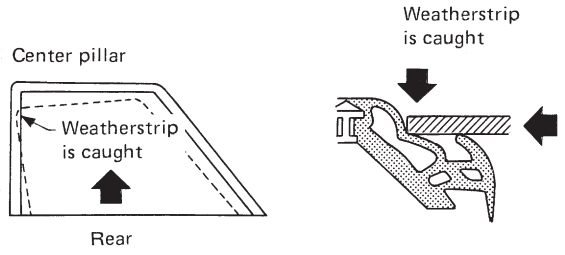
Condition	Apparent cause/Correction
<p>Raise or lower window glass</p>	<p>2) Center pillar weatherstrip is caught by rear window glass when glass is raised.</p>

<p style="text-align: right;">G5M0508</p>	<ul style="list-style-type: none"> Improper fore-aft or in-out alignment of window glass Lower B channel regulator to tilt window glass back.
	<p>3) Window glass tilts forward by more than 2 mm (0.08 in).</p>

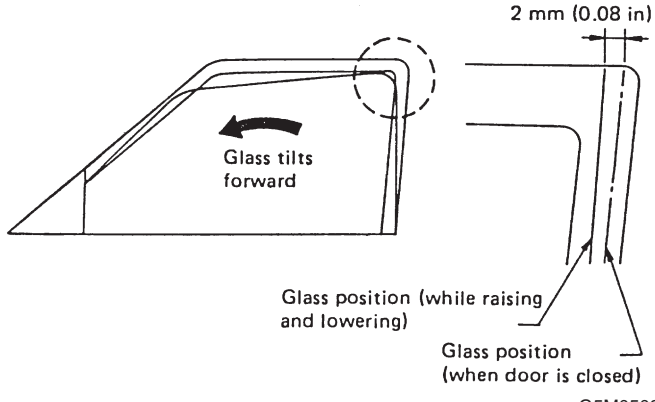
<p style="text-align: right;">G5M0509</p> <p>Excessive tilt of glass forward is due to excessive glass "contact" which causes reaction of center pillar weatherstrip. Glass can be tilted forward due to increase in reaction of shoulder weatherstrip or free play between sash and roller. Taking these symptoms into account, glass should be aligned.</p>	<ul style="list-style-type: none"> Excessive glass contact pressure or improper in-out alignment <ol style="list-style-type: none"> Lower B channel regulator to tilt window glass rearward. Reduce contact pressure using upper sash adjustment bolt.
