| <b>DTC</b> | <b>B1217 / 17</b> | <b>Rear left door ECU communication stop</b> |

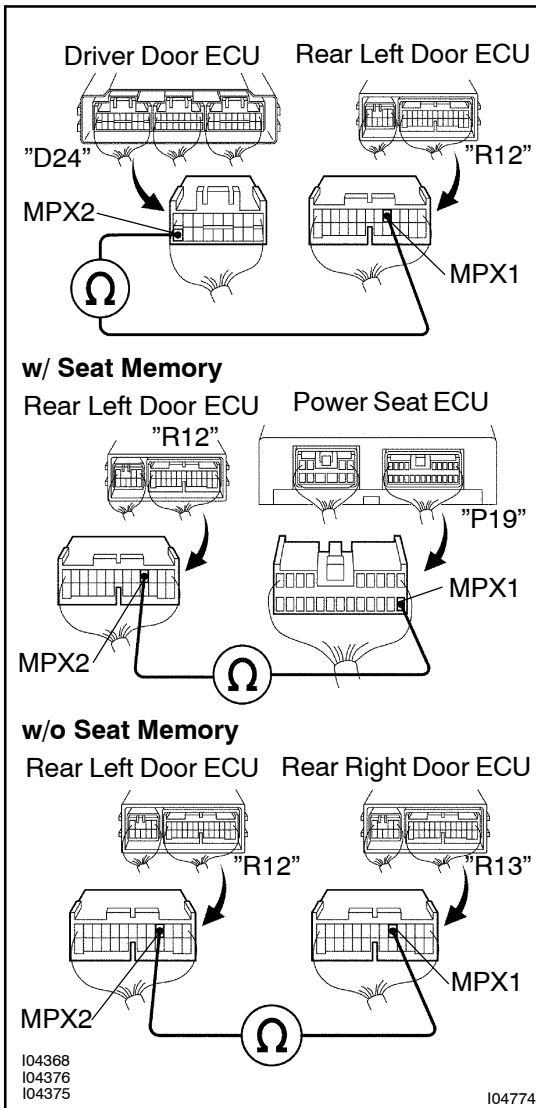
## 2 Check wireharness

Disconnect connector "D24" of driver door ECU, "R12" of rear left door ECU and "P19" of power seat ECU (or "R13" of rear right door ECU).

- Check continuity between terminals MPX2 of driver door ECU and MPX1 of rear left door ECU.
- w/Seat memory  
Check continuity between terminals MPX2 of rear left door ECU and MPX1 of power seat ECU.
- w/o Seat memory  
Check continuity between terminals MPX2 of rear left door ECU and MPX1 of rear right door ECU.

There is a continuity in wireharness of both (a) and (b) or (a) and (c), (a) or either (b) or (c).

If there is OPEN in wireharness of either (a), (b) or (c), please repair it.

Repair or replace wireharness.

Replace the rear left door ECU.
