| <b>DTC</b> | <b>6</b> | <b>”CODE 6. Loss of BEAN communication”</b> |

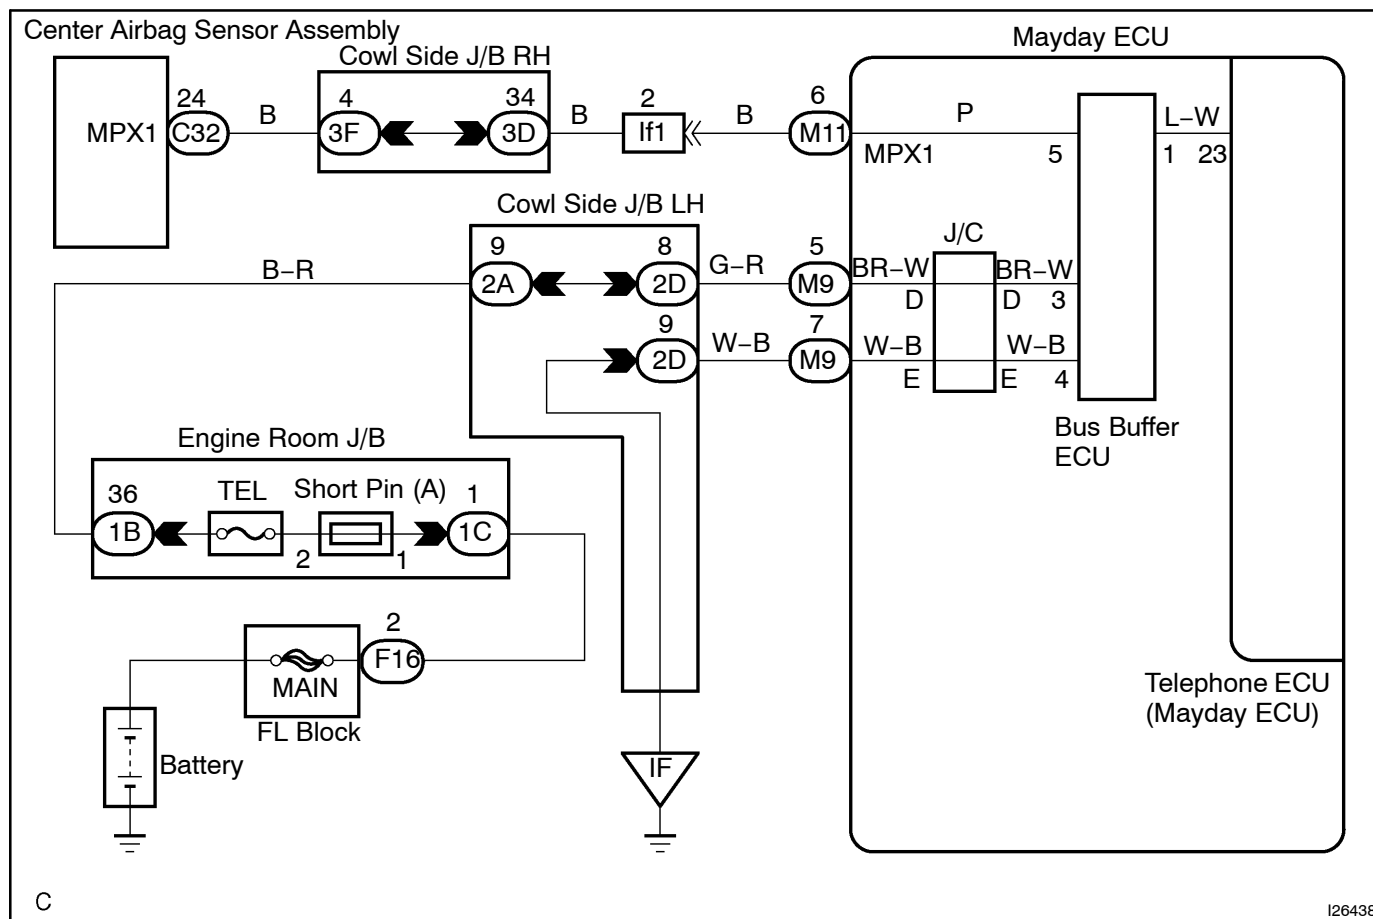
## WIRING DIAGRAM

This DTC is output when communication from the airbag ECU is interrupted for 10 sec. or more. In this case, possible causes are communication interruption from the airbag ECU, a failure in the bus buffer ECU or a break of the harness between the bus buffer ECU and the telephone ECU (Mayday ECU).

Replace or repair wire harness connector.

Replace the telephone ECU (Mayday ECU)  
(See page [IN-36](#)).

If DTC is not cleared even though the telephone ECU (Mayday ECU) is replaced, replace the Bus Buffer ECU.
