| <b>DTC</b> | <b>B1218</b> | <b>Body ECU No. 2 communication stop</b> |

This DTC is output when communication stops between the Body ECU (Sub) and the Body ECU (Main).

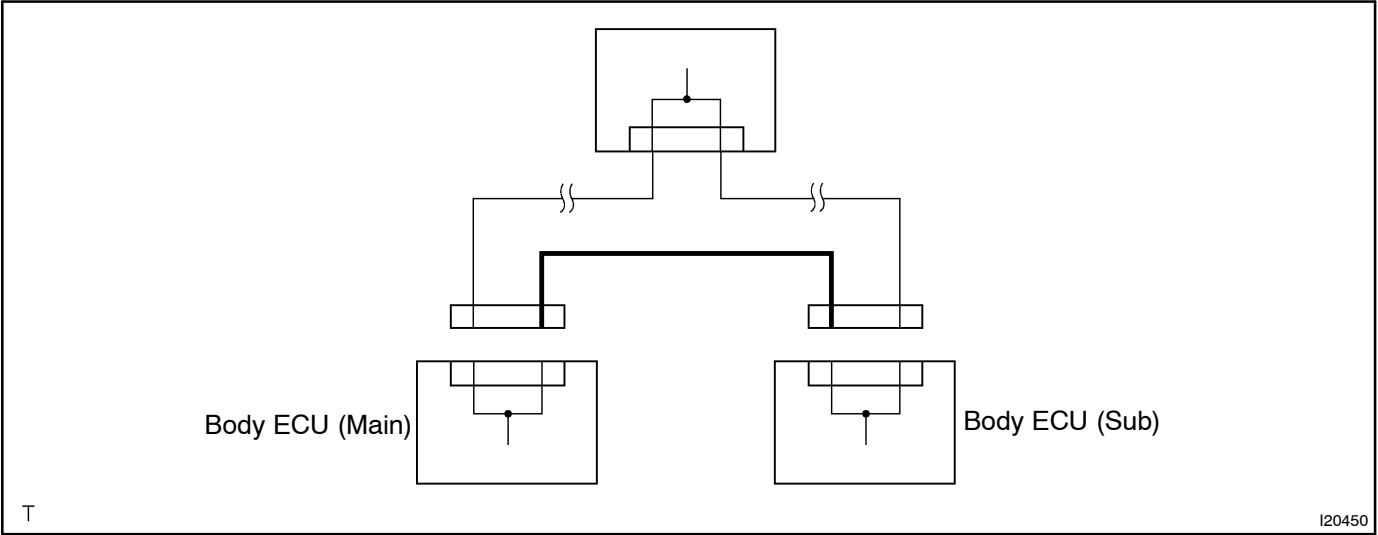
| Wire harness side connector of ECU | Terminal |
|---|---|
| Body ECU (Sub) - Body ECU (Main) | MPX+ (Z71-2) - MPX2 (B7-23) |

Check continuity of the wire harness between the connectors.

There is a continuity between the connectors.

If there is OPEN in any wire harness, please repair it.

Repair or replace wire harness.

Replace body ECU (Sub) (See page [IN-36](#)).
