GROUP 54

CHASSIS ELECTRICAL

OUTLINE OF CHANGES

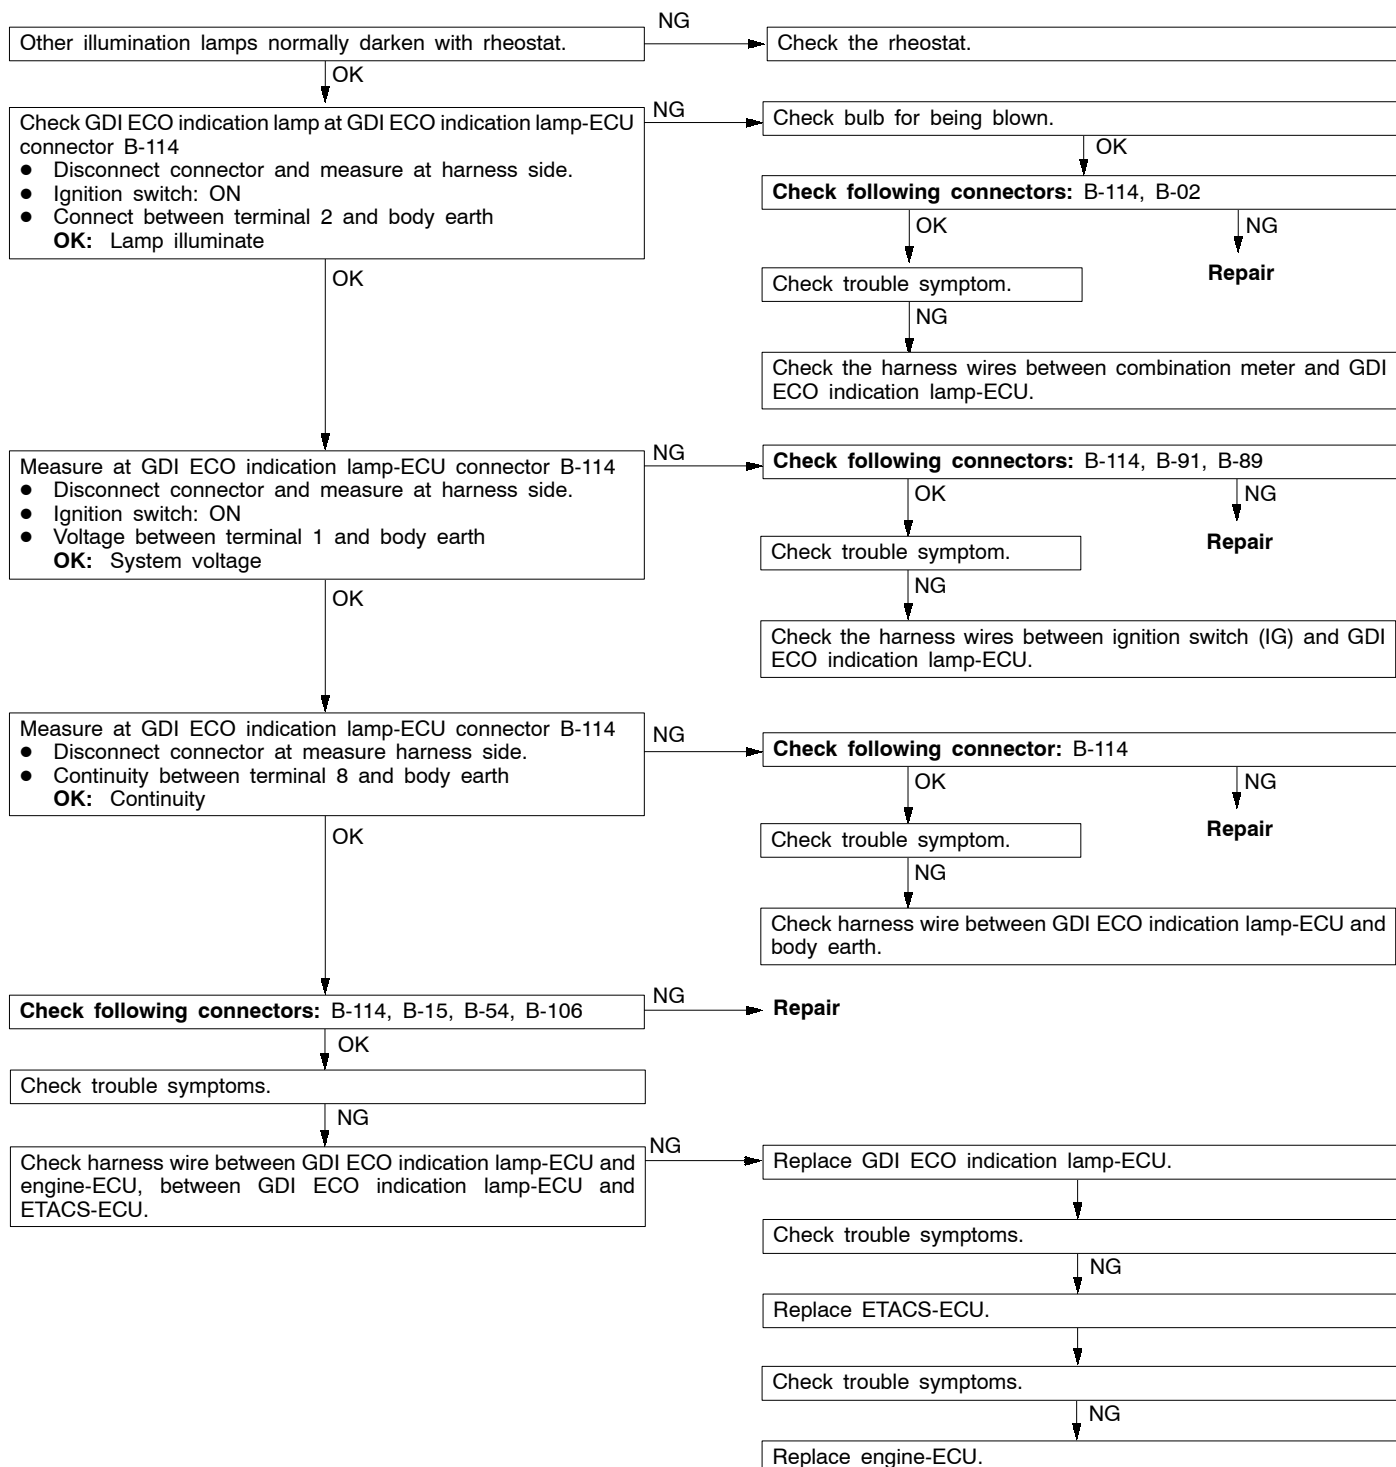
Inspection Procedure 6

GD I ECO indication lamp does not illuminate.	Probable cause
<p>GD I ECO indication lamp is illuminated by GD I ECO indication lamp-ECU. When it does not illuminates, GD I ECO indication lamp bulb may be blown, or combination meter, power supply circuit of GD I ECO indication lamp-ECU or GD I ECO indication lamp-ECU may be malfunctioning.</p>	<ul style="list-style-type: none"> • GD I ECO indication lamp bulb blown • Malfunction of combination meter • Malfunction of GD I ECO indication lamp • Malfunction of GD I ECO indication lamp-ECU • Malfunction of ETACS-ECU • Malfunction of engine-ECU • Damaged harness or connectors
