DTC

B0138/72

# Short in P/T Squib (LH) Circuit (to B+)

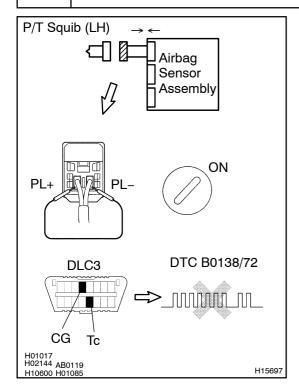
# 3 Check airbag sensor assembly.

#### PREPARATION:

- (a) Connect the connector to the airbag sensor assembly.
- (b) Using a service wire, connect PL+ and PL- of the connector (on the seat belt pretensioner side) between the seat belt pretensioner (LH) and the airbag sensor assembly.
- (c) Connect negative (–) terminal cable to the battery, and wait at least for 2 seconds.

#### **CHECK:**

- (a) Turn the ignition switch to ON, and wait at least for 20 seconds.
- (b) Clear the DTC stored in memory (See step 5 on page DI-3).
- (c) Turn the ignition switch to LOCK, and wait at least for 20 seconds.
- (d) Turn the ignition switch to ON, and wait at least for 20 seconds.
- (e) Check the DTC (See page DI-3).

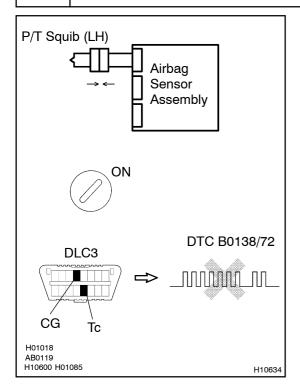
# 4 Check P/T squib (LH).

#### PREPARATION:

- (a) Turn the ignition switch to LOCK.
- (b) Disconnect negative (–) terminal cable from the battery, and wait at least for 90 seconds.
- (c) Connect the seat belt pretensioner (LH) connector.
- (d) Connect negative (-) terminal cable to the battery, and wait at least for 2 seconds.

#### **CHECK:**

- (a) Turn the ignition switch to ON, and wait at least for 20 seconds.
- (b) Clear the DTC stored in memory (See step 5 on page DI-3).
- (c) Turn the ignition switch to LOCK, and wait at least for 20 seconds.
- (d) Turn the ignition switch to ON, and wait at least for 20 seconds.
- (e) Check the DTC (See page DI-3).
