- DTC B1180/17

Short in Driver Side Squib 2nd Step Circuit

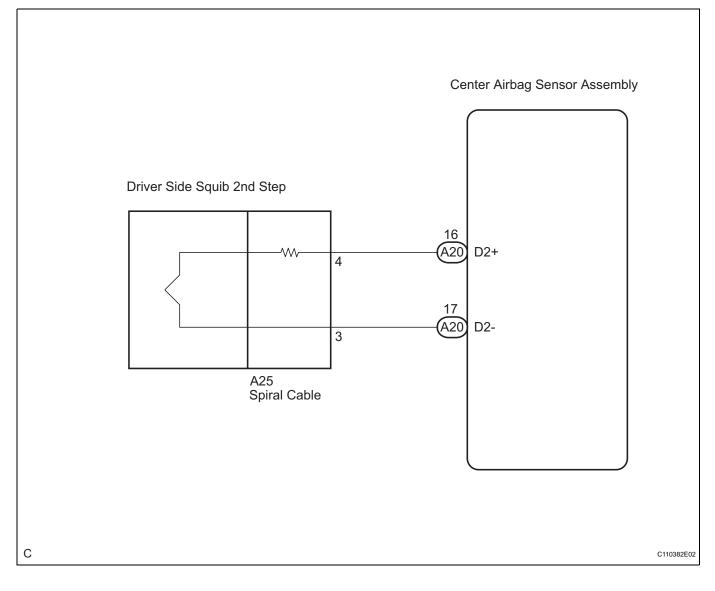
WIRING DIAGRAM

The driver side squib 2nd step circuit consists of the center airbag sensor assembly, the spiral cable and the steering pad.

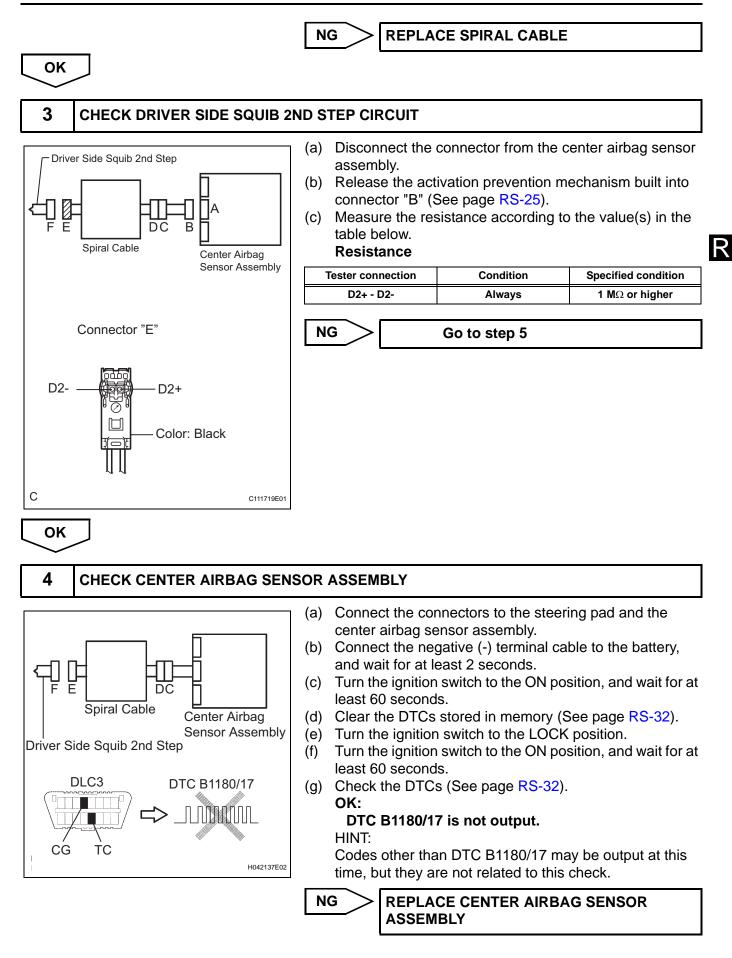
- (a) Turn the ignition switch to the LOCK position.
- (b) Disconnect the negative (-) terminal cable from the battery, and wait for at least 90 seconds.
- (c) Disconnect the SST (resistance 2.1 Ω) from the spiral cable.
- (d) Check that the spiral cable connectors (on the steering pad side) are not damaged.OK:

The lock button is not disengaged, and the claw of the lock is not deformed or damaged.
