OCCUPANT CLASSIFICATION SYSTEM

PARTS LOCATION

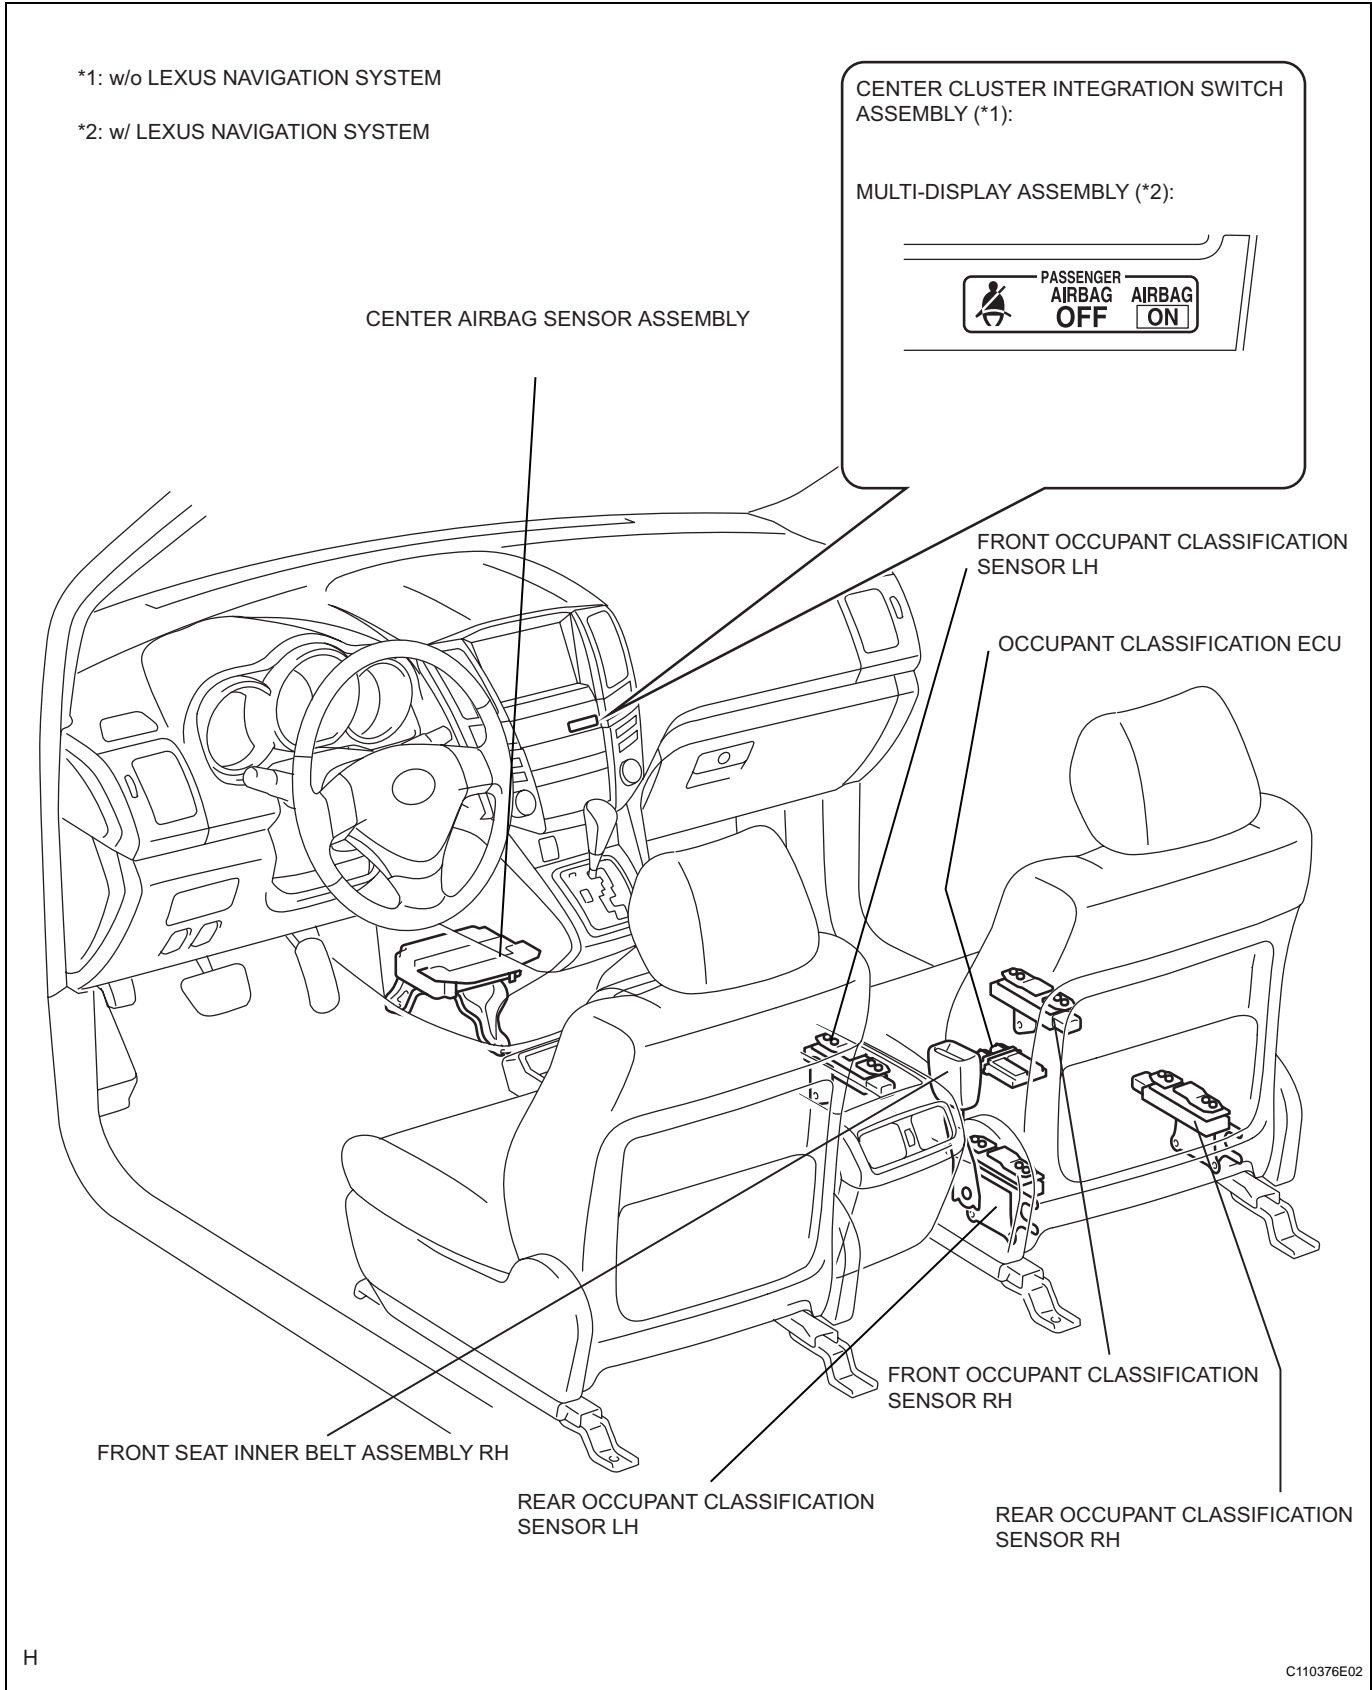
CENTER CLUSTER INTEGRATION SWITCH ASSEMBLY (*1):

MULTI-DISPLAY ASSEMBLY (*2):

CENTER AIRBAG SENSOR ASSEMBLY

FRONT OCCUPANT CLASSIFICATION SENSOR LH

OCCUPANT CLASSIFICATION ECU

FRONT OCCUPANT CLASSIFICATION SENSOR RH

FRONT SEAT INNER BELT ASSEMBLY RH

REAR OCCUPANT CLASSIFICATION SENSOR LH

REAR OCCUPANT CLASSIFICATION SENSOR RH
