# DRIVER SIDE KNEE AIRBAG ASSEMBLY

## COMPONENTS

## ON-VEHICLE INSPECTION

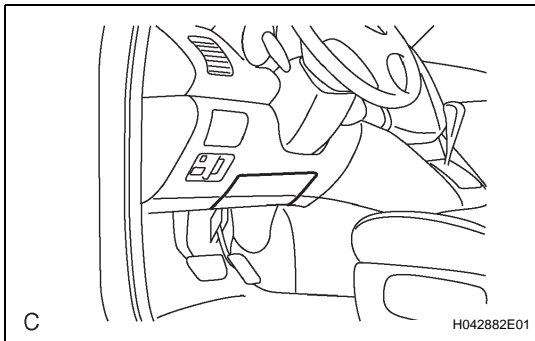
### 1. INSPECT DRIVER SIDE KNEE AIRBAG ASSEMBLY (VEHICLE NOT INVOLVED IN COLLISION)

- (a) Perform a diagnostic system check (See page [RS-25](#)).
- (b) With the driver side knee airbag assembly installed on the vehicle, perform a visual check. If there are any defects as mentioned below, replace the driver side knee airbag assembly with a new one:  
Cuts, minute cracks or marked discoloration on the driver side knee airbag assembly.

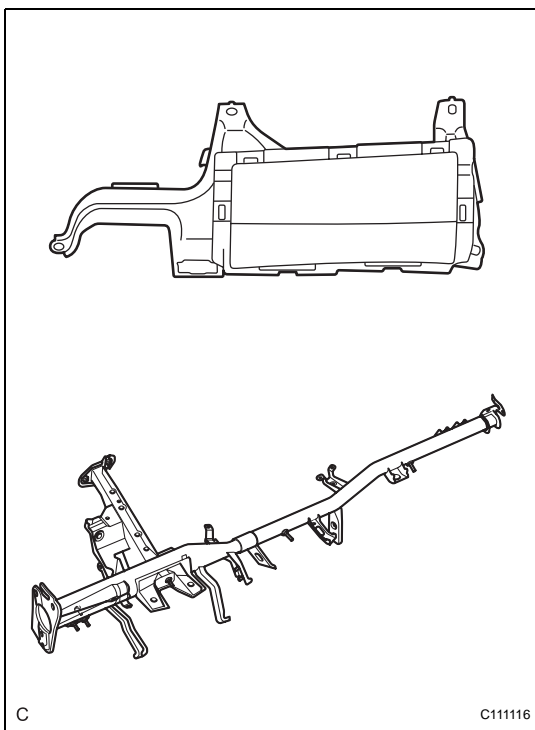
### 2. INSPECT DRIVER SIDE KNEE AIRBAG ASSEMBLY (VEHICLE INVOLVED IN COLLISION AND AIRBAG HAS NOT DEPLOYED)

- (a) Perform a diagnostic system check (See page [RS-25](#)).
- (b) With the driver side knee airbag assembly removed from the vehicle, perform a visual check. If there are any defects as mentioned below, replace the driver side knee airbag assembly with a new one:
  - Cuts, minute cracks or marked discoloration on the driver side knee airbag assembly.
  - Cracks or other damage to the connector.
  - Deformation or cracks on the instrument panel reinforcement.
