A/C Service Tips

The following tech tips apply to specific symptoms or conditions on Subaru air conditioning systems. Scan these pages to see if the symptoms on your problem vehicle match the descriptions here. Follow the recommended service procedures for all air conditioning repairs.

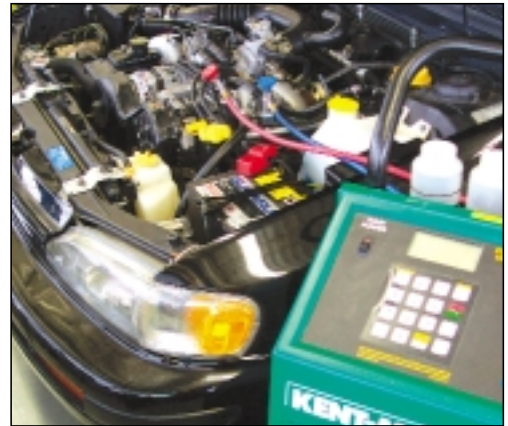
Recovering Refrigerant and Oil

Always examine the oil when replacing a failed (seized or not pumping) A/C compressor. If you find metal particles, flush the entire with an approved air conditioning system flushing agent to remove the particles. Simply installing a new receiver-drier with the replacement compressor may not be enough to keep the leftover par-

If compressed air is used to dry the system after the flushing agent has been used, the system must be evacuated for an extended period of time to remove any residual moisture. A 30 minute evacuation period is necessary for a new system that has not been opened to the atmosphere. Air conditioning manufacturers are recommending alternative system flushing procedures to comply with the Montreal protocol.
