Subaru Drivetrain

Additional Drivetrain Tips

2000 Impreza Front Axle

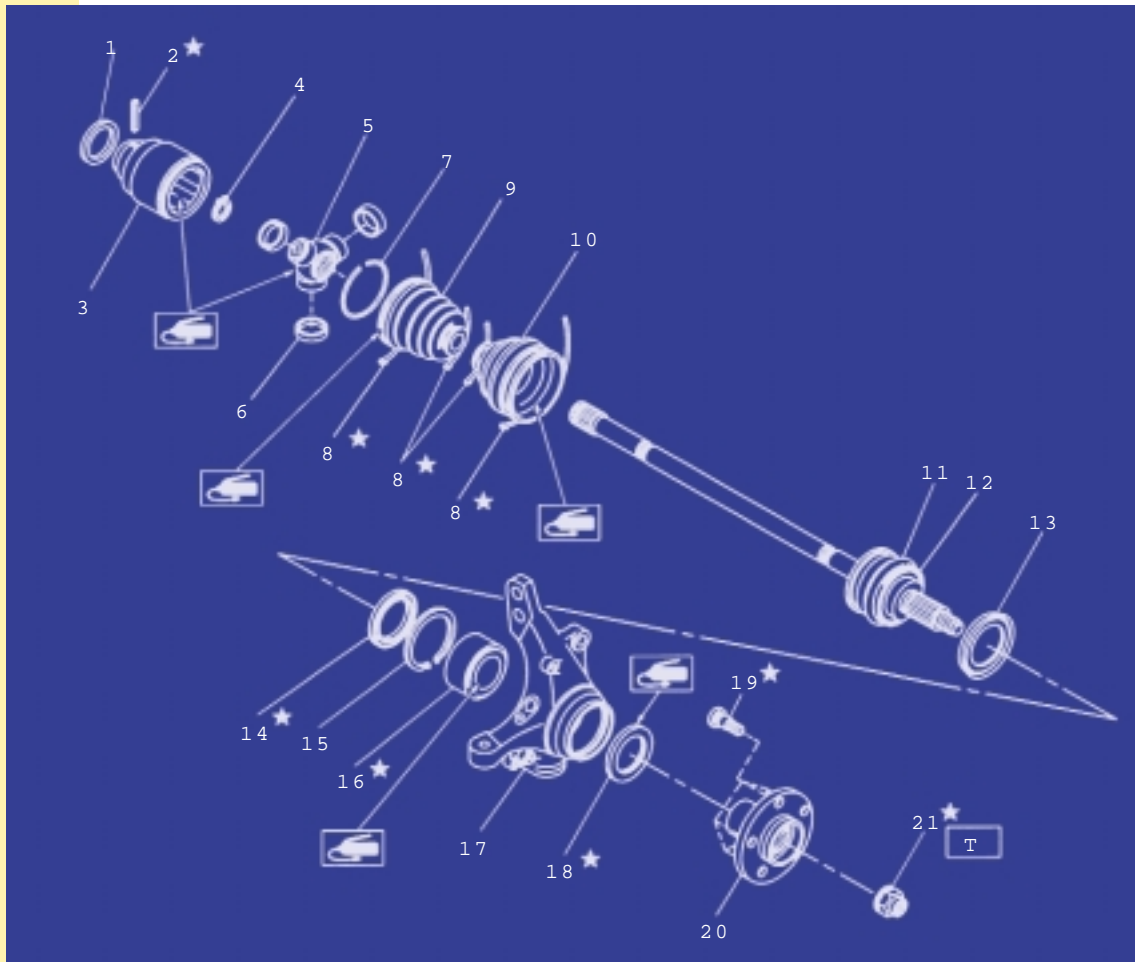
| 1. Baffle Plate (SFJ) | 6. Free ring | 11. BJ ASSY | 16. Bearing | 21. Axle nut |
| 2. Spring Pin | 7. Circlip | 12. Tone wheel | 17. Housing | |
| 3. Outer Race (SFJ) | 8. Boot band | 13. Baffle plate | 18. Oil seal (OUT) | |
| 4. Snap ring | 9. Boot (SFJ) | 14. Oil seal (IN) | 19. Hub bolt | |
| 5. Trunnion | 10. Boot (BJ) | 15. Snap ring | 20. Hub | |

Tightening torque:
N•m (kg-m, ft-lb)
T: 186±20 (19±2, 137±14)

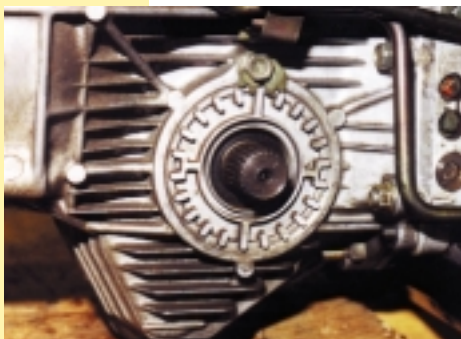
Front stub axle seal replacements require special precautions. The seals are pressed into a side bearing retainer, which must be removed to replace a leaking seal. The side bearing retainers also control front differential side bearing preload, as well as ring and pinion backlash. When replacing a stub axle seal, mark the position of the side bearing retainer before unthreading the retainer. Remove only one side bearing retainer at a time, or you'll risk disturbing the differential adjustments. If you've marked the position before removal, the correctly installed position of the side bearing retainer will be obvious, as you will be unable to turn the retainer another complete turn.

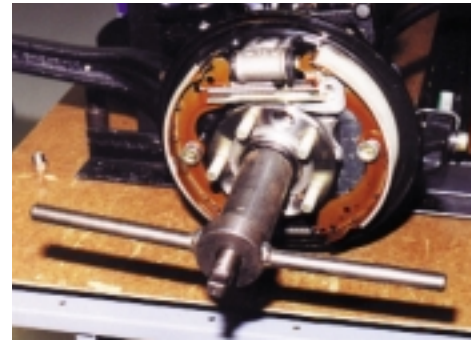
The driveaxles on some Subaru vehicles are pressed into the wheel hub with a light press fit. Blasting the axle out of the hub with an air chisel, center punch or other implement of destruction invites damage to the wheel bearings. All of the force brought to bear by these methods finds its way to the wheel bearings, possibly damaging their races or balls. Special tools are available for removing and installing (shown) press-fit driveaxles. Ignoring these cautions invites a comeback for noisy wheel bearings shortly after your CV axle repair work.

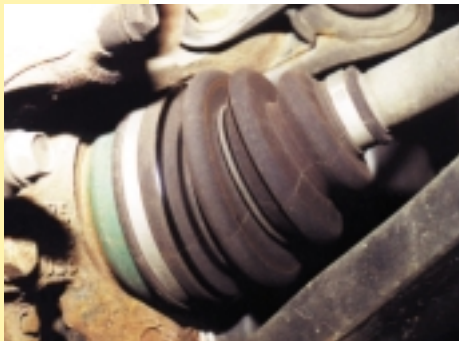
Some Subaru inner CV joint boots include a series of rubber O-rings that ride in the bottom of the CV boot creases. These O-rings keep the CV boot from rubbing against itself during sharp turning maneuvers and extend the life of the boot. If the original CV boot is torn or otherwise damaged, make sure its replacement includes this feature.

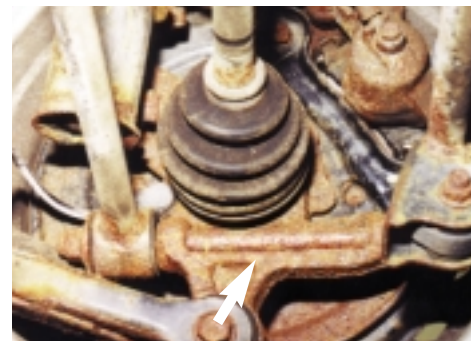
When replacing the rear wheel bearings on AWD Subaru Legacy, Impreza, SVX and Forester vehicles, do not overtorque the lateral link bolt (arrow) that secures the two transverse suspension arms to the wheel bearing housing. Do not use an impact wrench to remove or install the bolt. The proper torque is probably lower than you might think. The torque values are different for different models and years, so refer to the appropriate service manual for the proper specs for the vehicle you are working on. If this bolt is overtorqued, it can deform the housing and may lead to a repeat failure of the wheel bearing.

If you encounter a repeat wheel bearing failure in an unreasonably short period of time, the housing may have been deformed during the first repair. Replacement of the bearing and housing may be required.

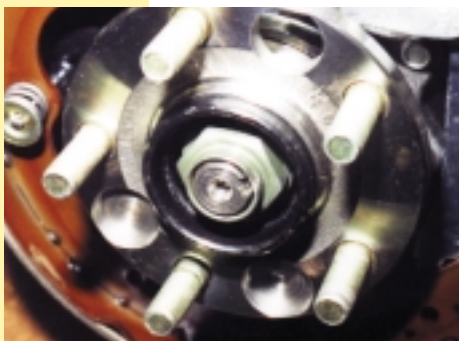
There are some other points to keep in mind when working on the front and rear wheel bearings. Never loosen or tighten the axle nut with the weight of the vehicle on the wheel. The vehicle should be in the air with the wheel removed prior to loosening or tightening the axle nut. If this precaution is not taken, damage to the wheel bearing may occur. The axle nuts are not reusable. A new nut should be used with the new bearing. Always insure that the new bearing is properly packed with suitable wheel bearing grease. The grease the bearing is shipped with is not sufficient. Always use the proper special tools to install the bearing and torque the axle nut to the correct specifications. To avoid wheel bearing damage, never use air tools to tighten or loosen a wheel bearing nut.
