Insider Info

Coolant Exchange Machine Approved

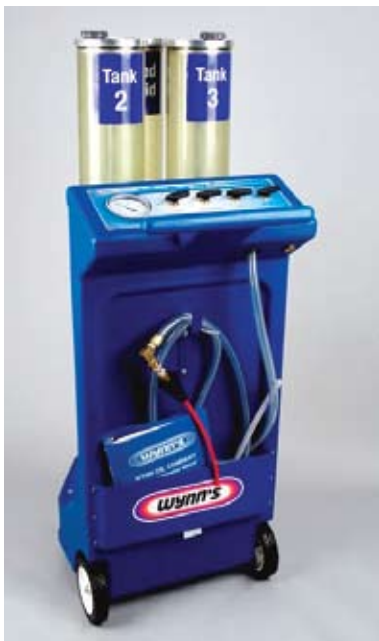
Subaru of America, Inc. has named the Wynn's PowerFlush III as its approved coolant exchange machine. The machine was chosen for its three separate tanks that allow the ability to perform a clean water flush of the cooling system quickly and efficiently. A clean water flush is possible by filling one tank with fresh water, while the other two tanks hold new coolant and removed liquids.

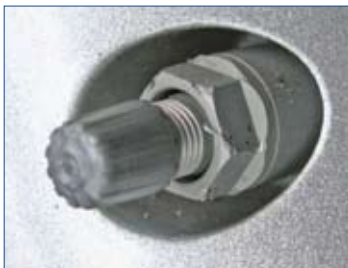
The 2007 and prior tire TPMS valve was silver in color, fitted with a retaining collar and topped with a silver cap (see photo).

2007 and prior tire valve/TPMS transmitter.

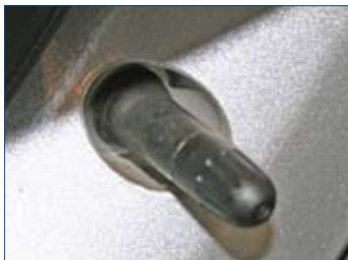
This is the new black rubber tire valve/TPMS transmitter used beginning with 2008 models.

The new “snap-in” valve is made from black rubber and fitted with a black cap. This new valve looks like the older-style valve used on vehicles without TPMS.

When deflating tires, never remove the valve stem with pliers as the delicate transmitter mounted on the valve stem base will be damaged. Instead, deflate the tire by depressing the valve stem or removing it with the proper tool. When reinstalling the valve, always tighten to the correct torque specifications using a valve stem torque tool.
