SERVICE BULLETIN

1991 LEGACY LS S/W

SUBJECT: WEAK/NOISY AM RADIO RECEPTION, WHEN RECEIVING DISTANT STATIONS

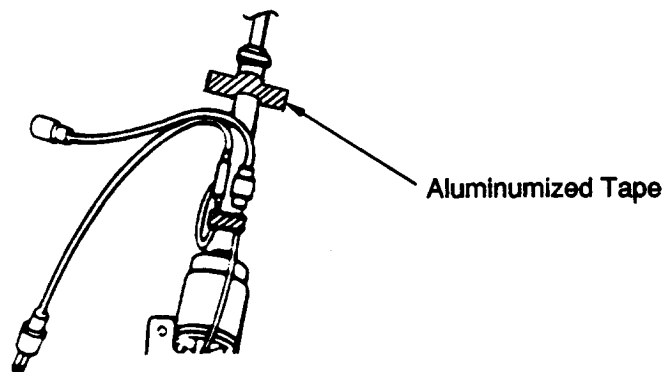
**Antenna Grounding
Figure 1**

Under certain conditions, AM radio reception may experience static or weak signal strength when tuned to distant or low power transmitting stations. Tests have shown that a modified antenna feeder cable, P/N 86324AA040, along with proper grounding of the antenna mounting bracket and the addition of shielding to the antenna base will improve the signal to noise ratio. These modifications have been incorporated in production since 2/14/91, starting with VIN 903307.

1. To ensure proper grounding of the antenna mounting hardware, the following steps should be carefully observed. See Figure 1.
 - a. Remove the pocket from the right rear interior quarter trim to gain access to the power antenna assembly.
 - b. Remove the screws securing the antenna mounting plate to the body and polish all areas of contact between the mounting plate and body.
 - c. Apply aluminized tape to the antenna base as shown in Figure 1.
 - d. Clean all areas where tape touches antenna and body, to ensure firm contact.
