19. Rear Turn Signal Light Bulb

S914421

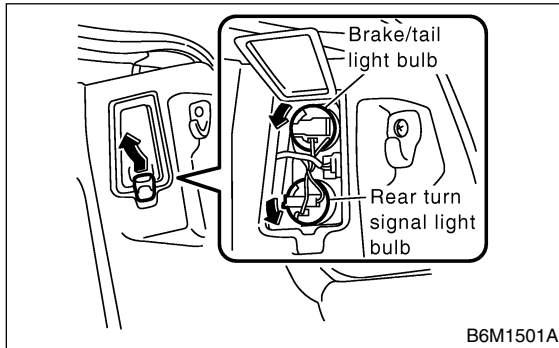
- 1) Open trunk lid and remove cover.

- 2) Turn the socket and remove the bulb.

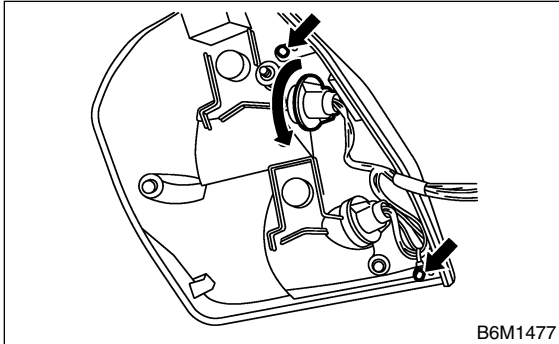
- 1) Remove rear combination light assembly. <Ref. to LI-18, WAGON, REMOVAL, Rear Combination Light Assembly.>
- 2) Remove the light cover mounting screws then detach the cover.
- 3) Turn the socket and remove the bulb.
