# Pipe Assembly

POWER ASSISTED SYSTEM (POWER STEERING)

### A: REMOVAL

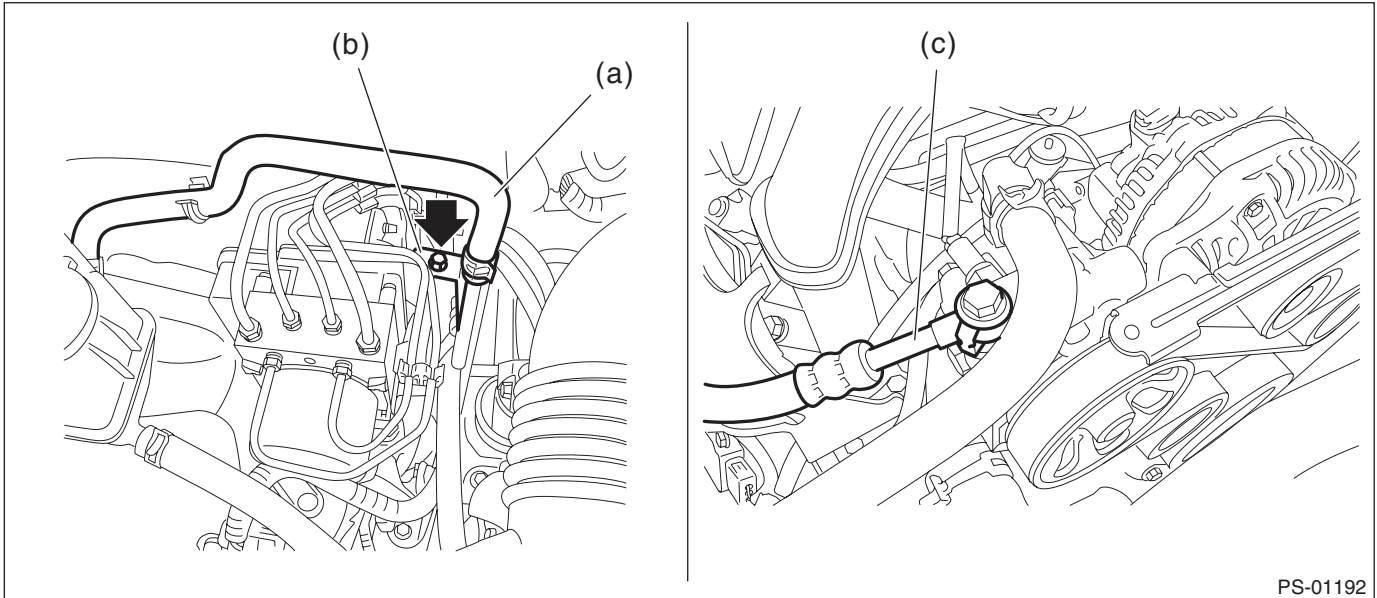
- (1) Remove the clip and disconnect the hose (a) from the pipe.
- (2) Remove the power steering hose bracket (b).
- (3) Remove the hose (c) from power steering pump.

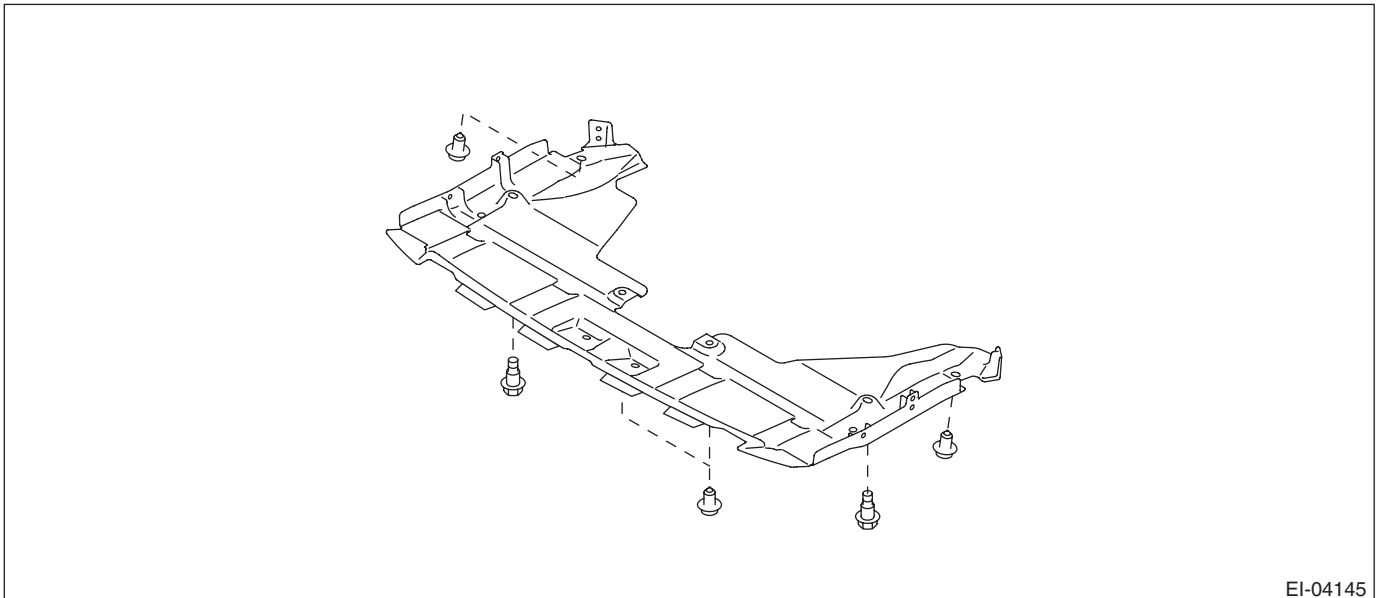
- 3) Lift up the vehicle, and then remove the under cover.

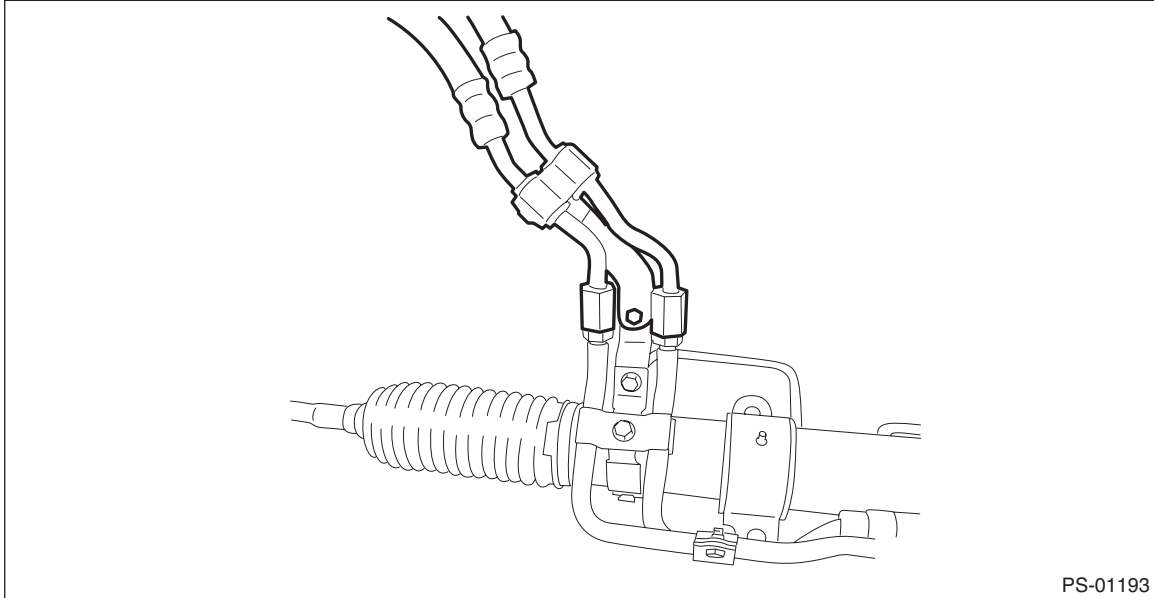
- 4) Disconnect the hose assembly from the steering gearbox.

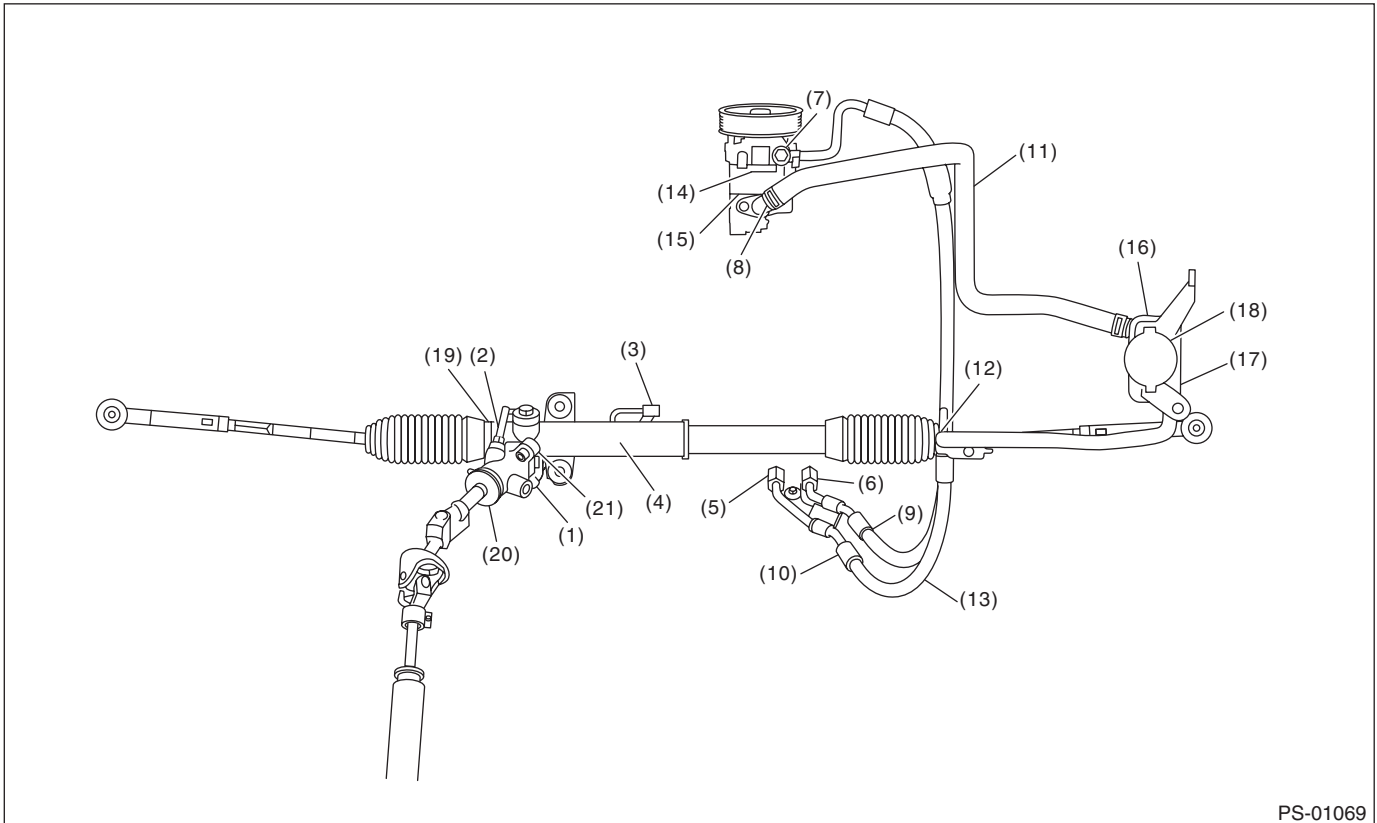
PS-01069

Fluid leaking area	Possible cause	Corrective action
Leakage from the connections of pipes and hoses, numbered (1) through (8) in the figure	Insufficient tightening of flare nut, adhesion of dirt, damage to flare or flare nut or eyebolt	Loosen and retighten. Replace if ineffective.
	Improper installation of hose or clamp	Replace.
	Damaged O-ring or gasket	Replace the O-ring, gasket pipe or hose with new part, if still no improvement, replace the gearbox or oil pump as well.
Leakage from hose (9) through (13) in the figure	Crack or damage in hose	Replace with a new part.
	Crack or damage in hose hardware	Replace with a new part.
Leakage from surrounding of aluminum portion of oil pump, (14) and (15) in the figure	Damaged O-ring	Replace the oil pump.
	Damaged gasket	Replace the oil pump.
Leakage from oil tank, (16) and (17) in the figure	Crack in oil tank	Replace the oil tank.
Leakage from filler neck of (18)	Damaged cap gasket	Replace the cap.

Crack in root of filler neck	Replace the oil tank.
	Fluid level too high	Adjust the fluid level.
Leakage from power cylinder of gearbox area (19) in the figure	Damaged oil seal	Replace the oil seal.
Leakage from (20), (21) in the figure and control valve of gearbox	Damaged gasket or oil seal	Replace the faulty parts.
	Damage in control valve	Replace the control valve.
